**Total Land Subsidence in the Fort Grant Rd and Willcox Areas, Cochise County
Based on ALOS-2 and Radarsat-2 Satellite Interferometric Synthetic Aperture Radar (InSAR) Data**

Time Period of Analysis: 8.4 Years 12/06/2006 To 04/09/2015

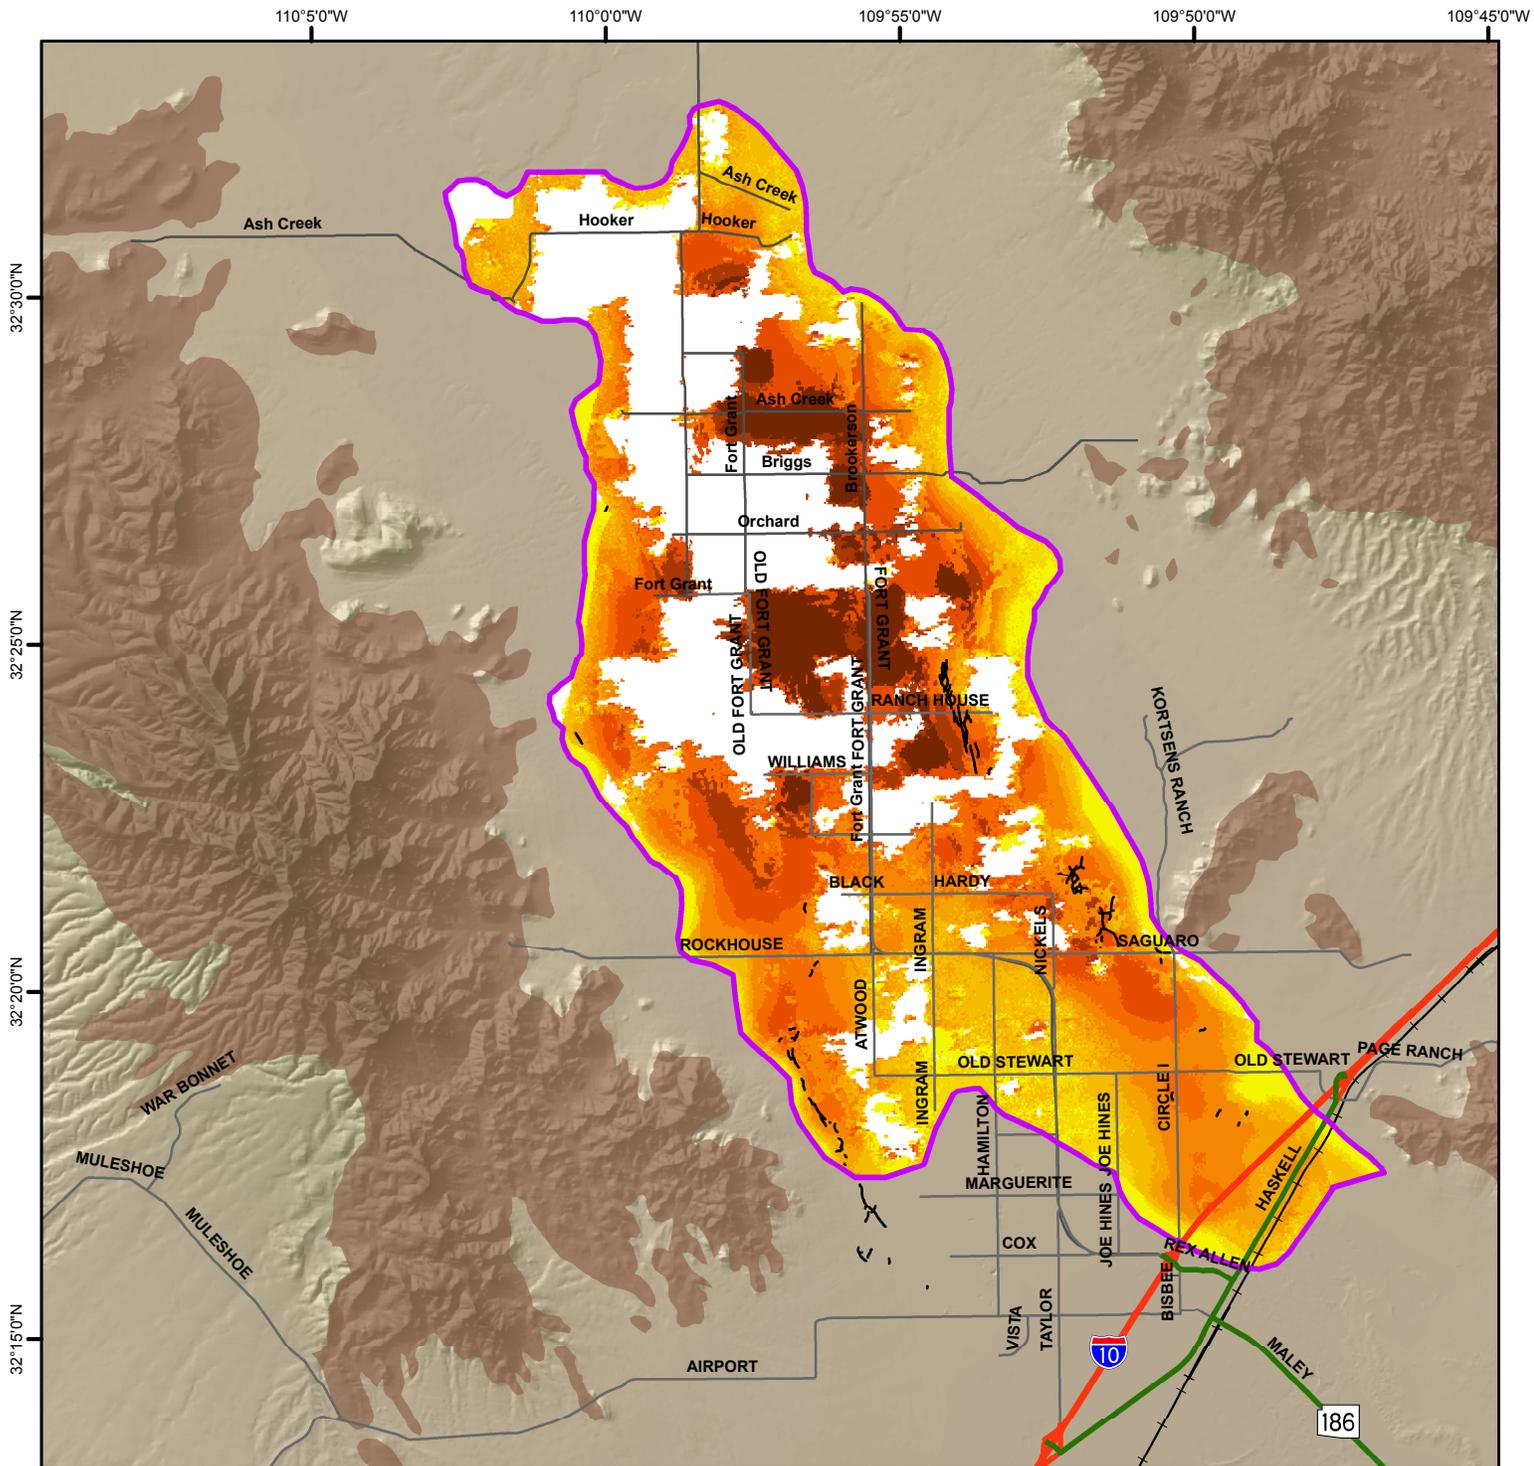
White	Decorrelation/No Data
Dark Brown	Greater 40 cm (15.7 in)
Brown	25 - 40 cm (9.8 - 15.7 in)
Orange	15 - 25 cm (5.9 - 9.8 in)
Light Orange	10 - 15 cm (3.9 - 5.9 in)
Yellow-Orange	6 - 10 cm (2.4 - 3.9 in)
Yellow	4 - 6 cm (1.6 - 2.4 in)
Light Yellow	2 - 4 cm (0.8 - 1.6 in)
Very Light Yellow	1 - 2 cm (0.4 - 0.8 in)
White	0 - 1 cm (0 - 0.4 in)

Decorrelation (white areas) are areas where the phase of the received satellite signal changed between satellite passes, causing the data to be unusable. This occurs in areas where the land surface has been disturbed (i.e. bodies of water, snow, agriculture areas, areas of development, etc).

Earth fissures were mapped by the Arizona Geological Survey. For information on earth fissures visit: www.azgs.gov/EFC
