**Total Land Subsidence in the Gila Bend Area, Southwestern Maricopa County
Based on Envisat Satellite Interferometric Synthetic Aperture Radar (InSAR) Data**

Time Period of Analysis: 1.0 Years 01/26/2008 To 02/14/2009

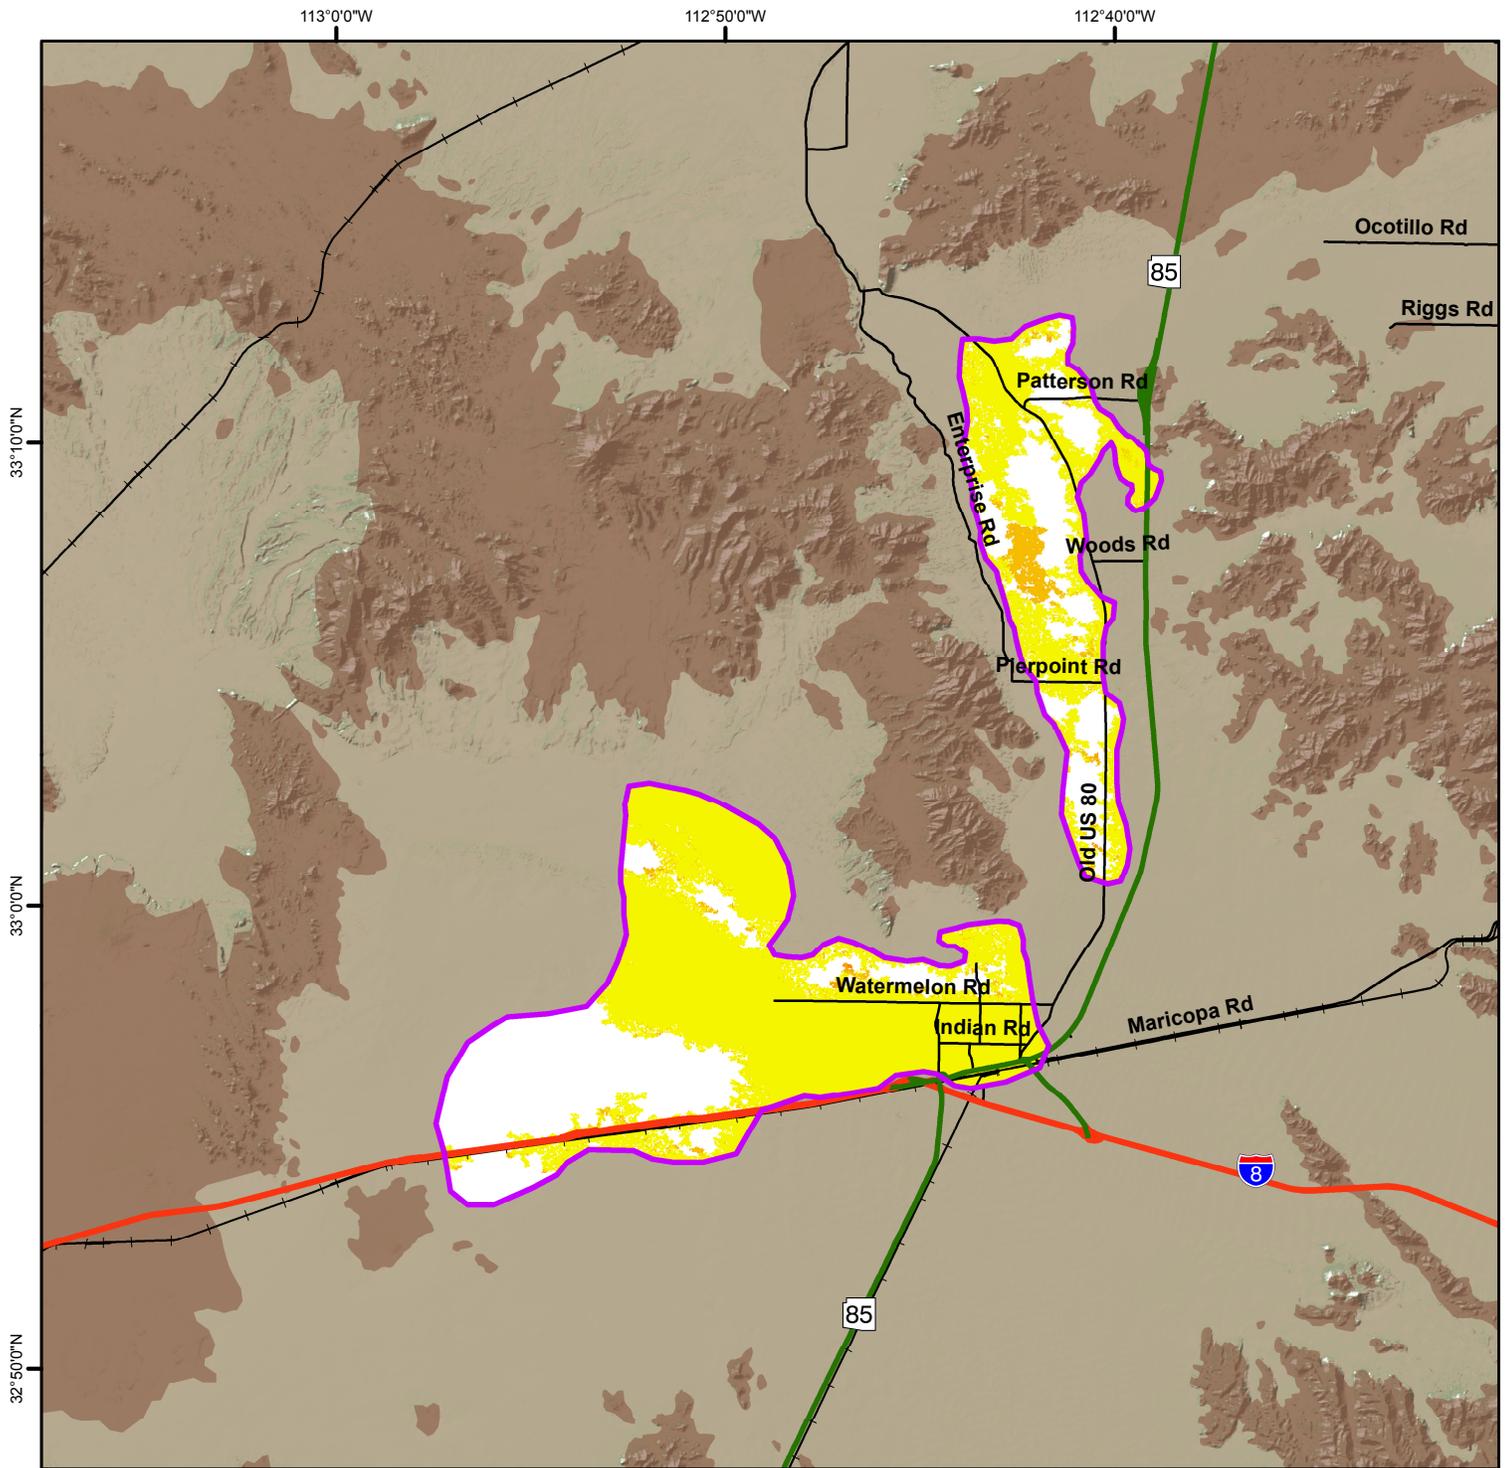
Total Land Subsidence

- Decorrelation/No Data
- Greater 40 cm (15.7 in)
- 25 - 40 cm (9.8 - 15.7 in)
- 15 - 25 cm (5.9 - 9.8 in)
- 10 - 15 cm (3.9 - 5.9 in)
- 6 - 10 cm (2.4 - 3.9 in)
- 4 - 6 cm (1.6 - 2.4 in)
- 2 - 4 cm (0.8 - 1.6 in)
- 1 - 2 cm (0.4 - 0.8 in)
- 0 - 1 cm (0 - 0.4 in)

Decorrelation (white areas) are areas where the phase of the received satellite signal changed between satellite passes, causing the data to be unusable. This occurs in areas where the land surface has been disturbed (i.e. bodies of water, snow, agriculture areas, areas of development, etc).
