Total Land Subsidence in the Gila Bend Area, Southwestern Maricopa County
Based on Envisat Satellite Interferometric Synthetic Aperture Radar (InSAR) Data
Time Period of Analysis: 2.1 Years 01/26/2008 To 03/06/2010

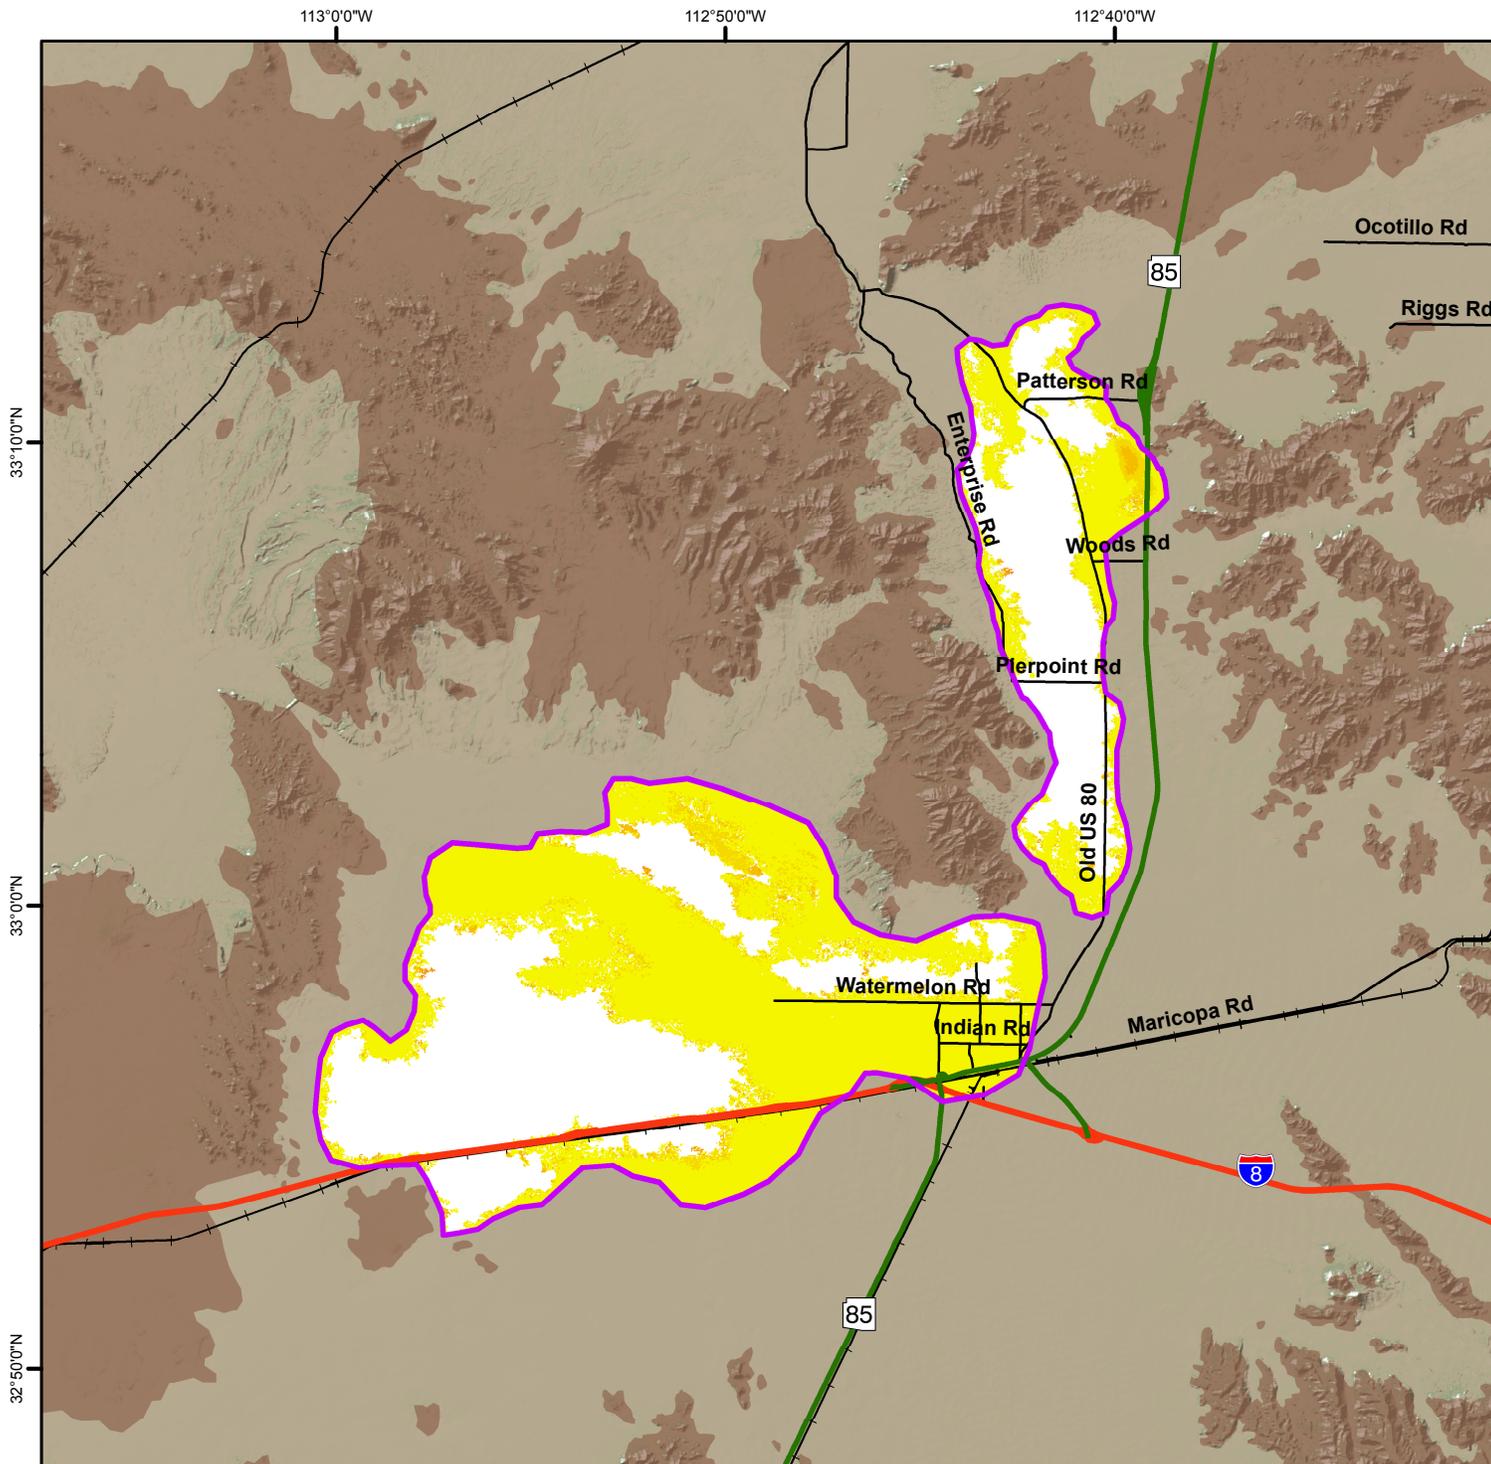
Decorrelation (white areas) are areas where the phase of the received satellite signal changed between satellite passes, causing the data to be unusable. This occurs in areas where the land surface has been disturbed (i.e. bodies of water, snow, agriculture areas, areas of development, etc).
