Total Land Subsidence in the Gila Bend Area, Southwestern Maricopa County
Based on Envisat Satellite Interferometric Synthetic Aperture Radar (InSAR) Data
Time Period of Analysis: 1.0 Years 02/14/2009 To 03/06/2010

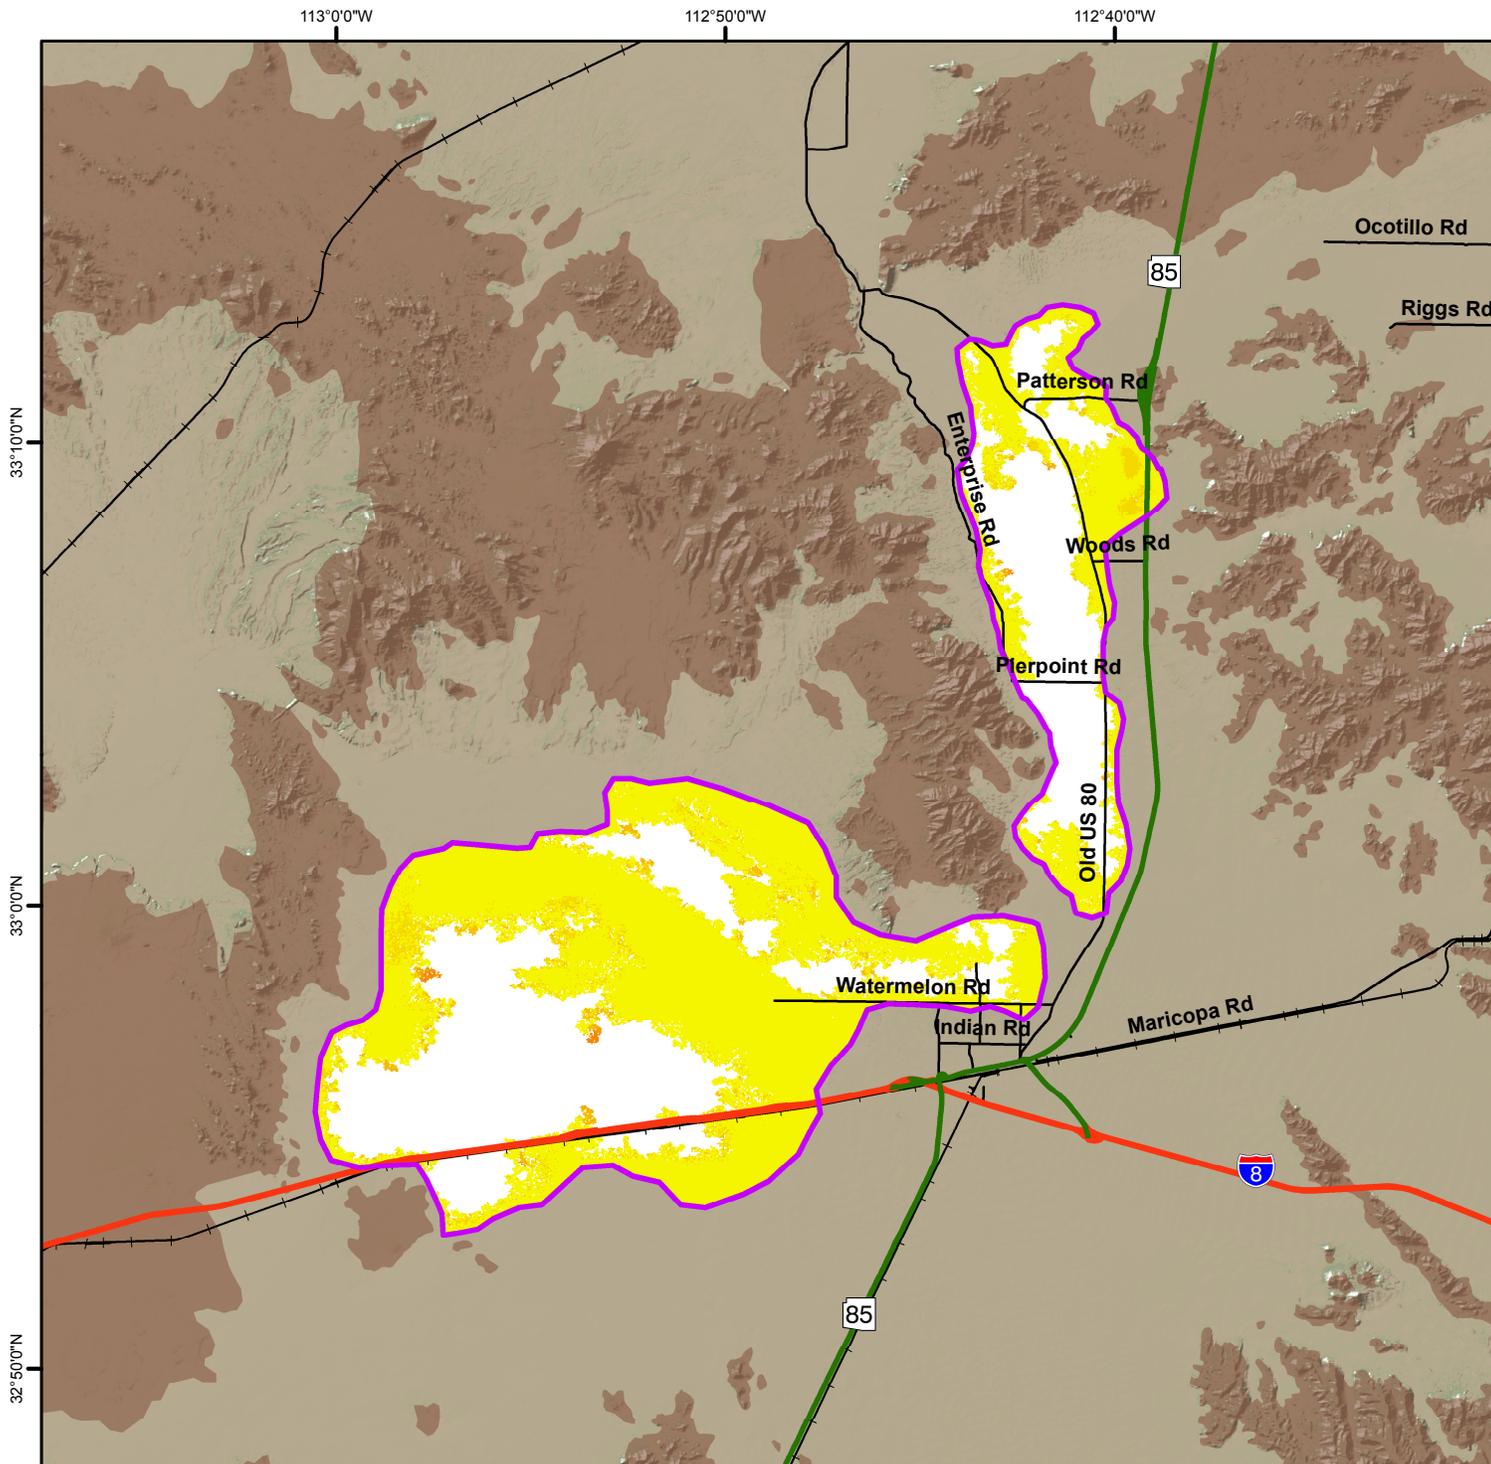
Decorrelation (white areas) are areas where the phase of the received satellite signal changed between satellite passes, causing the data to be unusable. This occurs in areas where the land surface has been disturbed (i.e. bodies of water, snow, agriculture areas, areas of development, etc).
