Land Subsidence Rate in the Sahuarita and Green Valley Areas, Pima County
 Based on Envisat Satellite Interferometric Synthetic Aperture Radar (InSAR) Data
 Time Period of Analysis: 1.1 Years 02/23/2007 To 03/14/2008

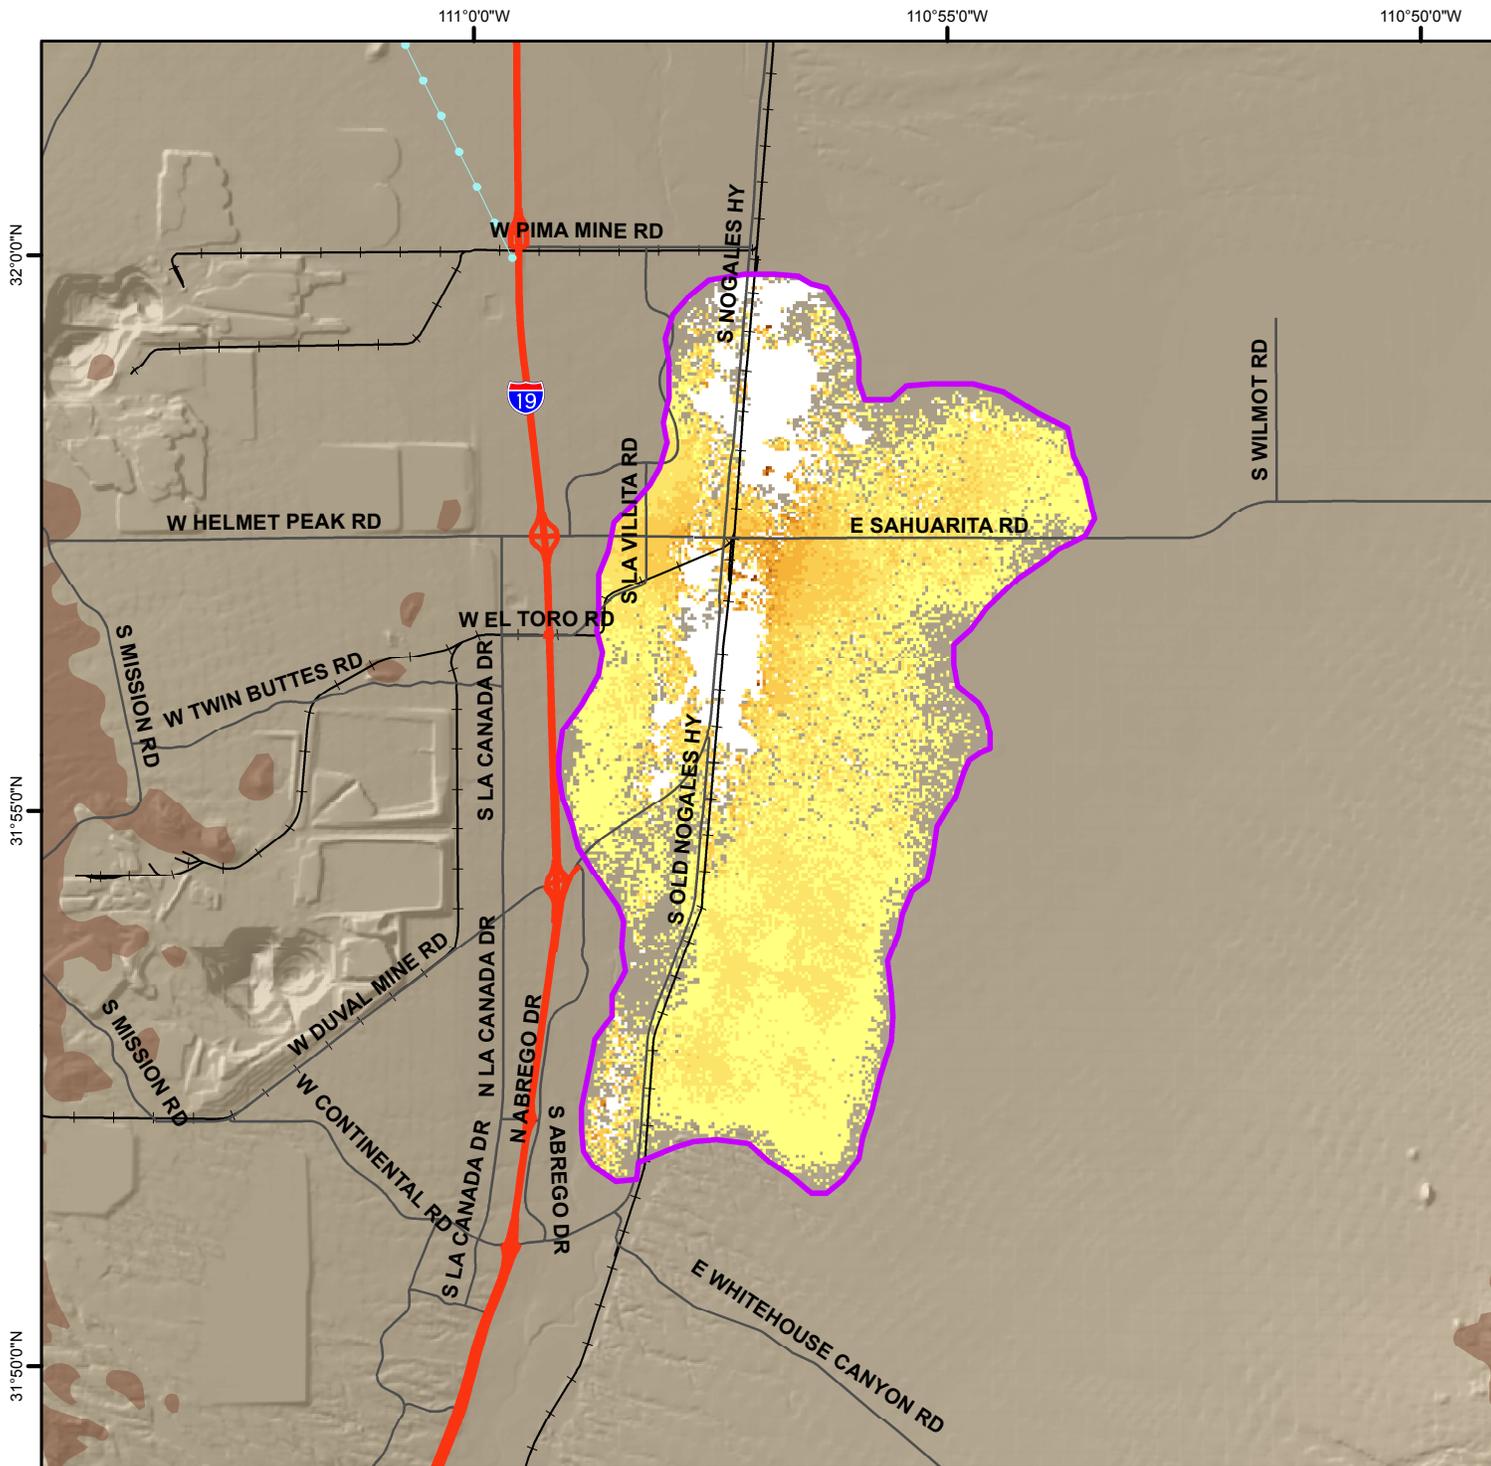
Decorrelation (white areas) are areas where the phase of the received satellite signal changed between satellite passes, causing the data to be unusable. This occurs in areas where the land surface has been disturbed (i.e. bodies of water, snow, agriculture areas, areas of development, etc).
