Total Land Subsidence in the Hawk Rock Area, Maricopa and Pinal Counties
 Based on Radarsat-2 Satellite Interferometric Synthetic Aperture Radar (InSAR) Data
 Time Period of Analysis: 5.9 Years 05/15/2010 To 03/30/2016

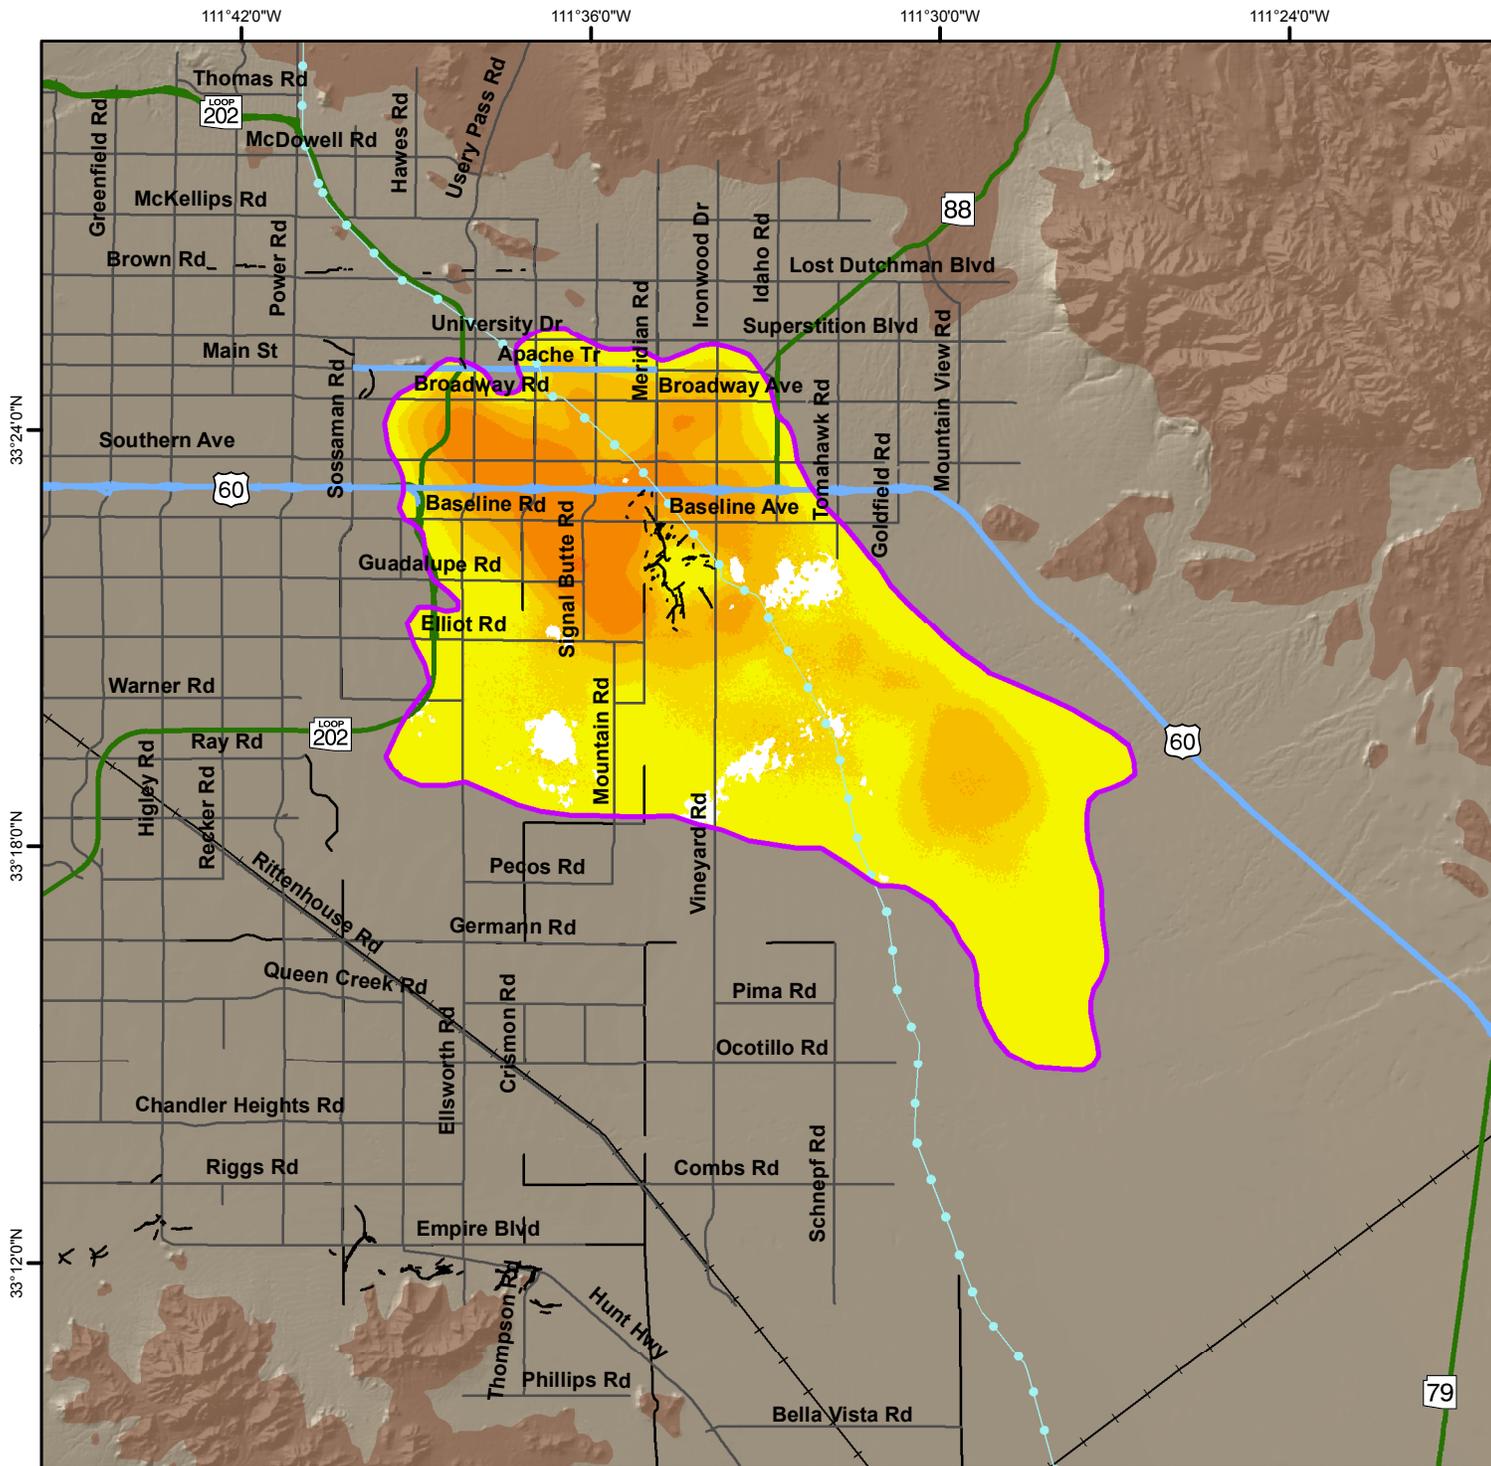
Decorrelation (white areas) are areas where the phase of the received satellite signal changed between satellite passes, causing the data to be unusable. This occurs in areas where the land surface has been disturbed (i.e. bodies of water, snow, agriculture areas, areas of development, etc).

Earth fissures were mapped by the Arizona Geological Survey. For information on earth fissures visit: www.azgs.gov/EFC
