Land Subsidence Rate in the Hawk Rock Area, Maricopa and Pinal Counties
 Based on Radarsat-2 Satellite Interferometric Synthetic Aperture Radar (InSAR) Data
 Time Period of Analysis: 1.0 Years 04/19/2015 To 03/30/2016

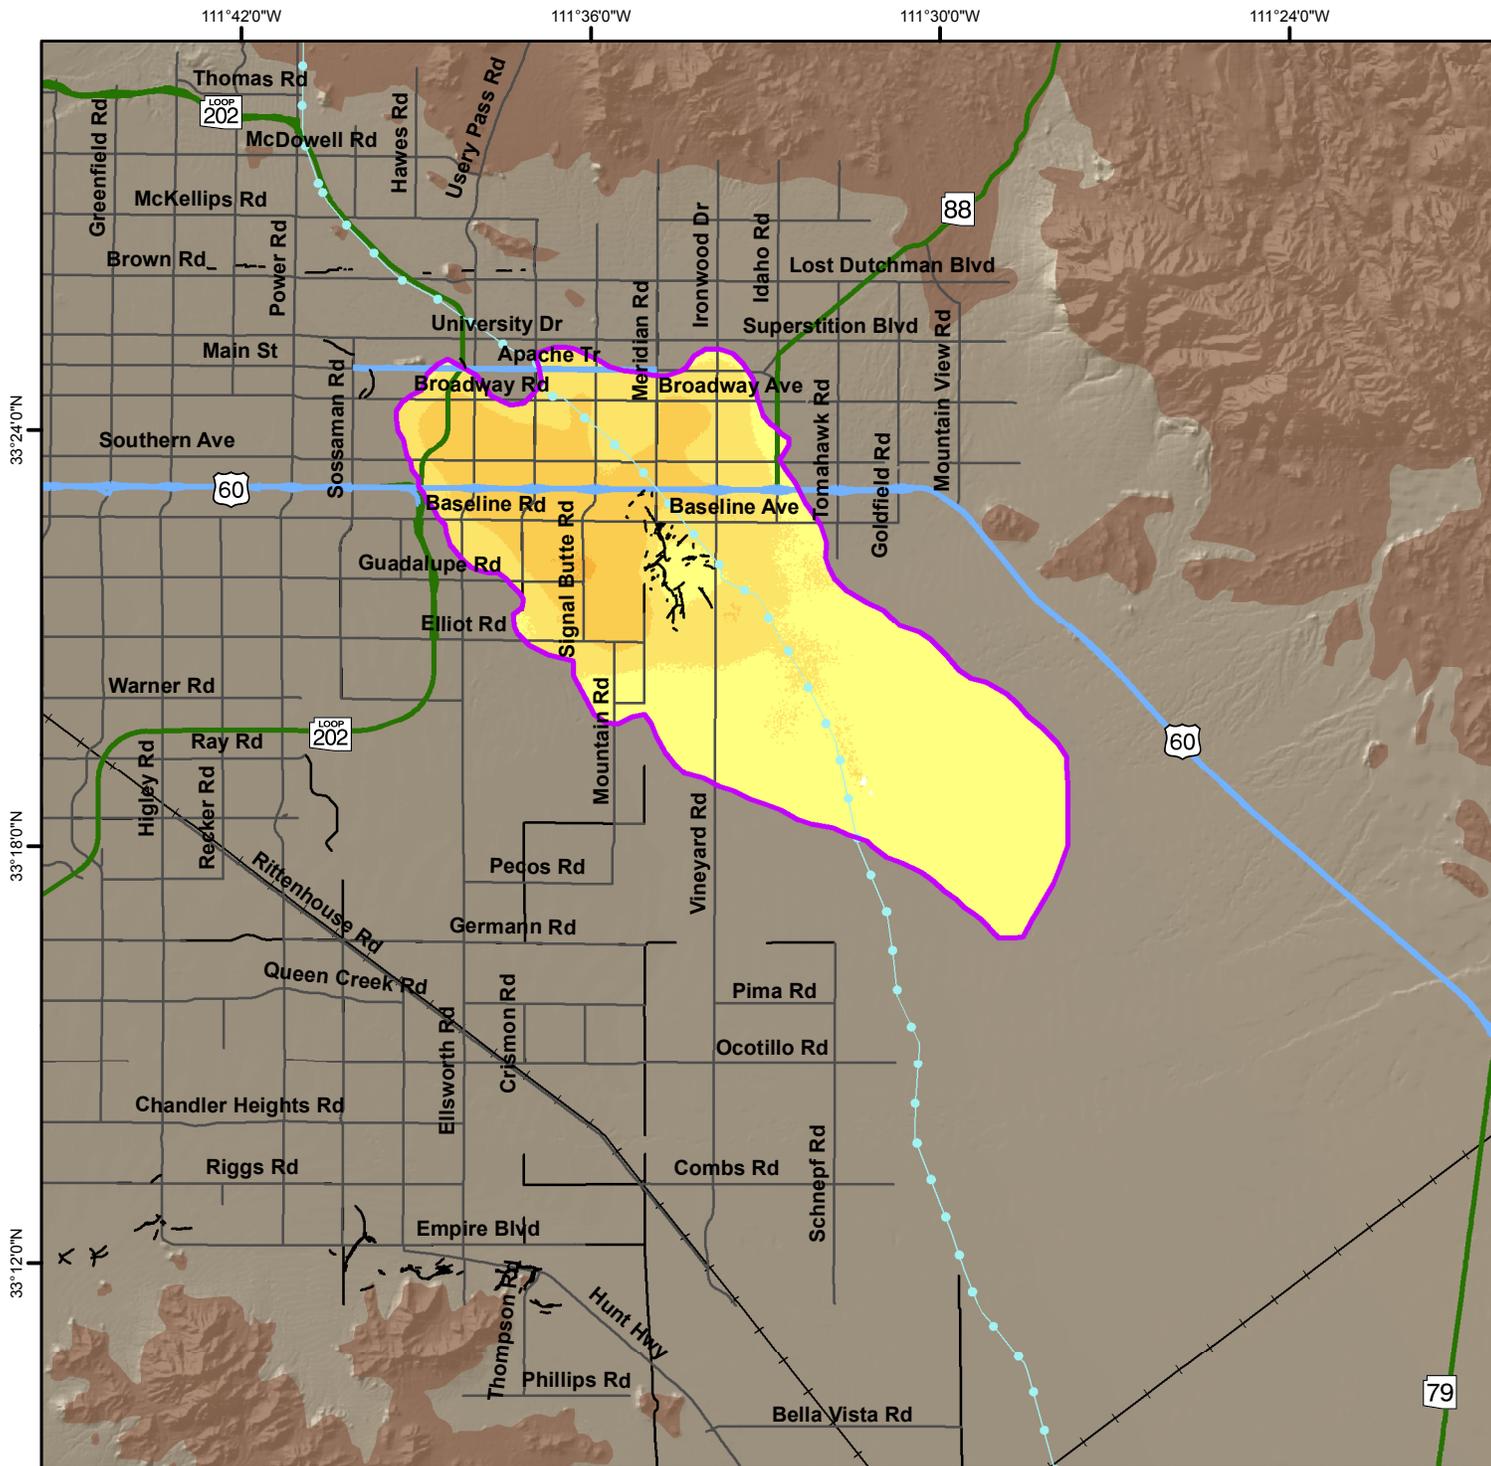
Decorrelation (white areas) are areas where the phase of the received satellite signal changed between satellite passes, causing the data to be unusable. This occurs in areas where the land surface has been disturbed (i.e. bodies of water, snow, agriculture areas, areas of development, etc).
