**Land Subsidence Rate in the Hawk Rock Area, Maricopa and Pinal Counties**  
 Based on ERS-1 and 2 Satellite Interferometric Synthetic Aperture Radar (InSAR) Data  
 Time Period of Analysis: 8.0 Years 05/17/1992 To 04/19/2000

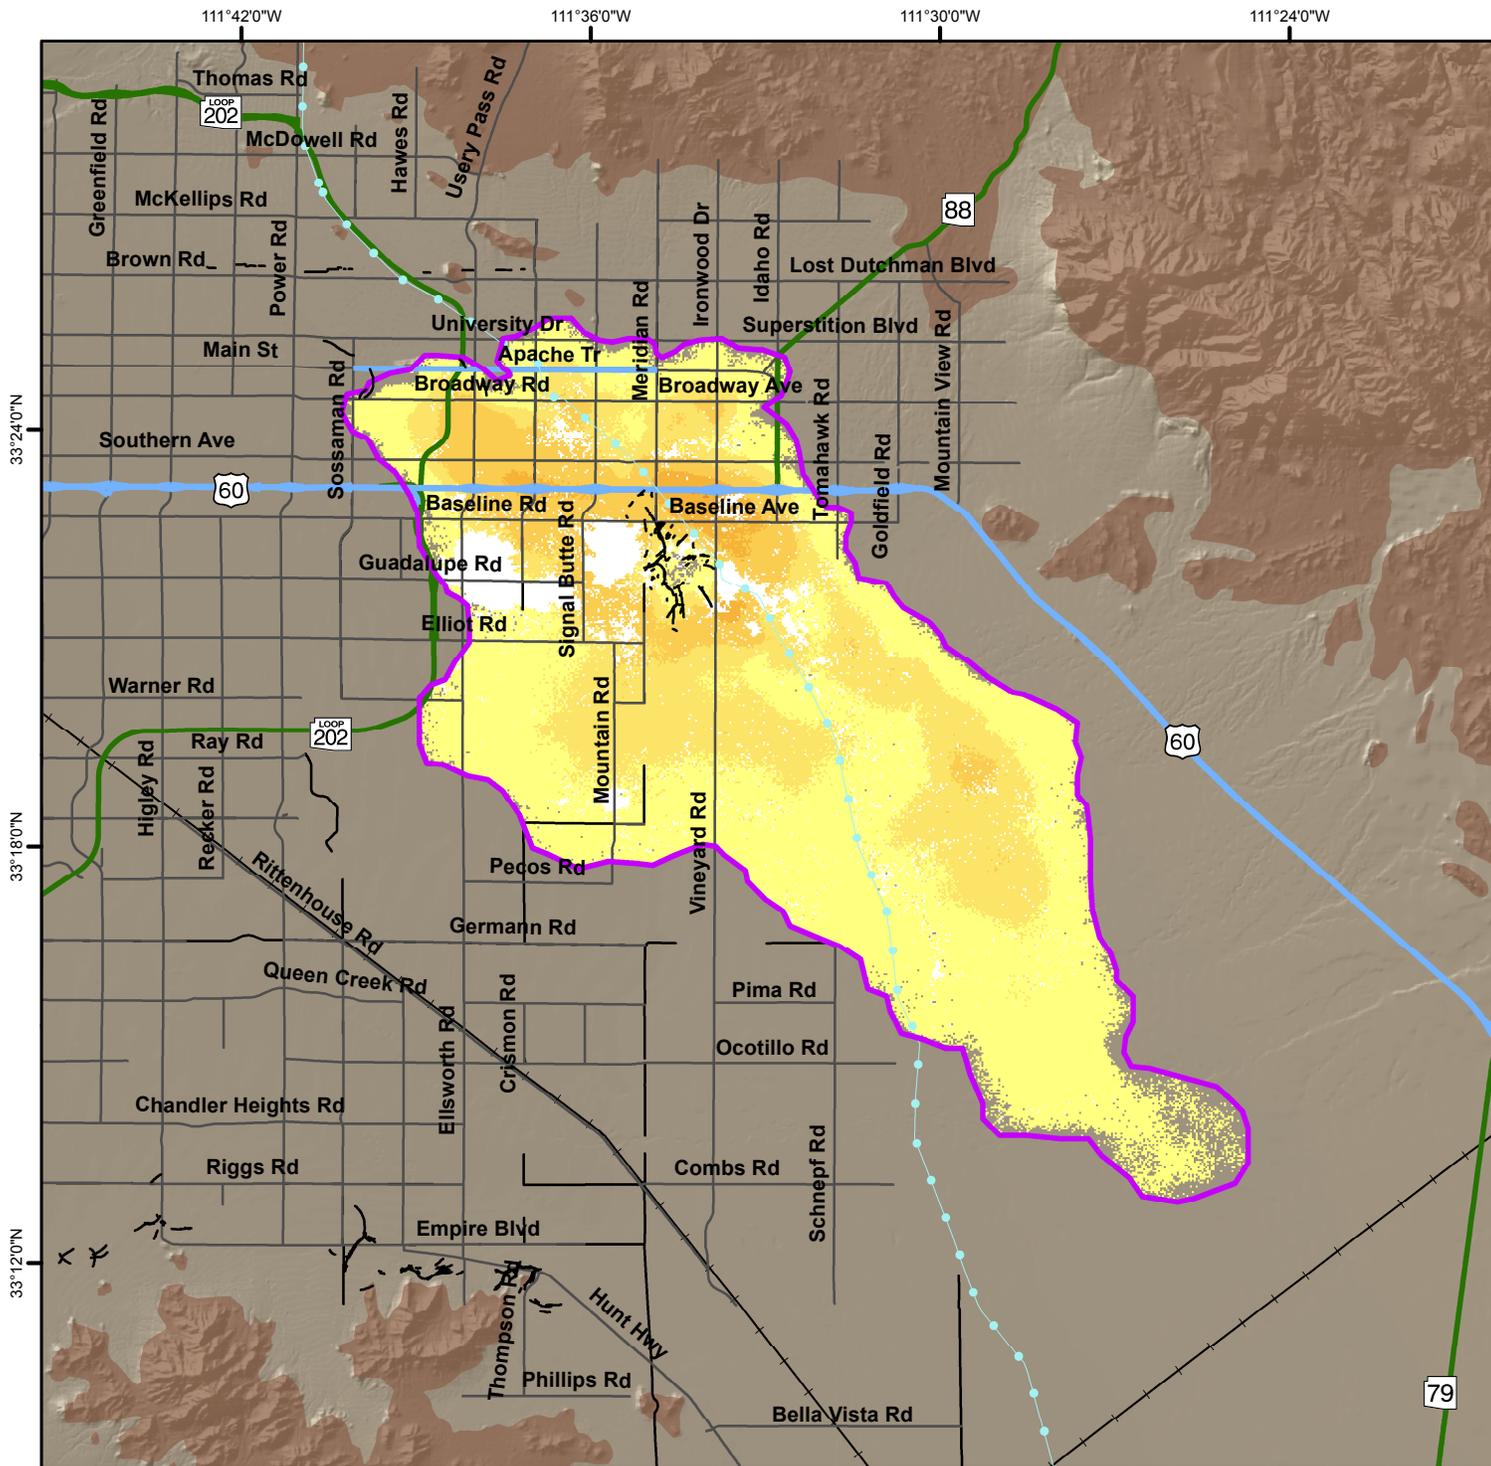
Decorrelation (white areas) are areas where the phase of the received satellite signal changed between satellite passes, causing the data to be unusable. This occurs in areas where the land surface has been disturbed (i.e. bodies of water, snow, agriculture areas, areas of development, etc).

Earth fissures were mapped by the Arizona Geological Survey. For information on earth fissures visit: [www.azgs.gov/EFC](http://www.azgs.gov/EFC)
