**Total Land Subsidence in the Willcox and Kansas Settlement Areas, Cochise County
Based on ERS-1 Satellite Interferometric Synthetic Aperture Radar (InSAR) Data**

Time Period of Analysis: 1.0 Years 11/12/1992 To 11/06/1993

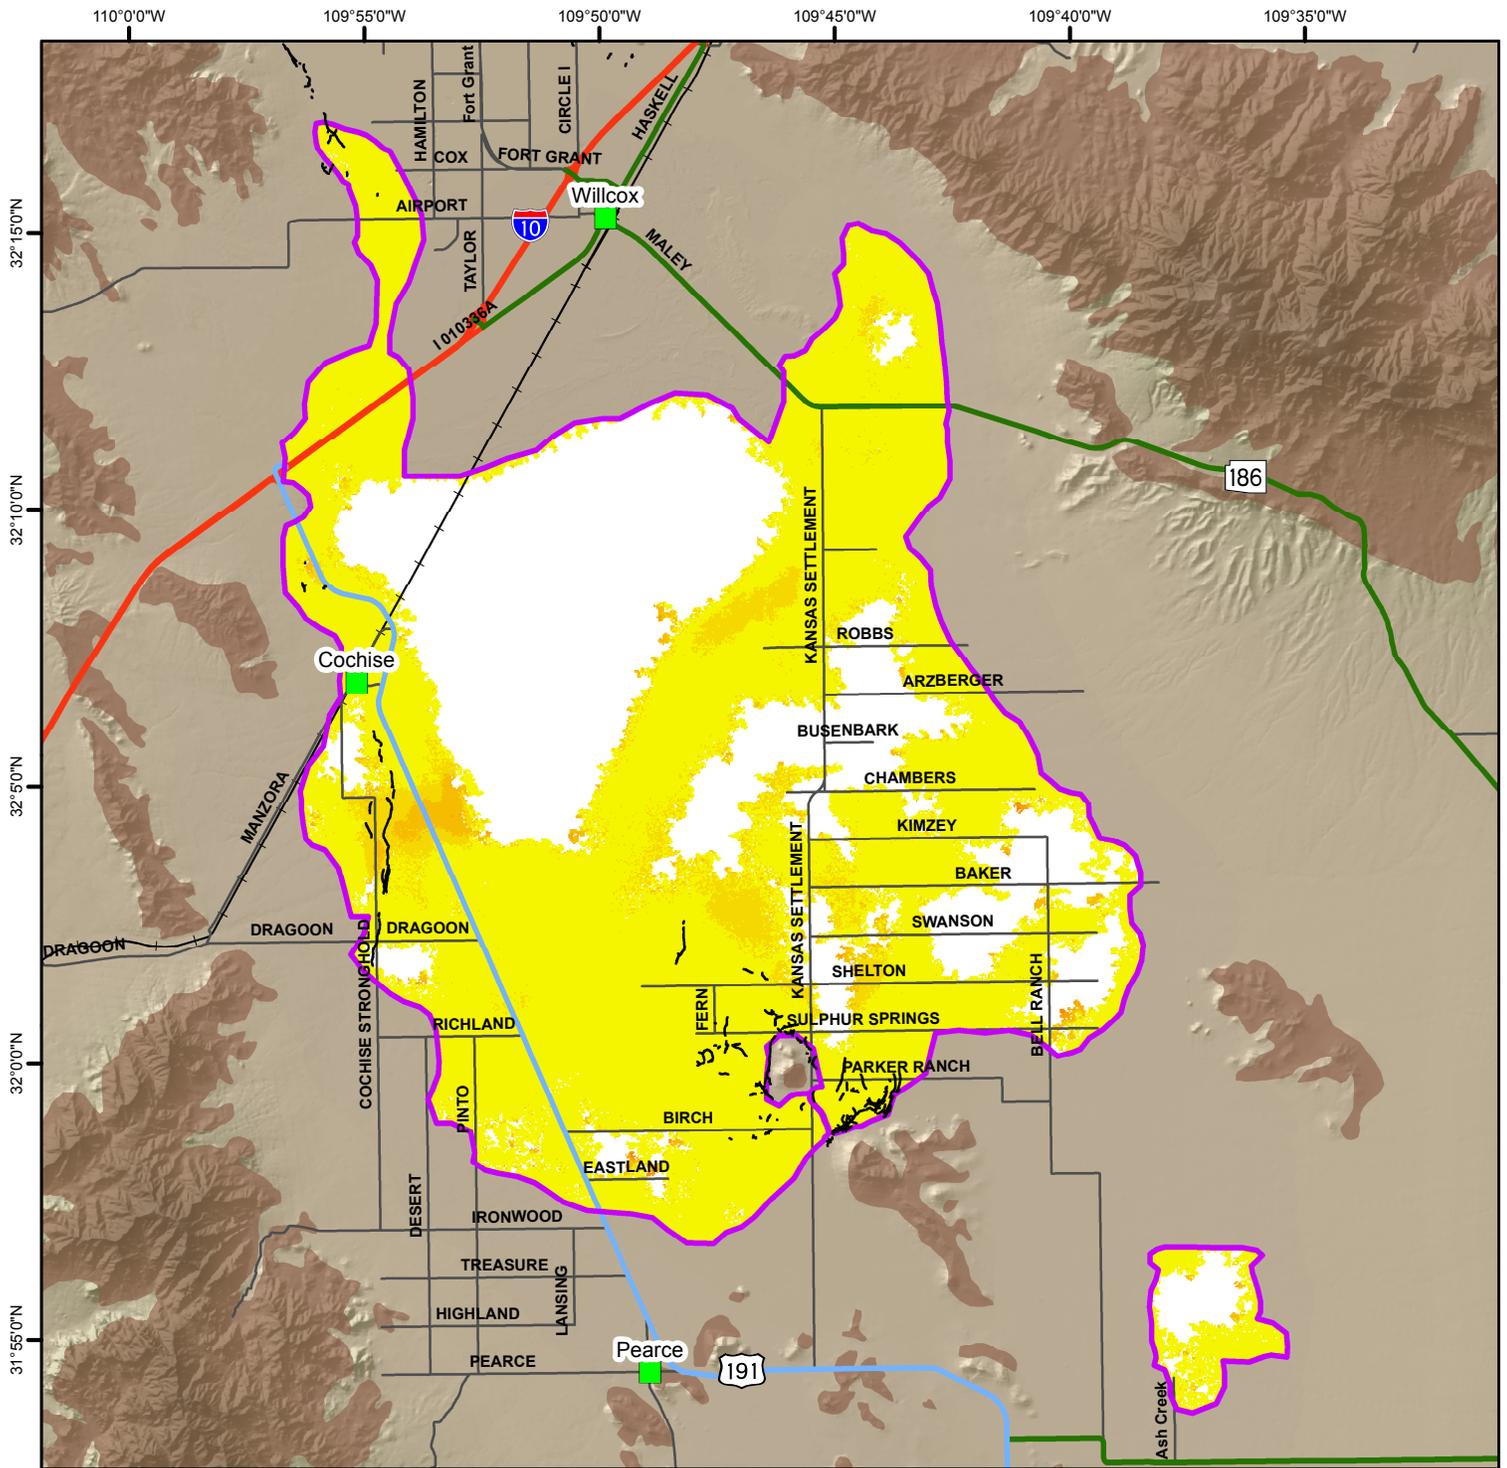
Decorrelation (white areas) are areas where the phase of the received satellite signal changed between satellite passes, causing the data to be unusable. This occurs in areas where the land surface has been disturbed (i.e. bodies of water, snow, agriculture areas, areas of development, etc).

Earth fissures were mapped by the Arizona Geological Survey. For information on earth fissures visit: www.azgs.gov/EFC
