Total Land Subsidence in the Willcox and Kansas Settlement Areas, Cochise County
 Based on ALOS-2 and Radarsat-2 Satellite Interferometric Synthetic Aperture Radar (InSAR) Data

Time Period of Analysis: 8.4 Years 12/06/2006 To 04/09/2015

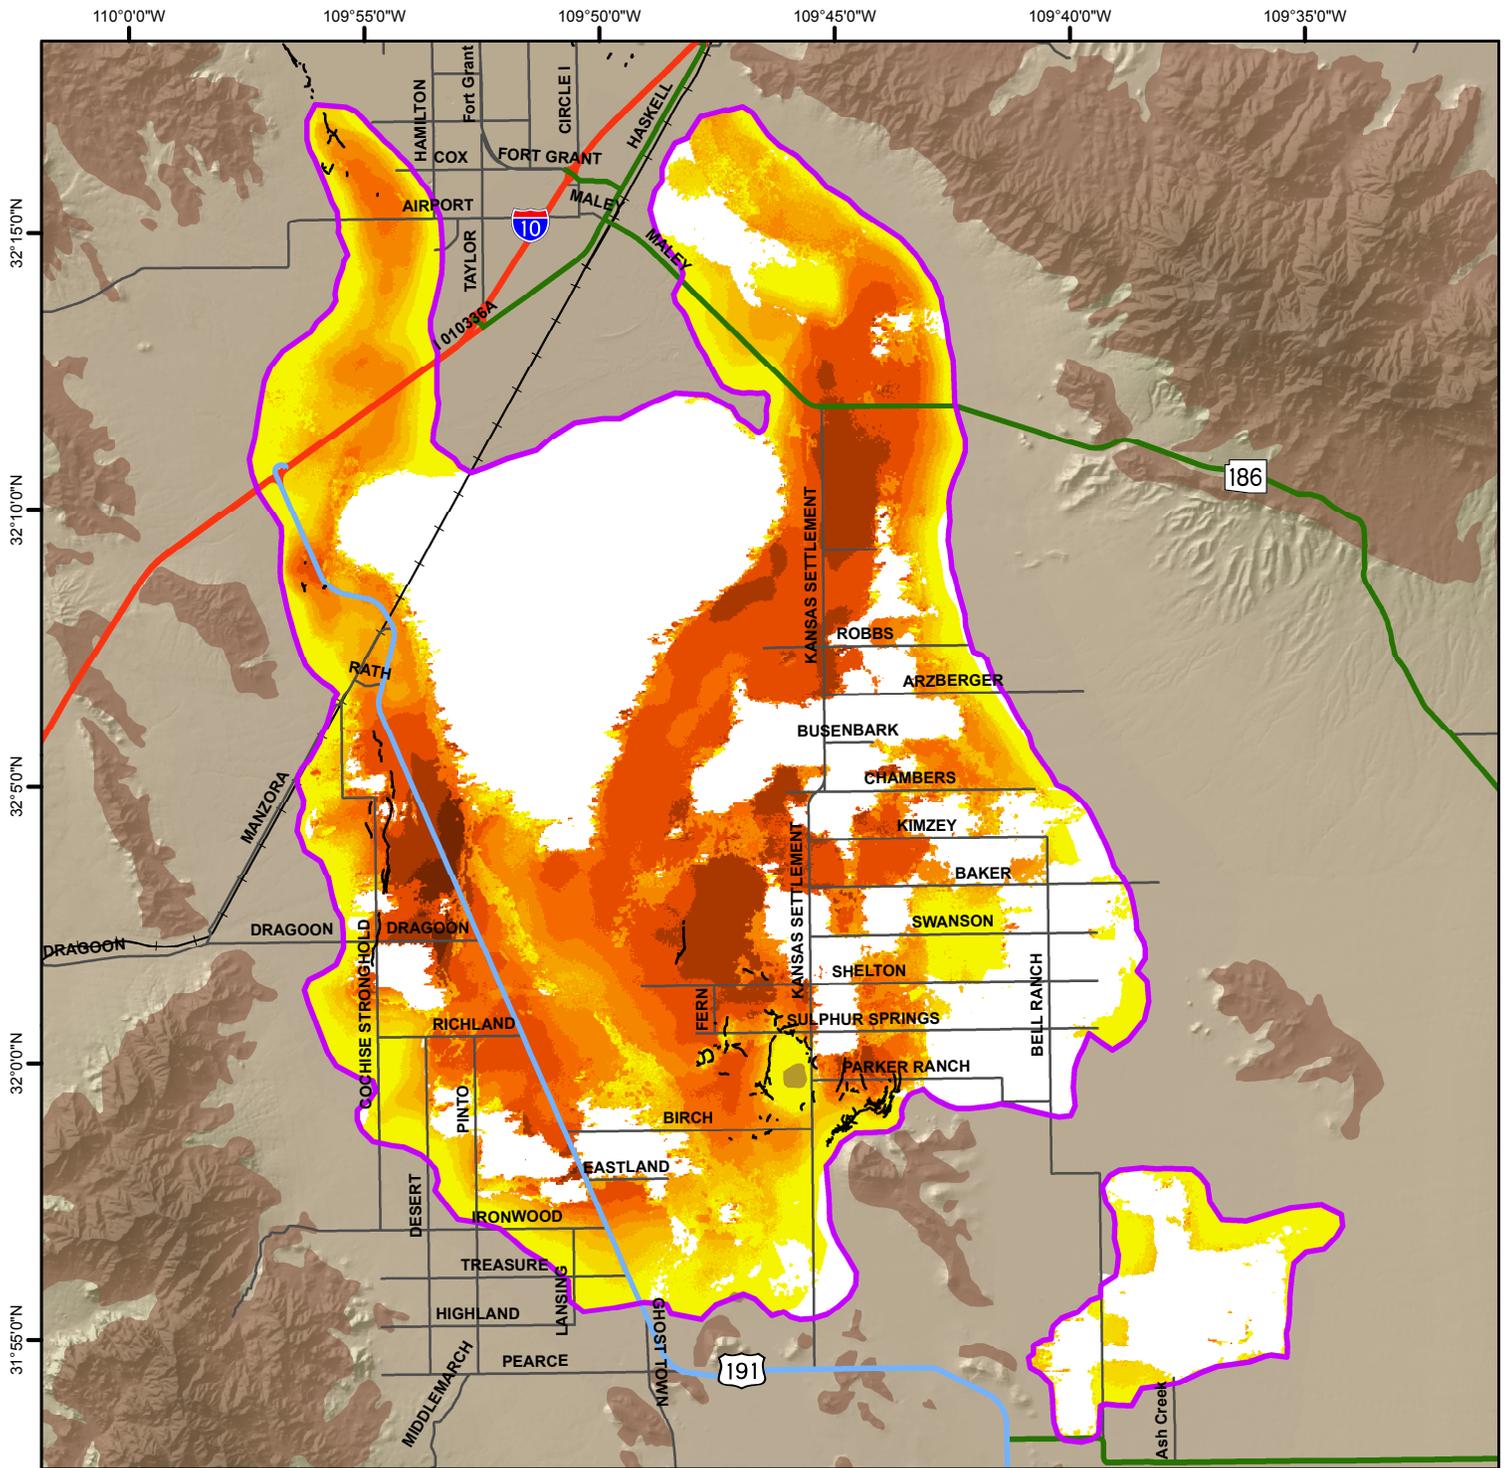
Total Land Subsidence

Decorrelation (white areas) are areas where the phase of the received satellite signal changed between satellite passes, causing the data to be unusable. This occurs in areas where the land surface has been disturbed (i.e. bodies of water, snow, agriculture areas, areas of development, etc).

Earth fissures were mapped by the Arizona Geological Survey. For information on earth fissures visit: www.azgs.gov/EFC
