**Land Subsidence Rate in the Willcox and Kansas Settlement Areas, Cochise County
Based on ERS-1 and 2 Satellite Interferometric Synthetic Aperture Radar (InSAR) Data**

Time Period of Analysis: 1.0 Years 01/06/1996 To 12/24/1996

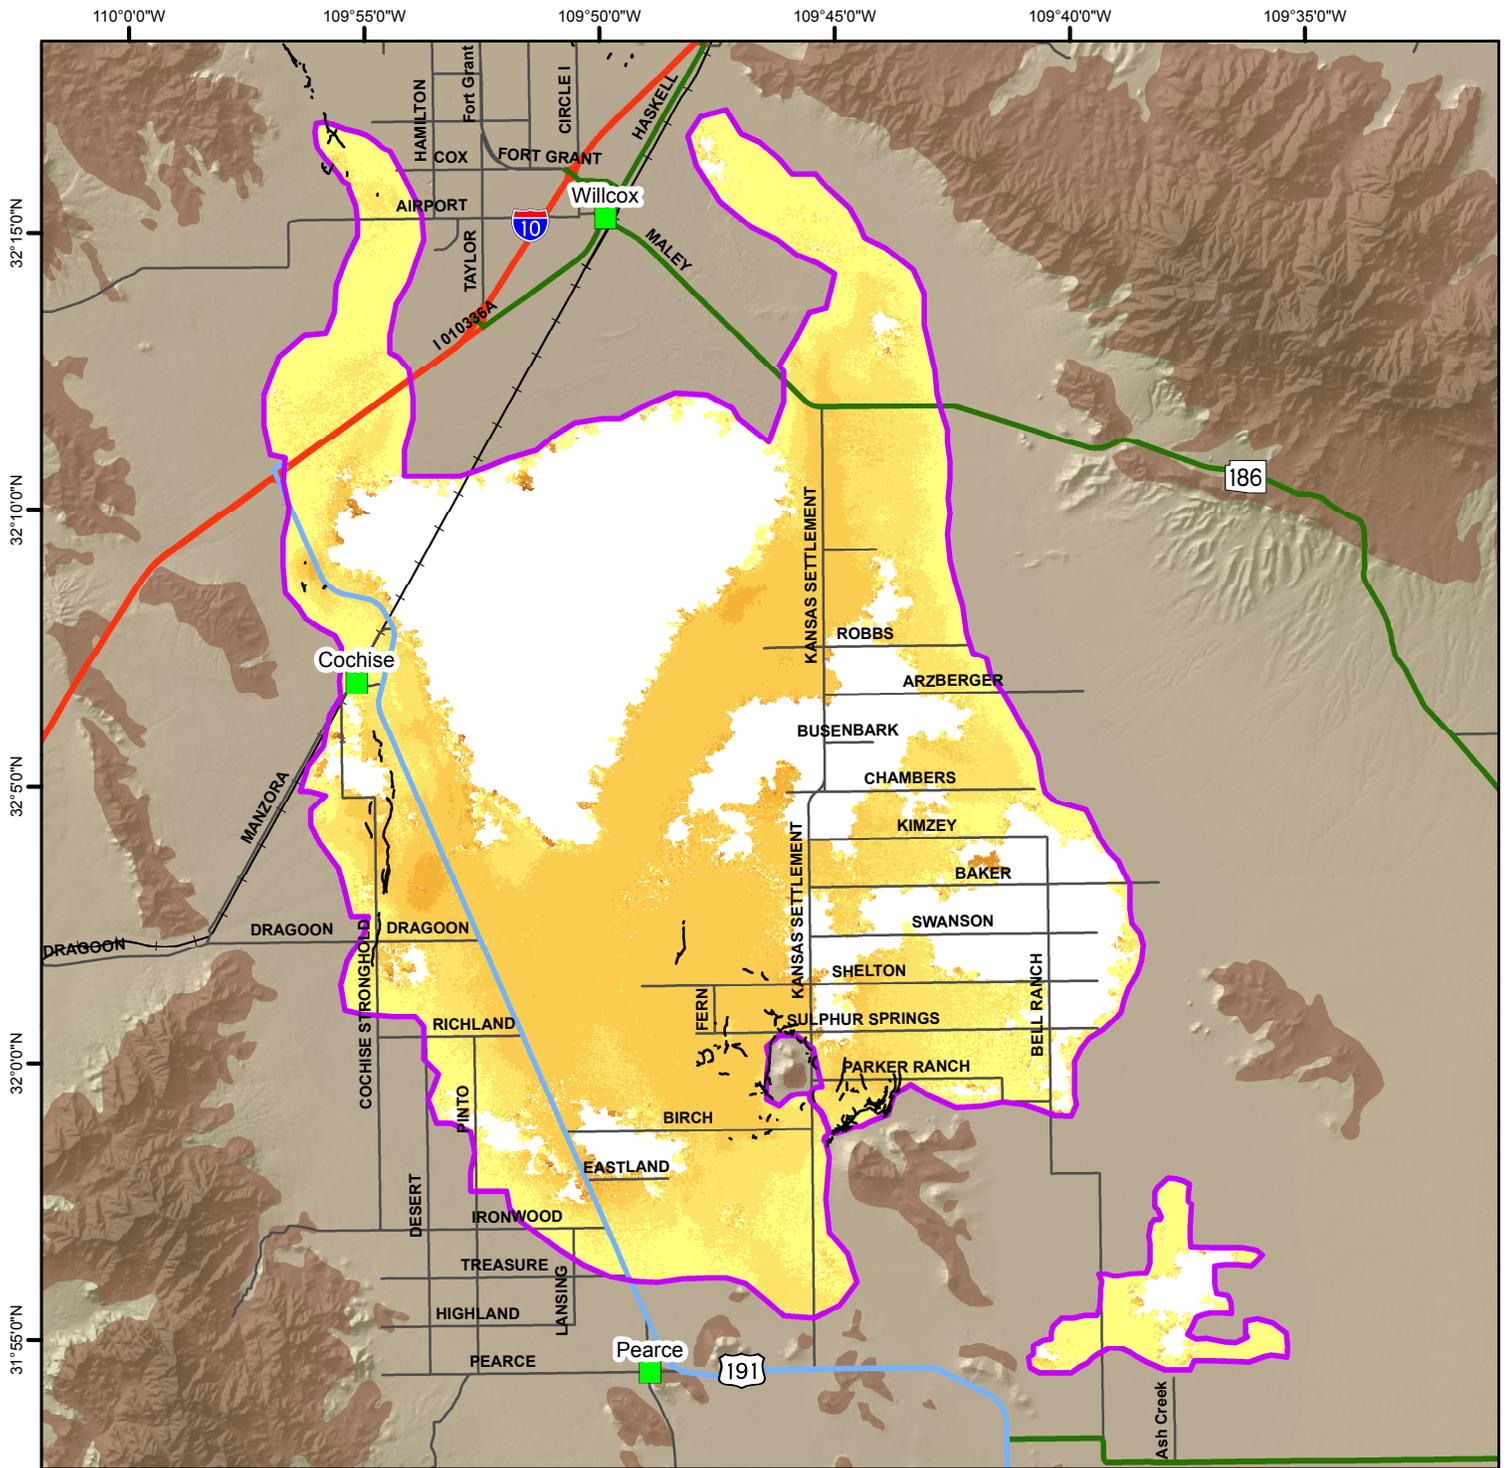
Decorelation (white areas) are areas where the phase of the received satellite signal changed between satellite passes, causing the data to be unusable. This occurs in areas where the land surface has been disturbed (i.e. bodies of water, snow, agriculture areas, areas of development, etc).

Earth fissures were mapped by the Arizona Geological Survey. For information on earth fissures visit: www.azgs.gov/EFC
