Land Subsidence Rate in the Willcox and Kansas Settlement Areas, Cochise County
Based on Radarsat-2 Satellite Interferometric Synthetic Aperture Radar (InSAR) Data

Time Period of Analysis: 1.0 Years 03/26/2013 To 03/21/2014

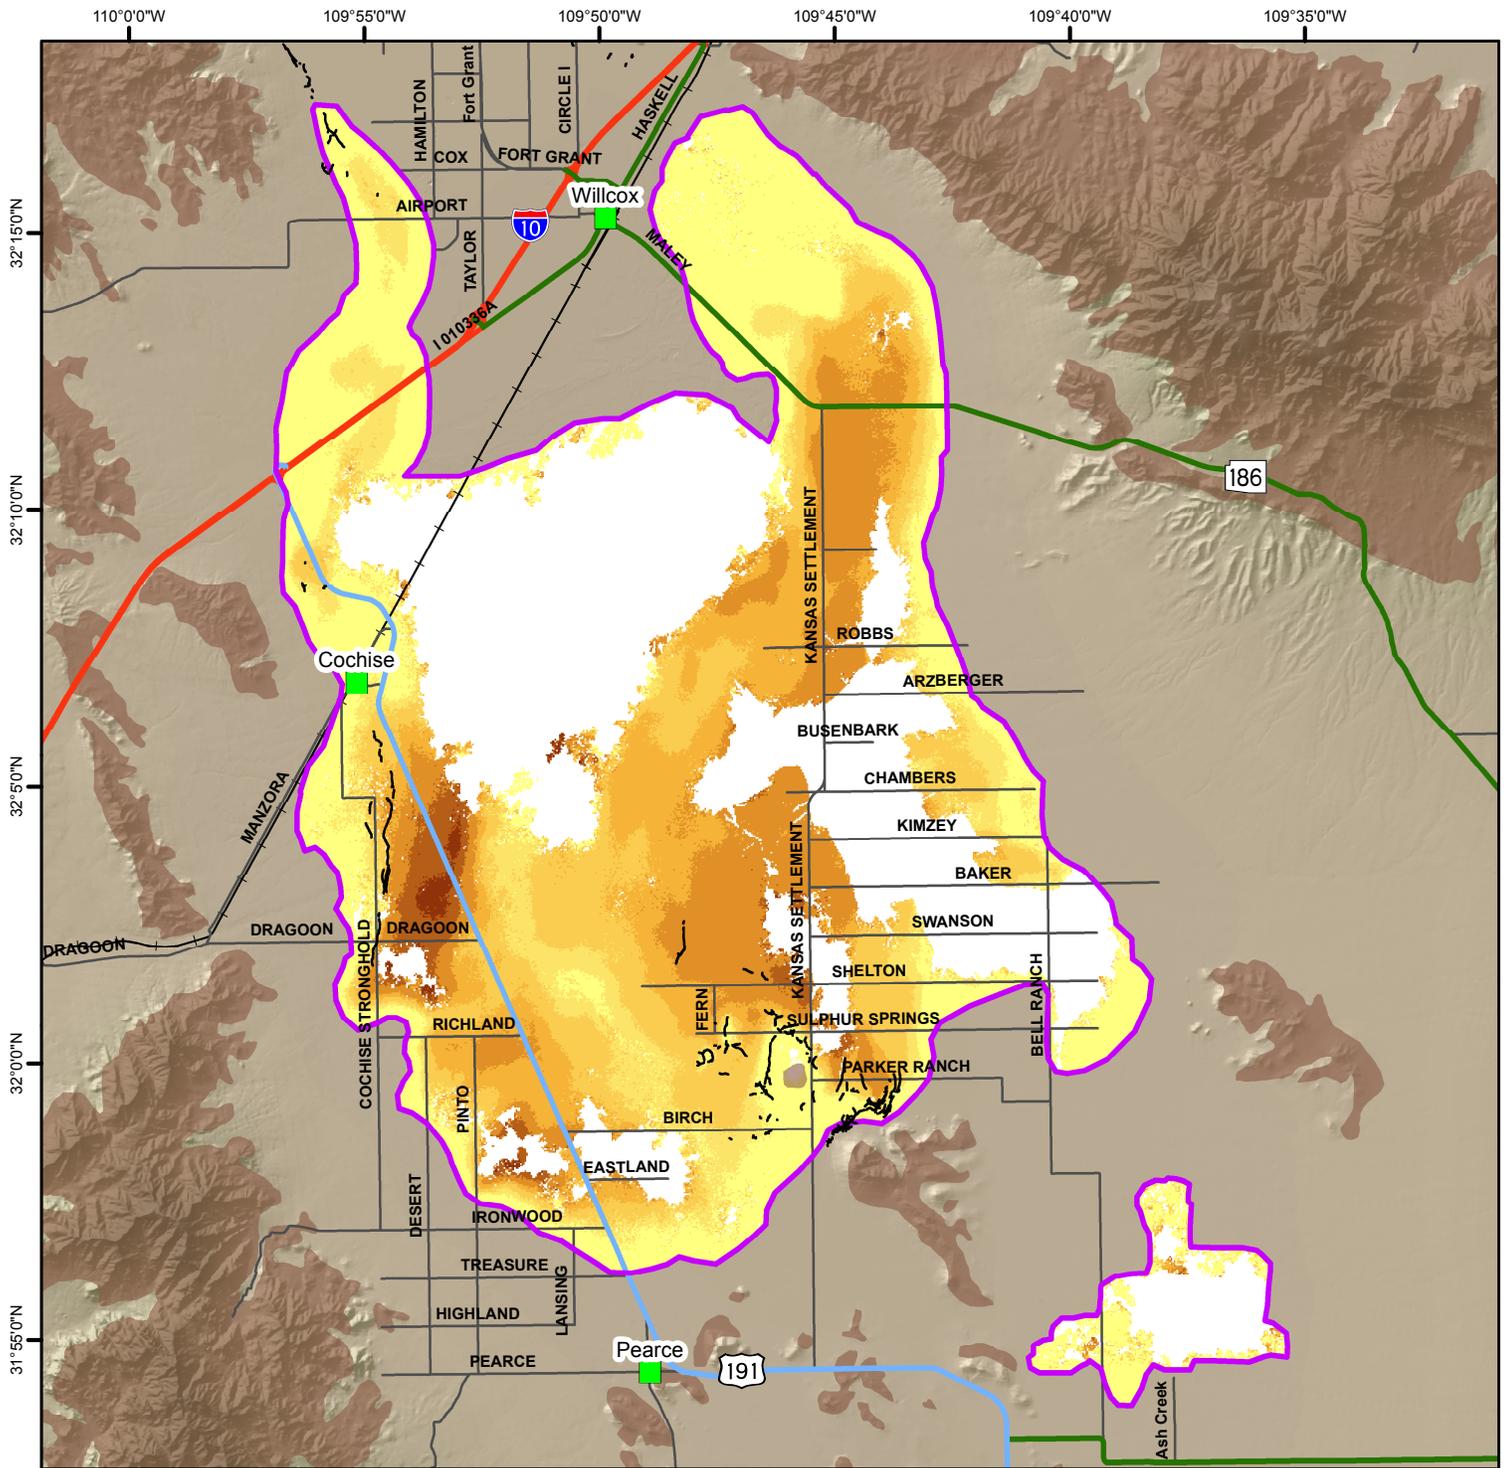
Decorelation (white areas) are areas where the phase of the received satellite signal changed between satellite passes, causing the data to be unusable. This occurs in areas where the land surface has been disturbed (i.e. bodies of water, snow, agriculture areas, areas of development, etc).

Earth fissures were mapped by the Arizona Geological Survey. For information on earth fissures visit: www.azgs.gov/EFC
