**Total Land Subsidence in the Maricopa-Stanfield Sub-Basin, Pinal County  
Based on Envisat Satellite Interferometric Synthetic Aperture Radar (InSAR) Data  
Time Period of Analysis: 1.0 Years 02/11/2009 To 03/03/2010**

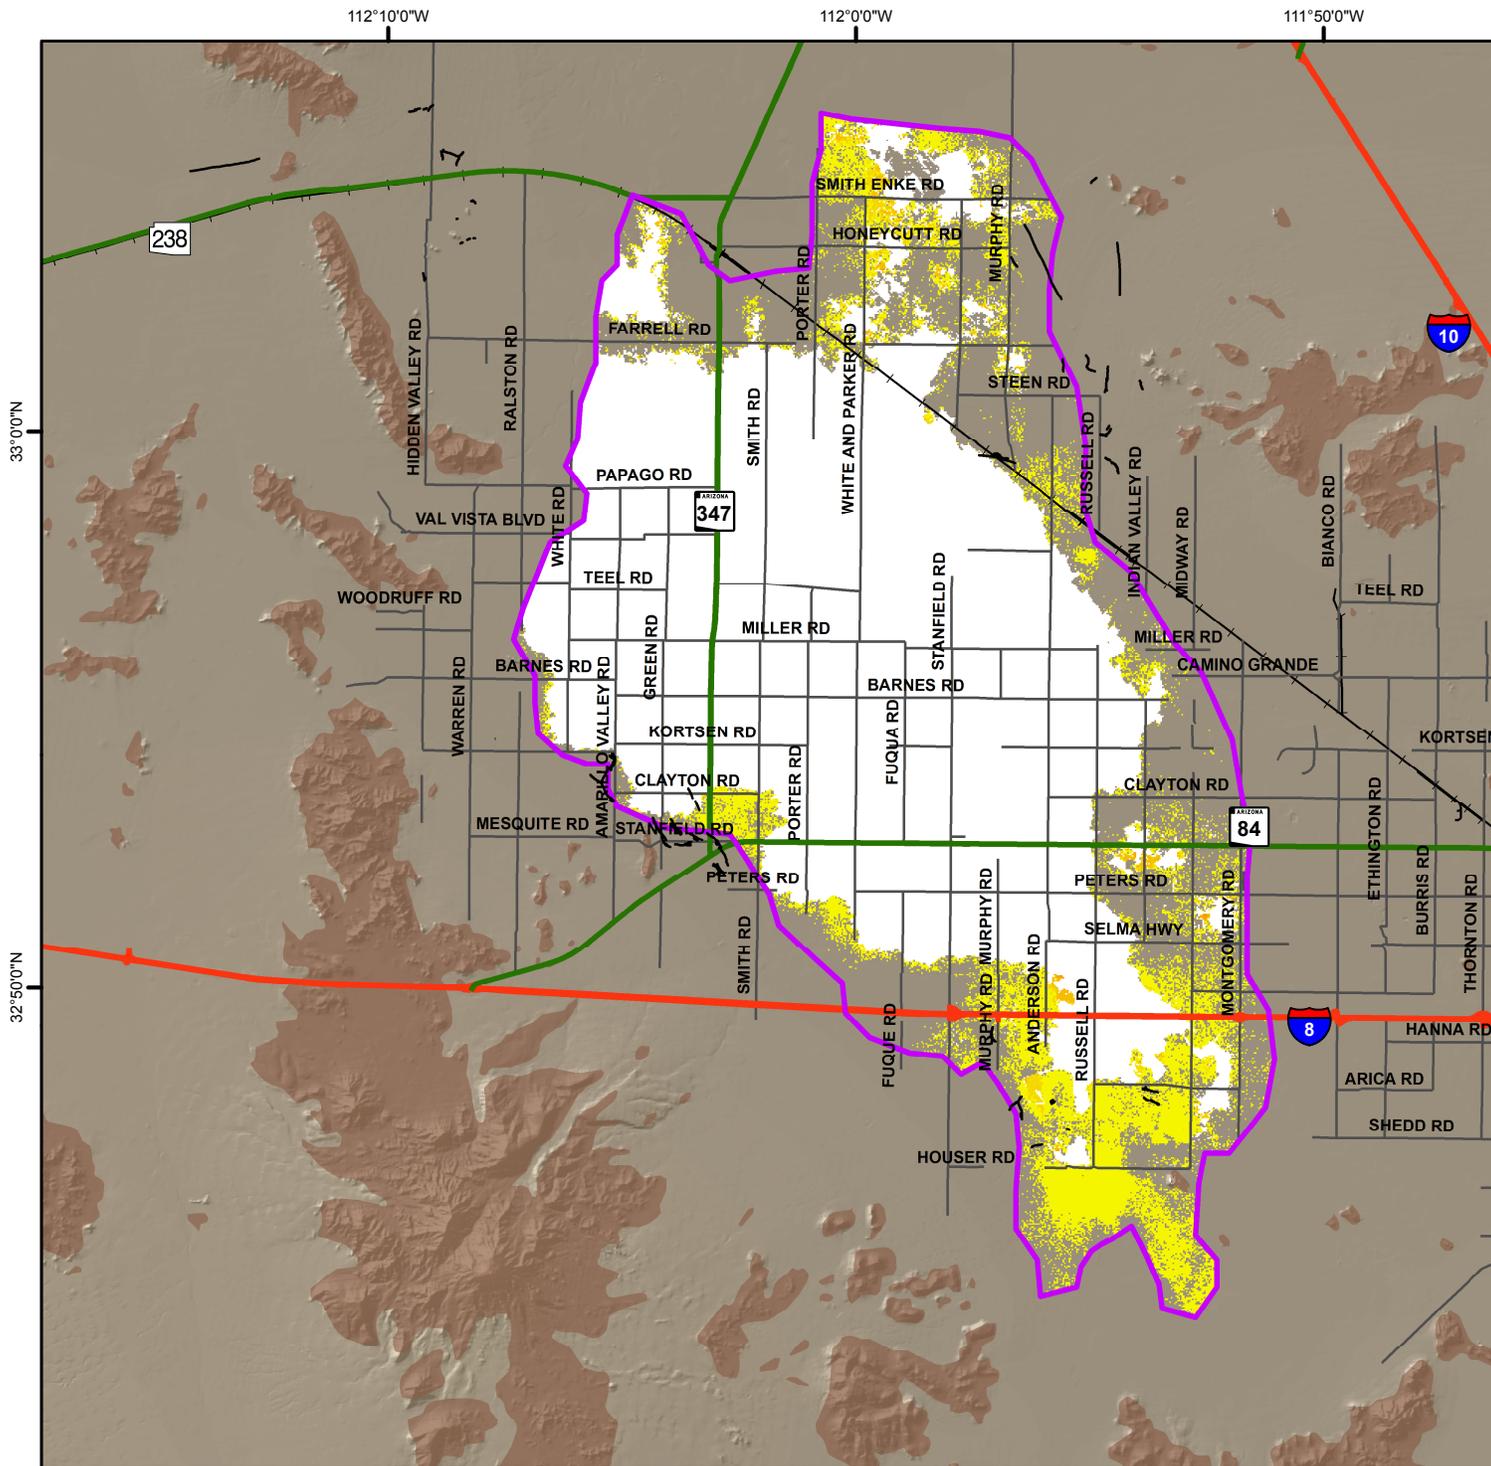
Decorrelation (white areas) are areas where the phase of the received satellite signal changed between satellite passes, causing the data to be unusable. This occurs in areas where the land surface has been disturbed (i.e. bodies of water, snow, agriculture areas, areas of development, etc).

Earth fissures were mapped by the Arizona Geological Survey. For information on earth fissures visit: [www.azgs.gov/EFC](http://www.azgs.gov/EFC)
