Total Land Subsidence in the Maricopa-Stanfield Sub-Basin, Pinal County
 Based on Radarsat-2 Satellite Interferometric Synthetic Aperture Radar (InSAR) Data
 Time Period of Analysis: 2.0 Years 04/22/2013 To 03/19/2015

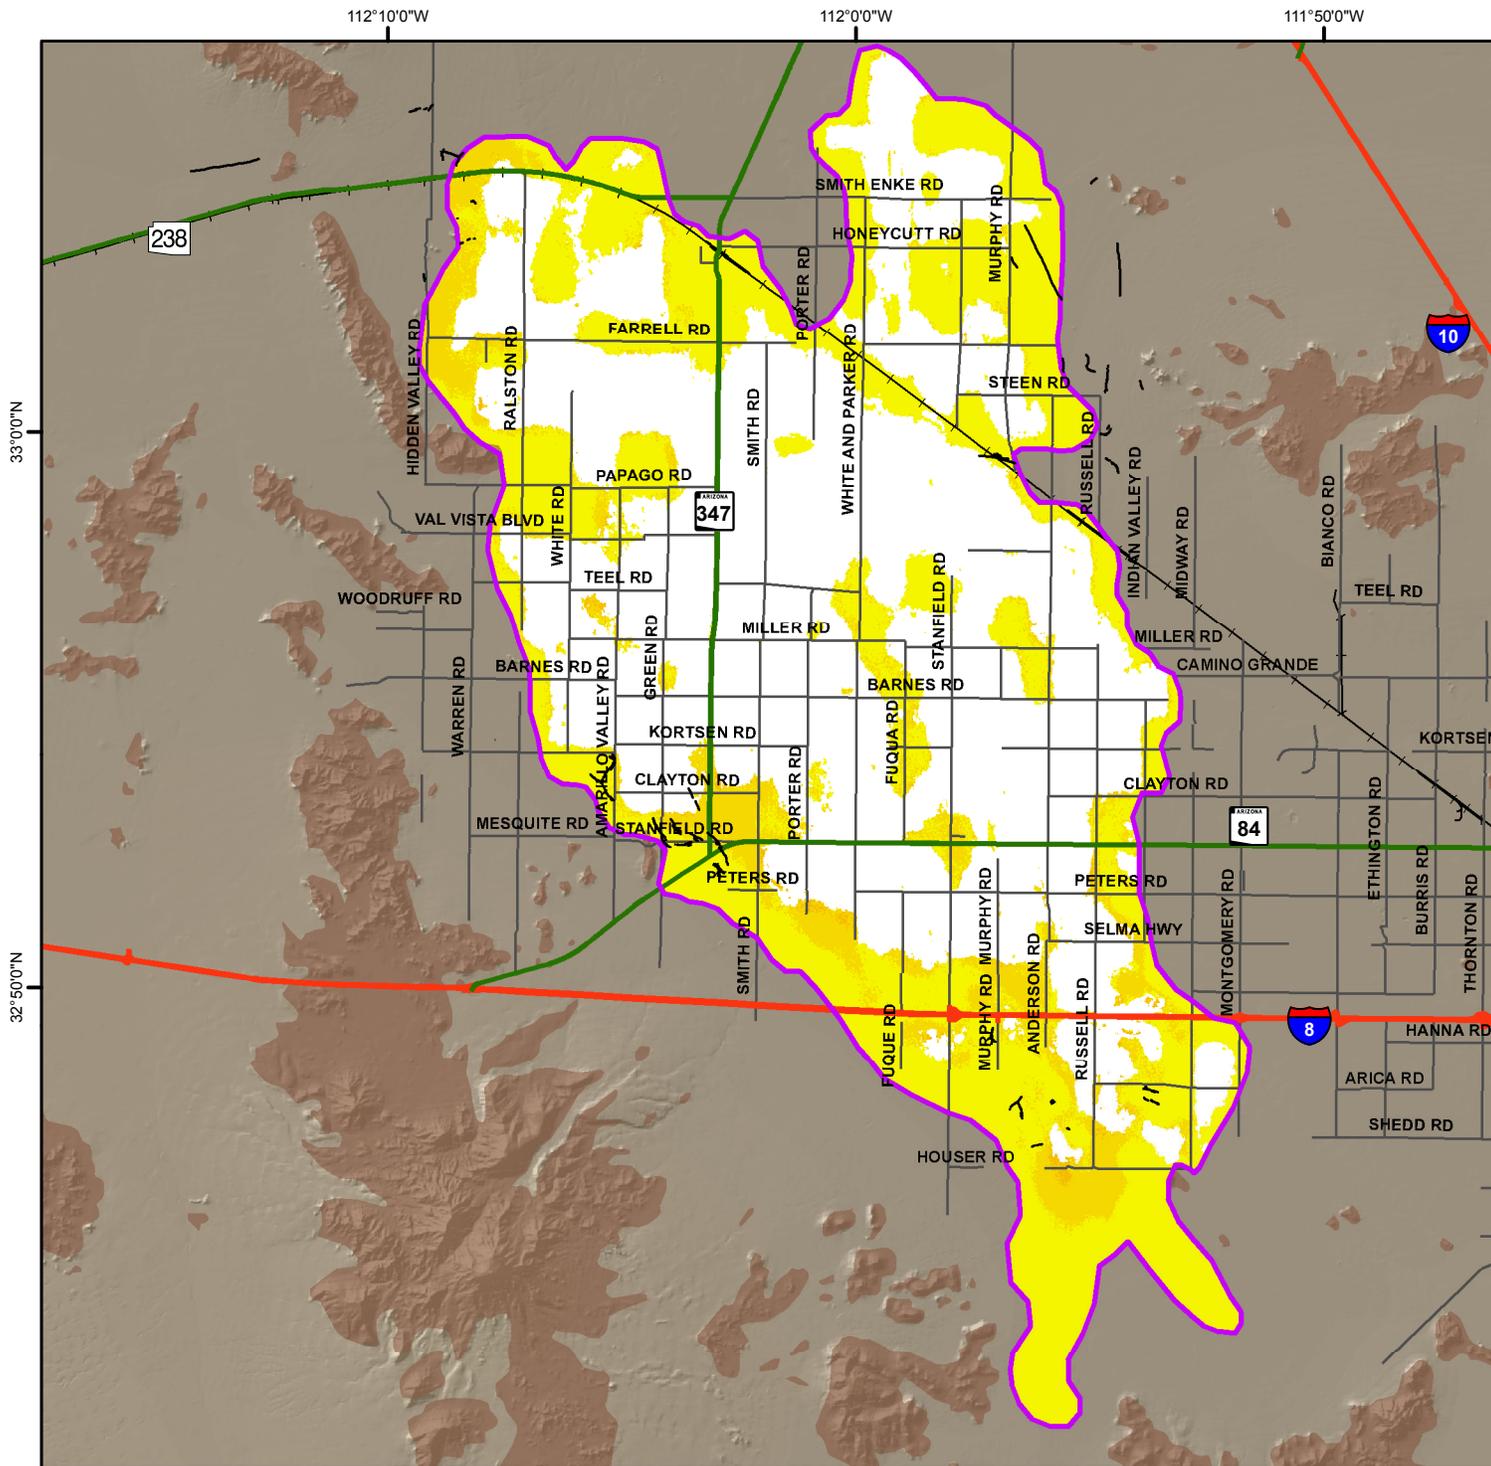
Decorrelation (white areas) are areas where the phase of the received satellite signal changed between satellite passes, causing the data to be unusable. This occurs in areas where the land surface has been disturbed (i.e. bodies of water, snow, agriculture areas, areas of development, etc).
