Total Land Subsidence in the Maricopa-Stanfield Sub-Basin, Pinal County
Based on Radarsat-2 Satellite Interferometric Synthetic Aperture Radar (InSAR) Data
Time Period of Analysis: 2.0 Years 05/03/2011 To 04/22/2013

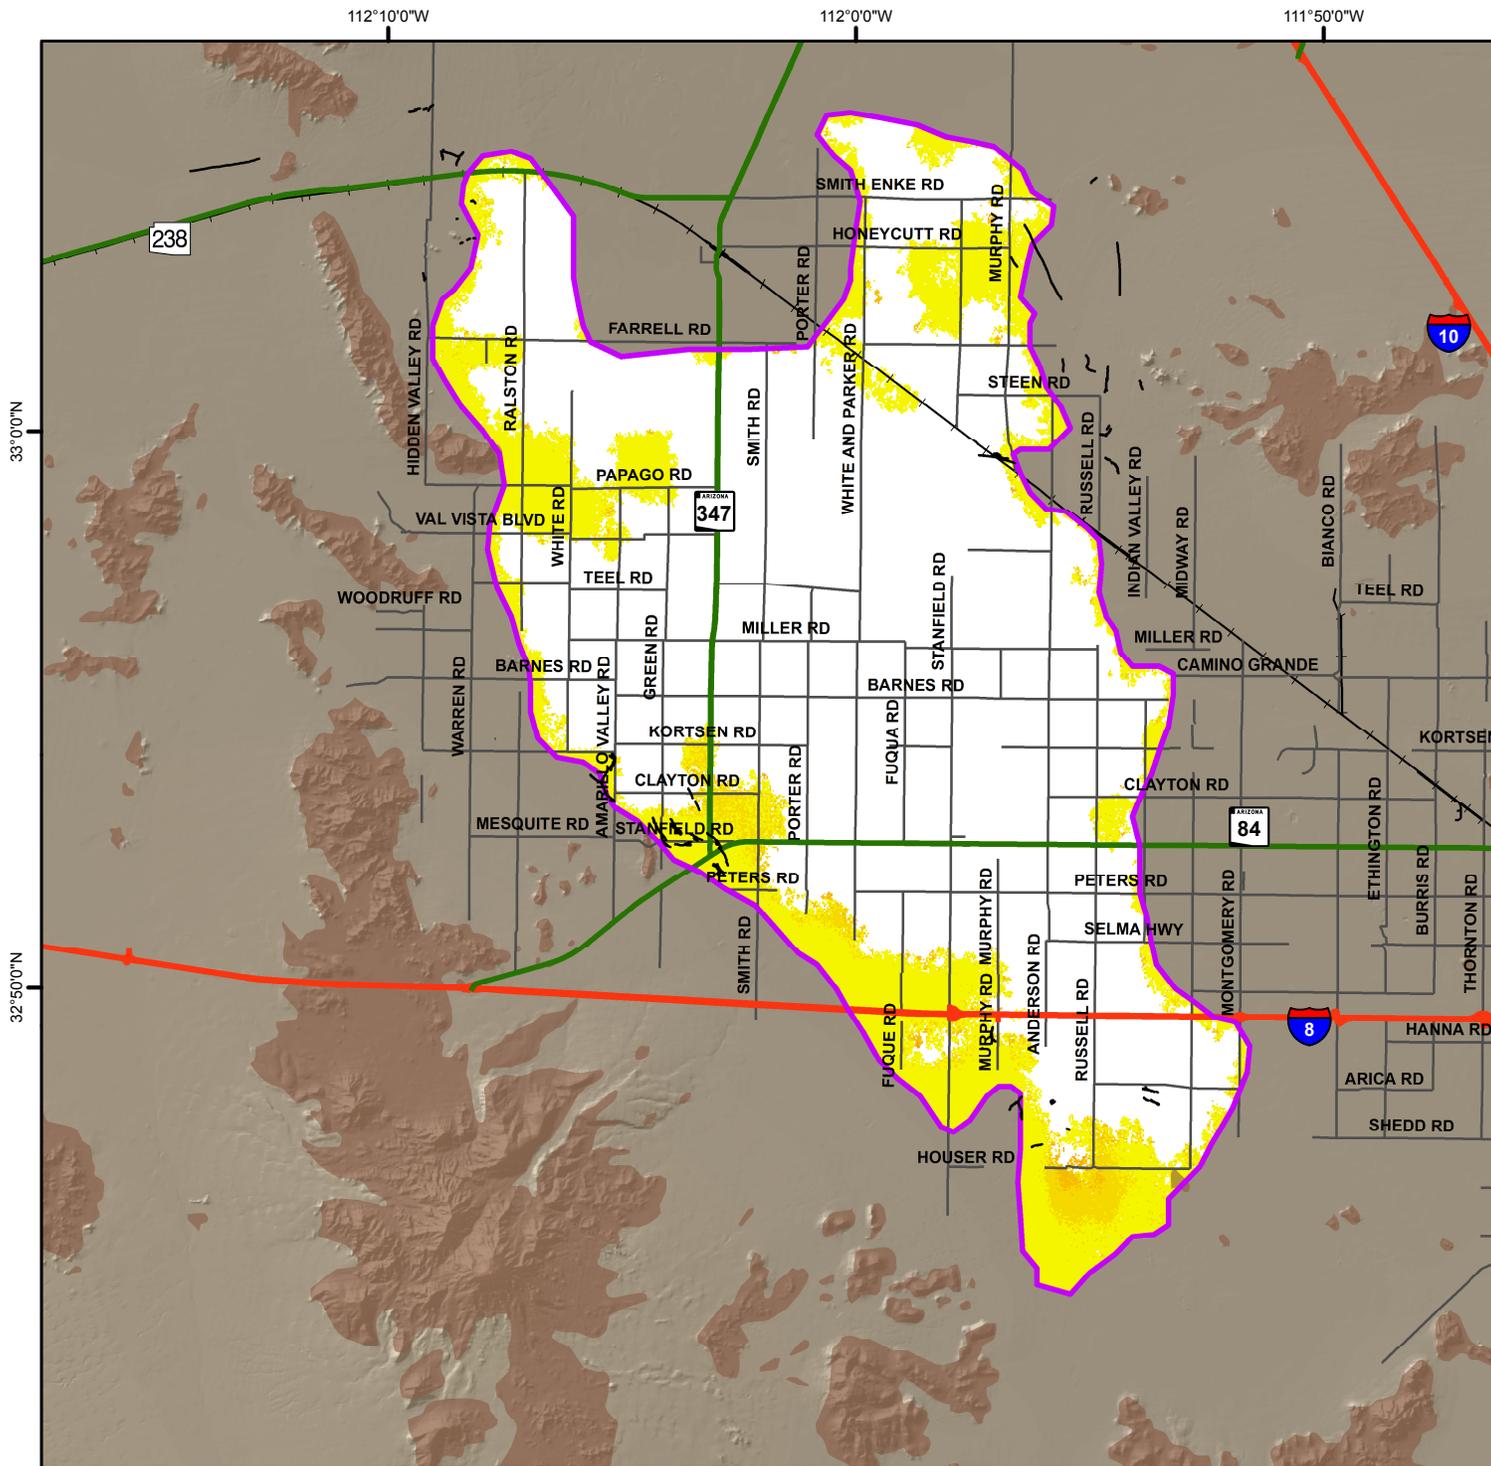
Decorrelation (white areas) are areas where the phase of the received satellite signal changed between satellite passes, causing the data to be unusable. This occurs in areas where the land surface has been disturbed (i.e. bodies of water, snow, agriculture areas, areas of development, etc).

Earth fissures were mapped by the Arizona Geological Survey. For information on earth fissures visit: www.azgs.gov/EFC
