**Total Land Subsidence in the McMullen Valley, La Paz and Maricopa Counties
Based on Radarsat-2 Satellite Interferometric Synthetic Aperture Radar (InSAR) Data
Time Period of Analysis: 5.9 Years 05/01/2010 To 03/30/2016**

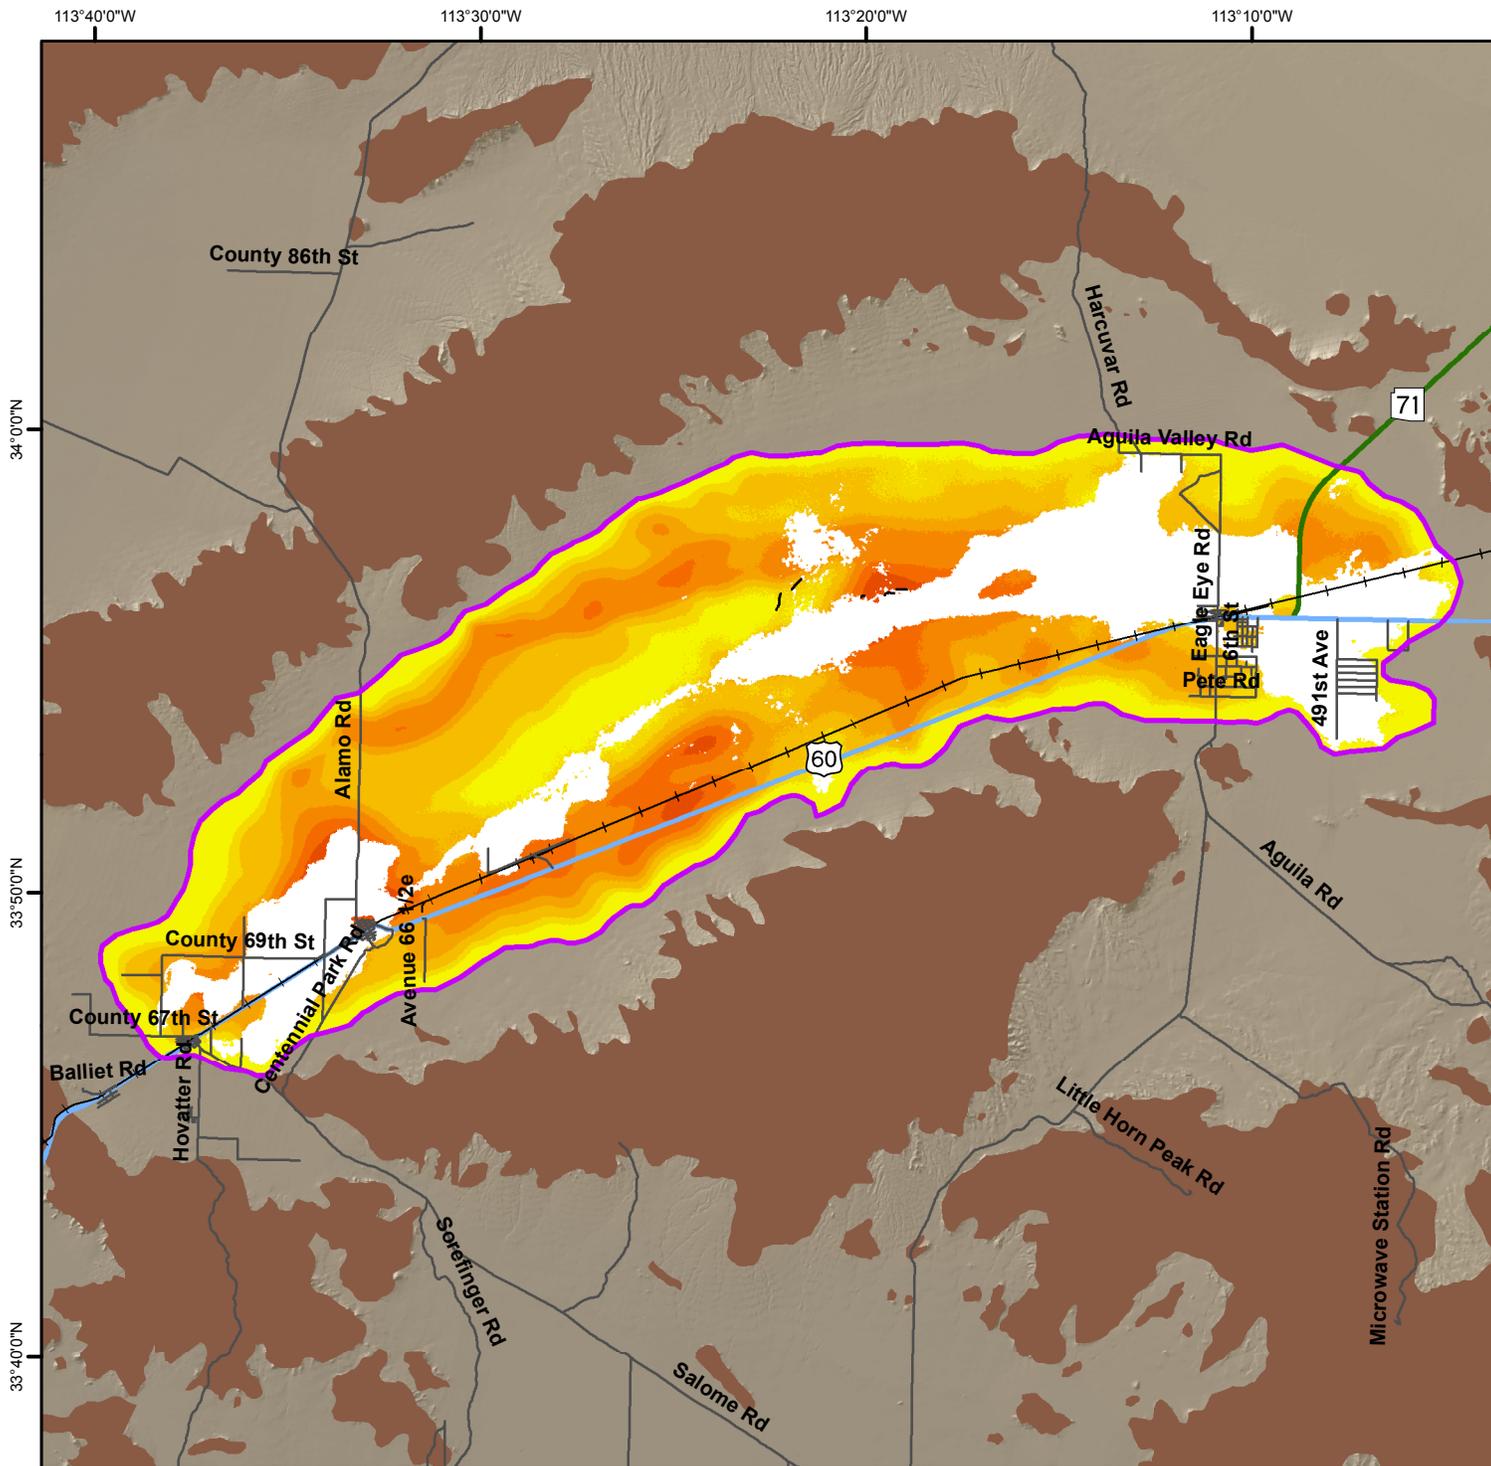
Decorrelation (white areas) are areas where the phase of the received satellite signal changed between satellite passes, causing the data to be unusable. This occurs in areas where the land surface has been disturbed (i.e. bodies of water, snow, agriculture areas, areas of development, etc).
