Land Subsidence Rate in the McMullen Valley, La Paz and Maricopa Counties  
 Based on ALOS-2 Satellite Interferometric Synthetic Aperture Radar (InSAR) Data  
 Time Period of Analysis: 1.1 Years 03/14/2015 To 05/07/2016

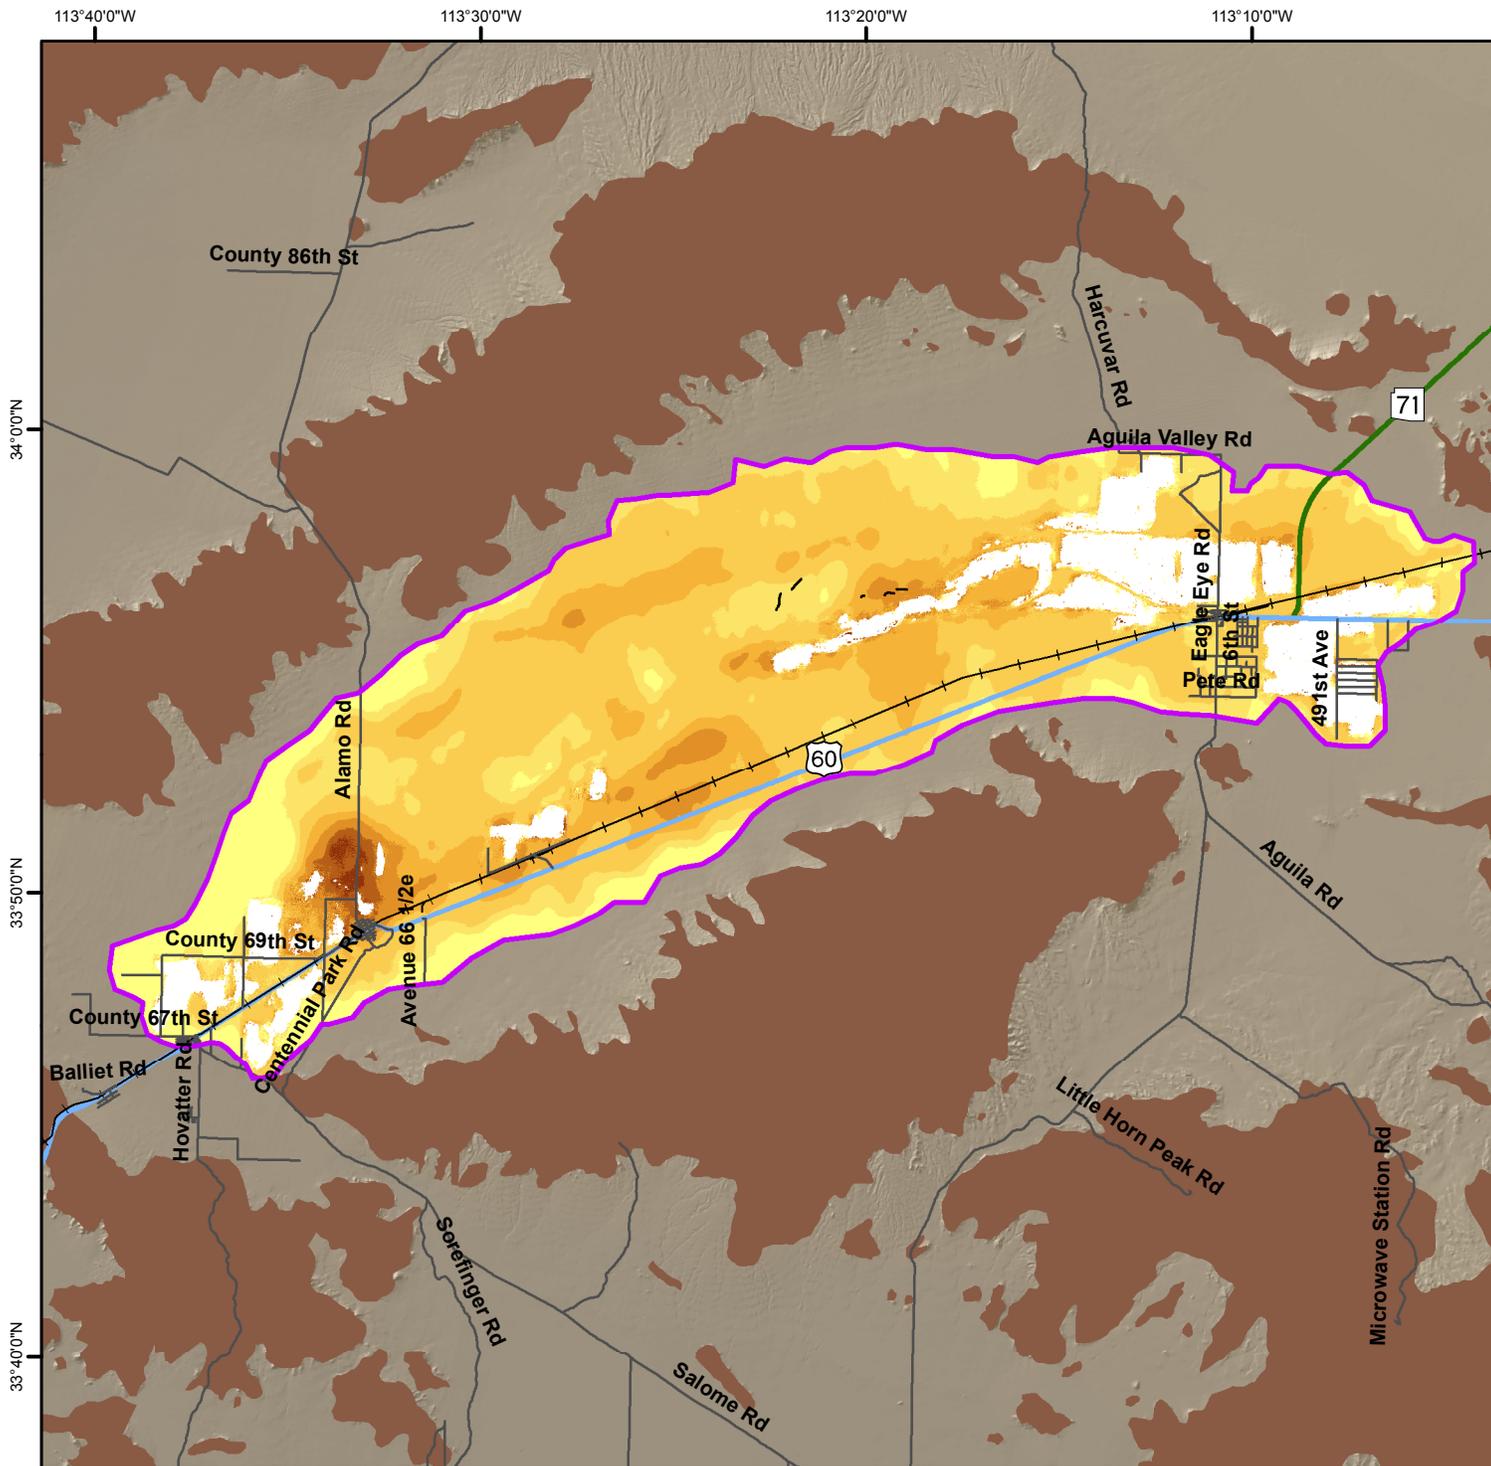
Decorrelation (white areas) are areas where the phase of the received satellite signal changed between satellite passes, causing the data to be unusable. This occurs in areas where the land surface has been disturbed (i.e. bodies of water, snow, agriculture areas, areas of development, etc).
