**Total Land Subsidence in the Eloy Sub-Basin, Pinal County**  
 Based on Envisat Satellite Interferometric Synthetic Aperture Radar (InSAR) Data  
 Time Period of Analysis: 6.7 Years 01/14/2004 To 09/29/2010

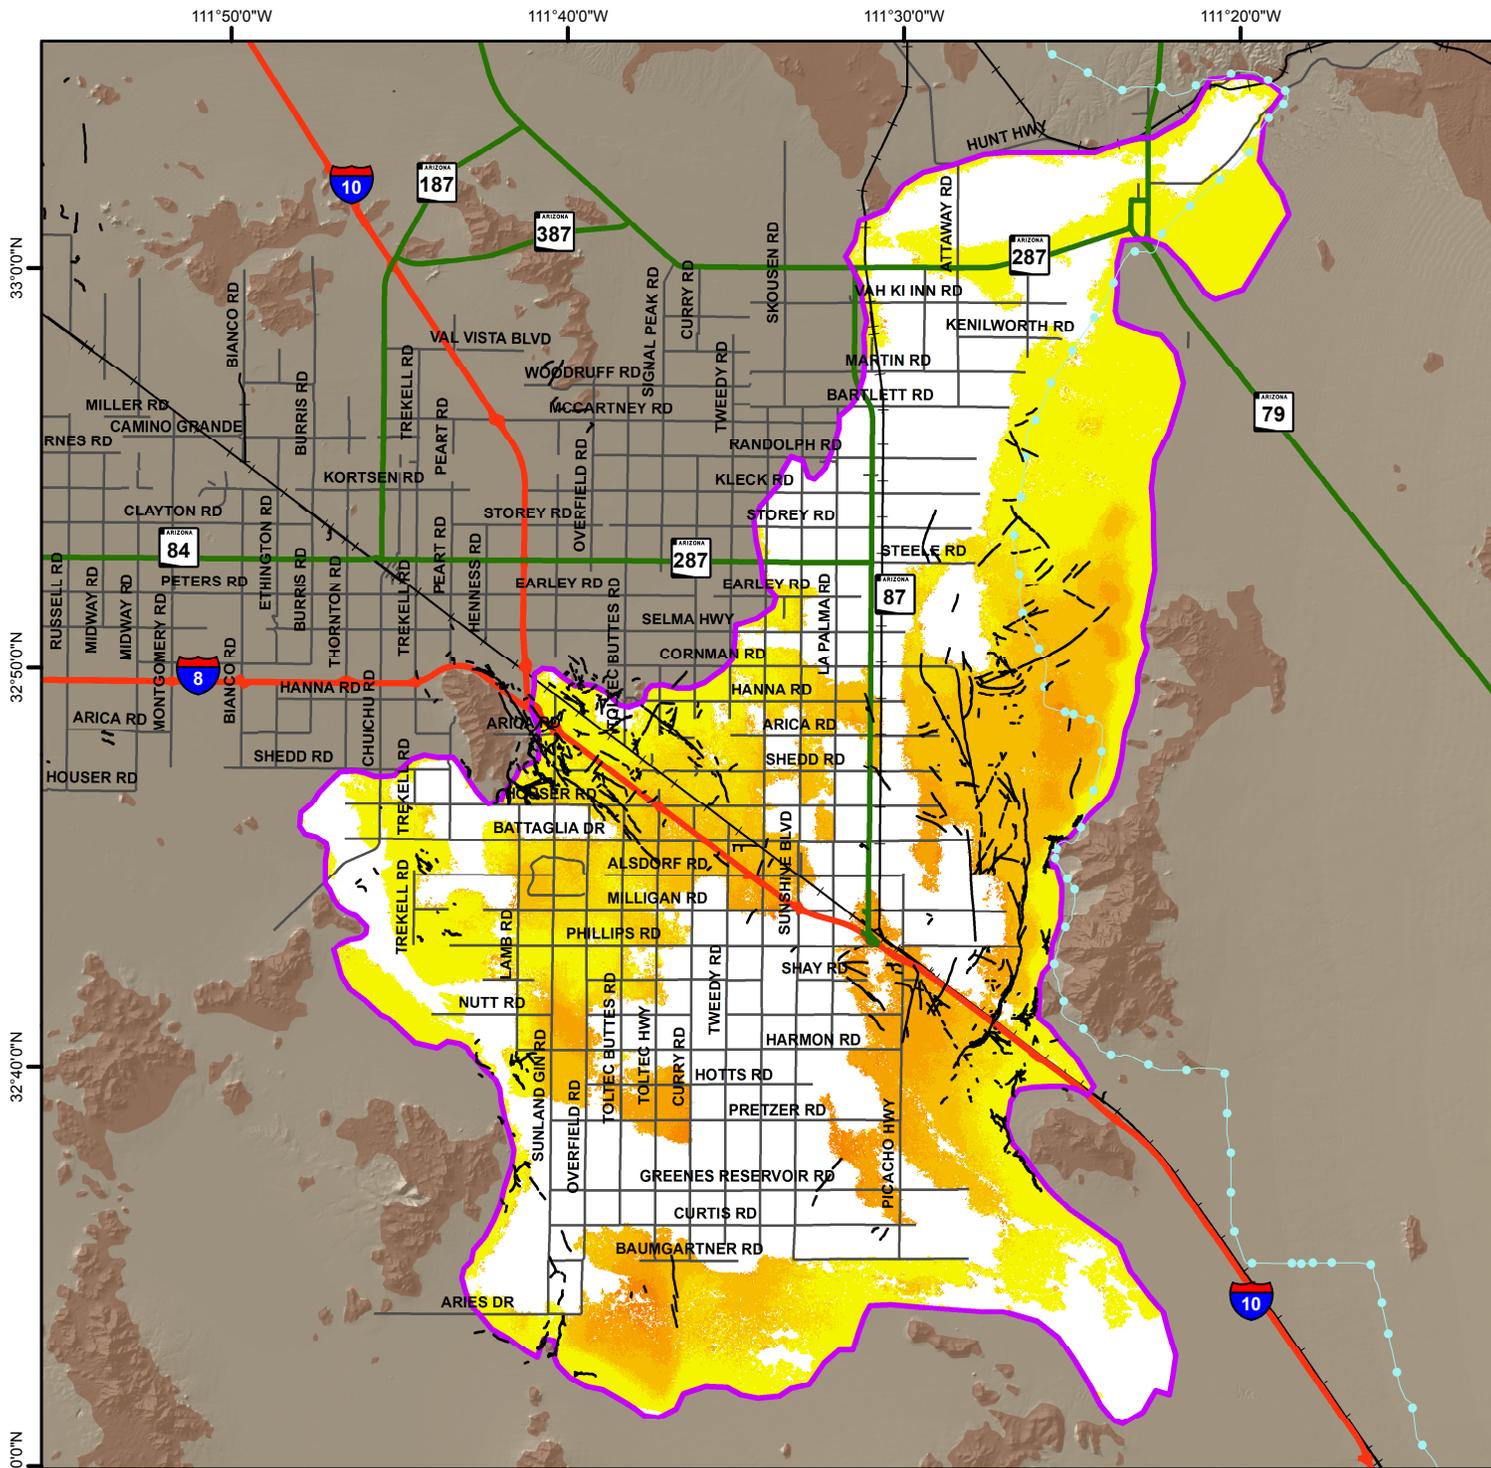
Decorrelation (white areas) are areas where the phase of the received satellite signal changed between satellite passes, causing the data to be unusable. This occurs in areas where the land surface has been disturbed (i.e. bodies of water, snow, agriculture areas, areas of development, etc).
