**Total Land Subsidence in the Eloy Sub-Basin, Pinal County**  
 Based on Radarsat-2 Satellite Interferometric Synthetic Aperture Radar (InSAR) Data  
 Time Period of Analysis: 2.0 Years 04/16/2011 To 04/29/2013

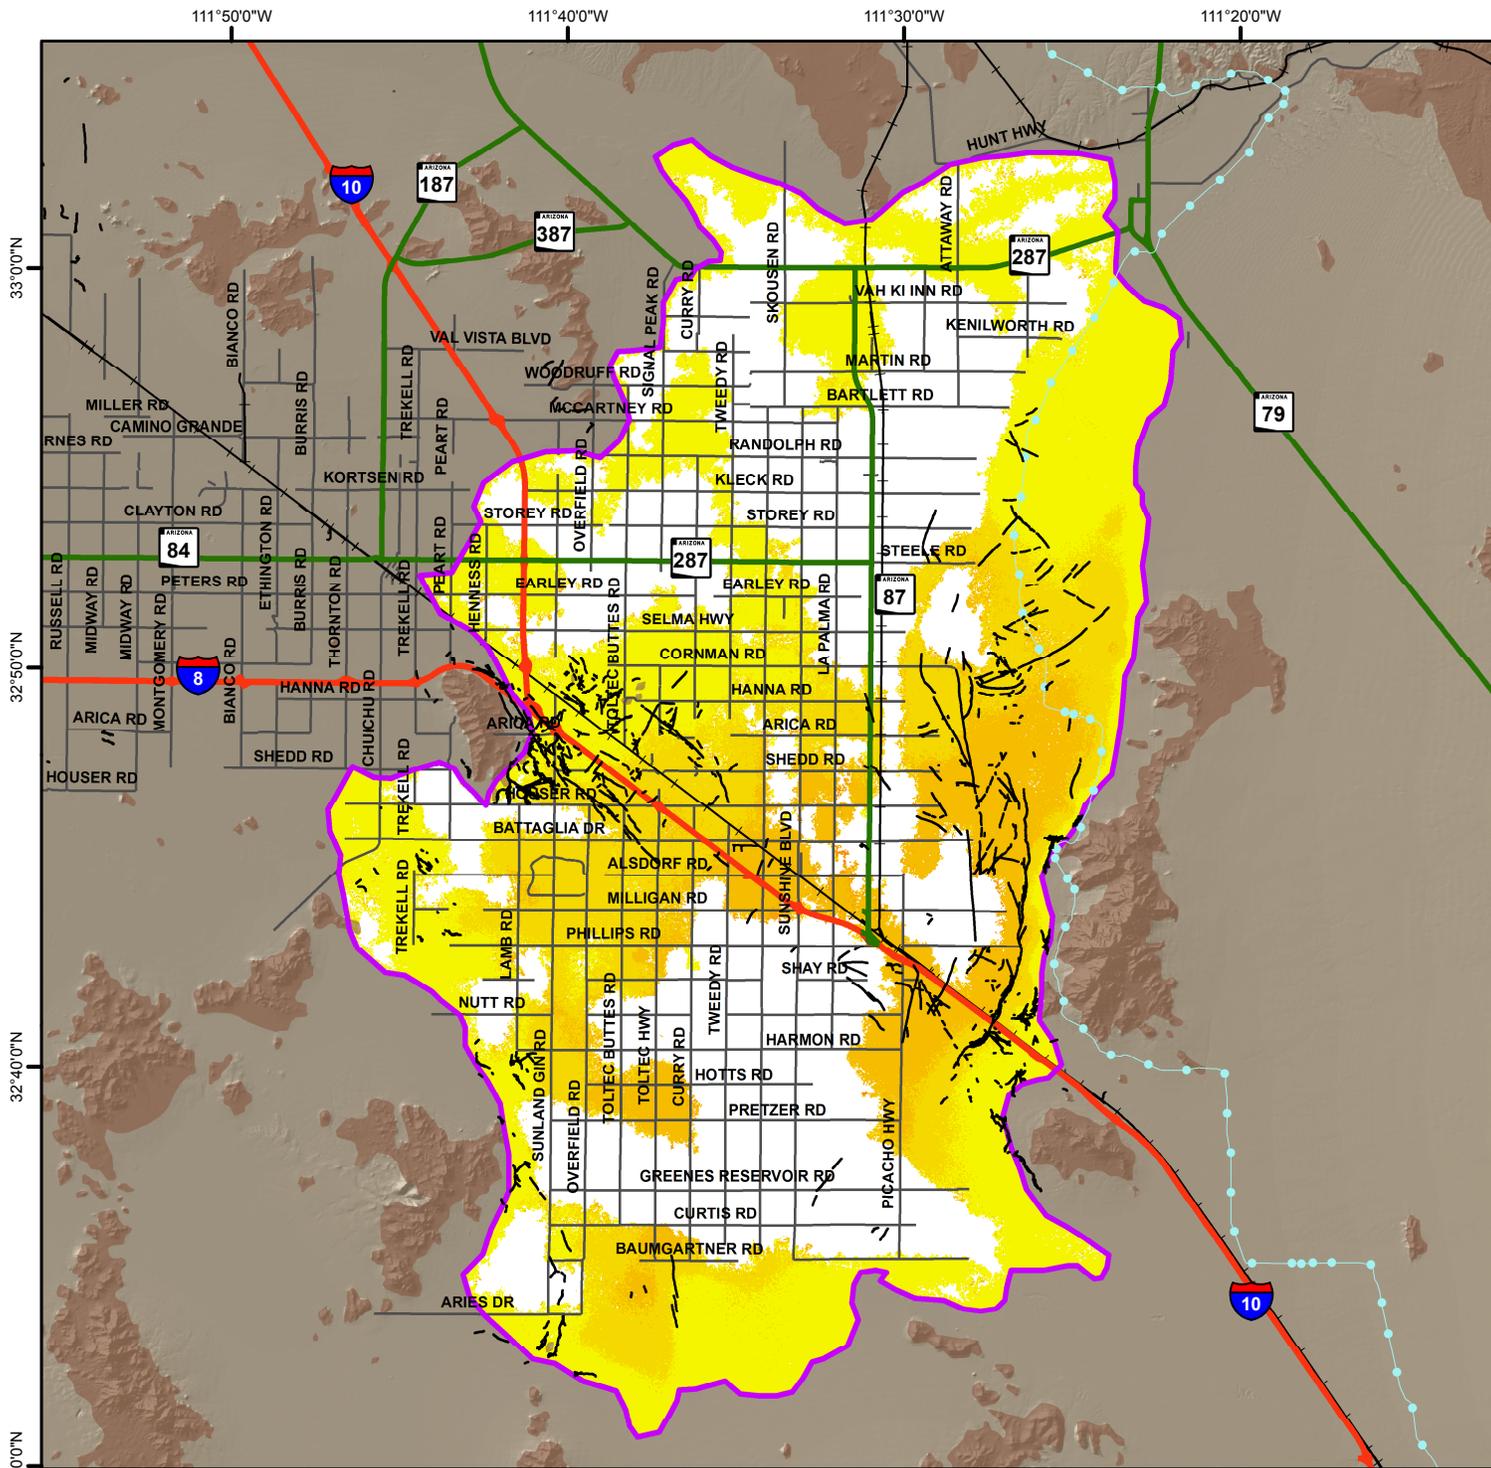
Decorrelation (white areas) are areas where the phase of the received satellite signal changed between satellite passes, causing the data to be unusable. This occurs in areas where the land surface has been disturbed (i.e. bodies of water, snow, agriculture areas, areas of development, etc).

Earth fissures were mapped by the Arizona Geological Survey. For information on earth fissures visit: [www.azgs.gov/EFC](http://www.azgs.gov/EFC)
