Land Subsidence Rate in the Eloy Sub-Basin, Pinal County
 Based on Envisat Satellite Interferometric Synthetic Aperture Radar (InSAR) Data
 Time Period of Analysis: 0.9 Years 04/18/2007 To 02/27/2008

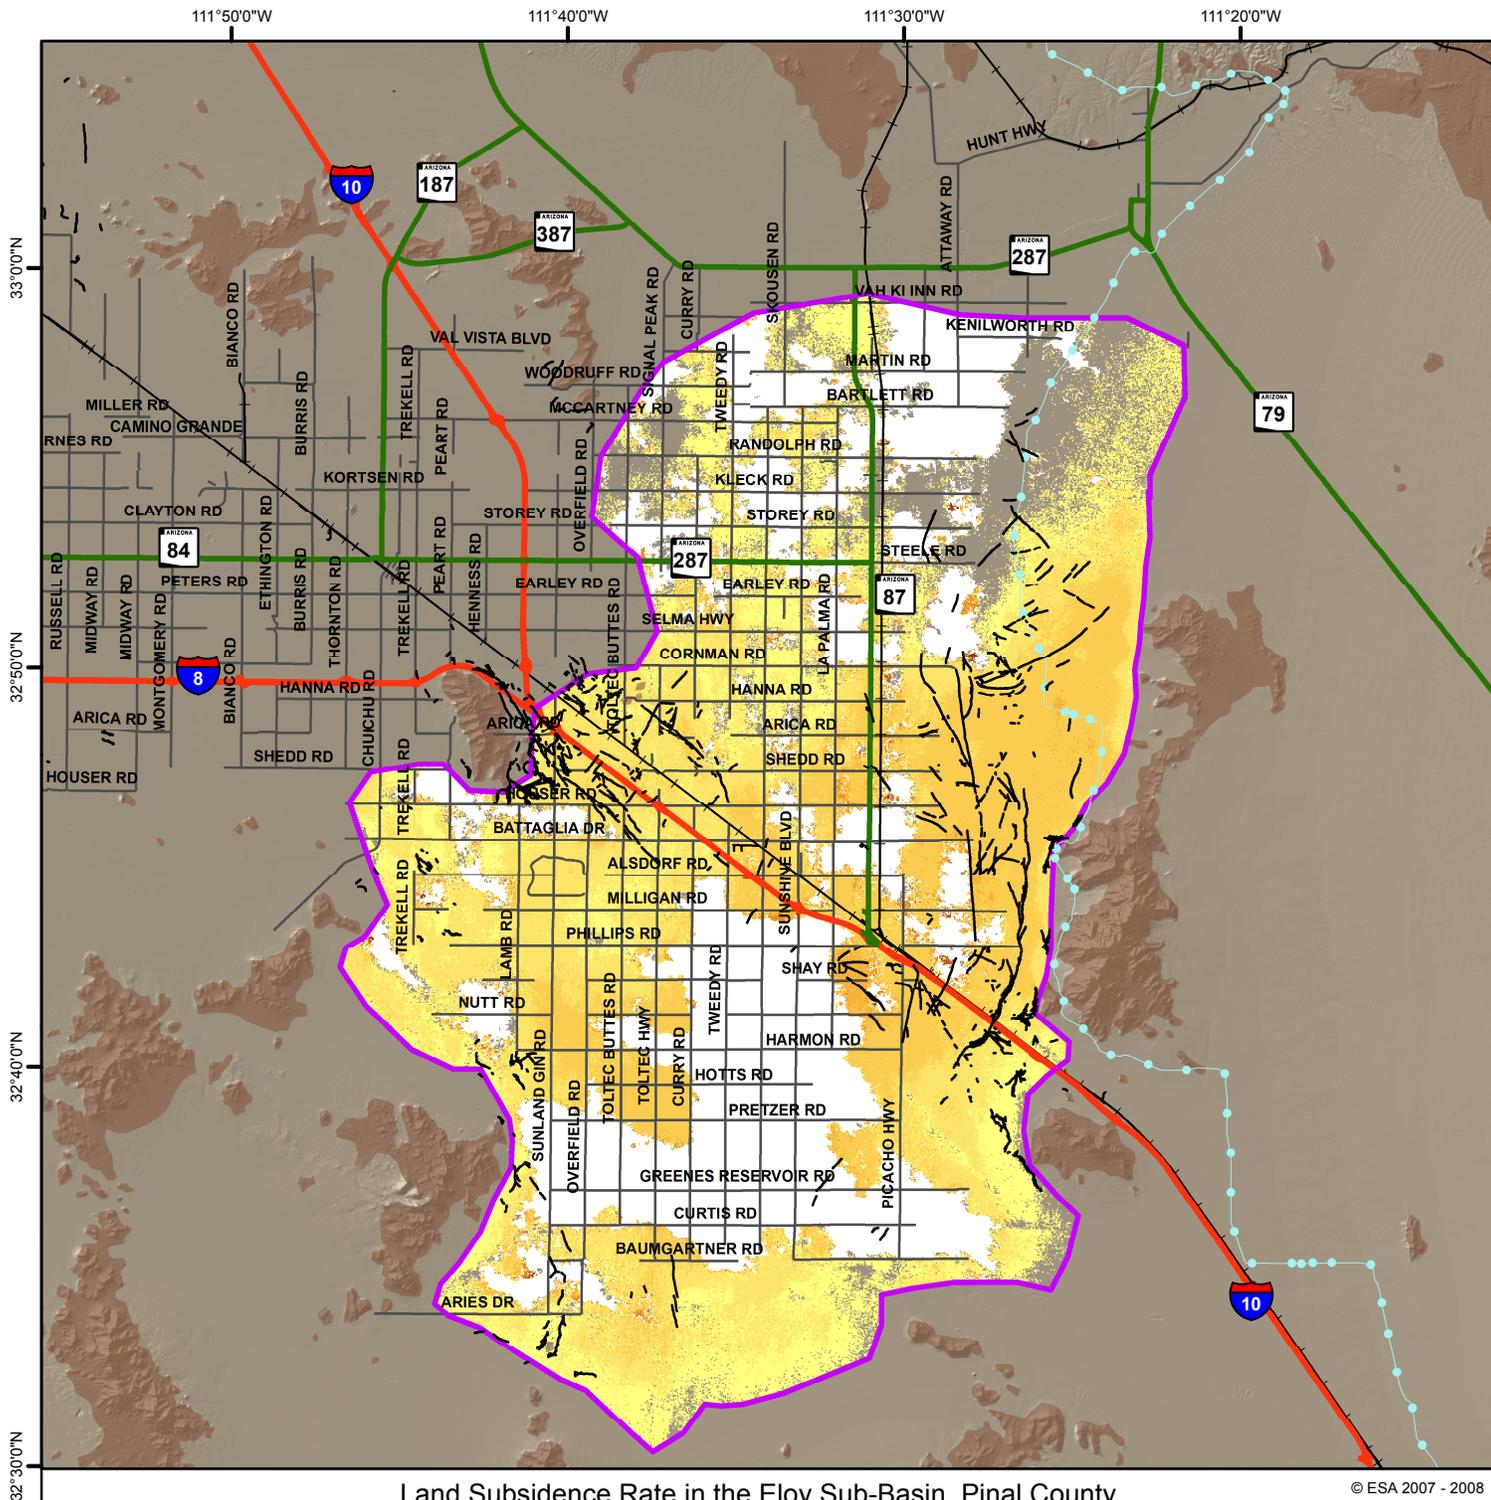
Decorrelation (white areas) are areas where the phase of the received satellite signal changed between satellite passes, causing the data to be unusable. This occurs in areas where the land surface has been disturbed (i.e. bodies of water, snow, agriculture areas, areas of development, etc).
