Land Subsidence Rate in the Ranegras Valley, La Paz County
 Based on Envisat Satellite Interferometric Synthetic Aperture Radar (InSAR) Data
Time Period of Analysis: 1.0 Years 01/29/2009 To 02/18/2010

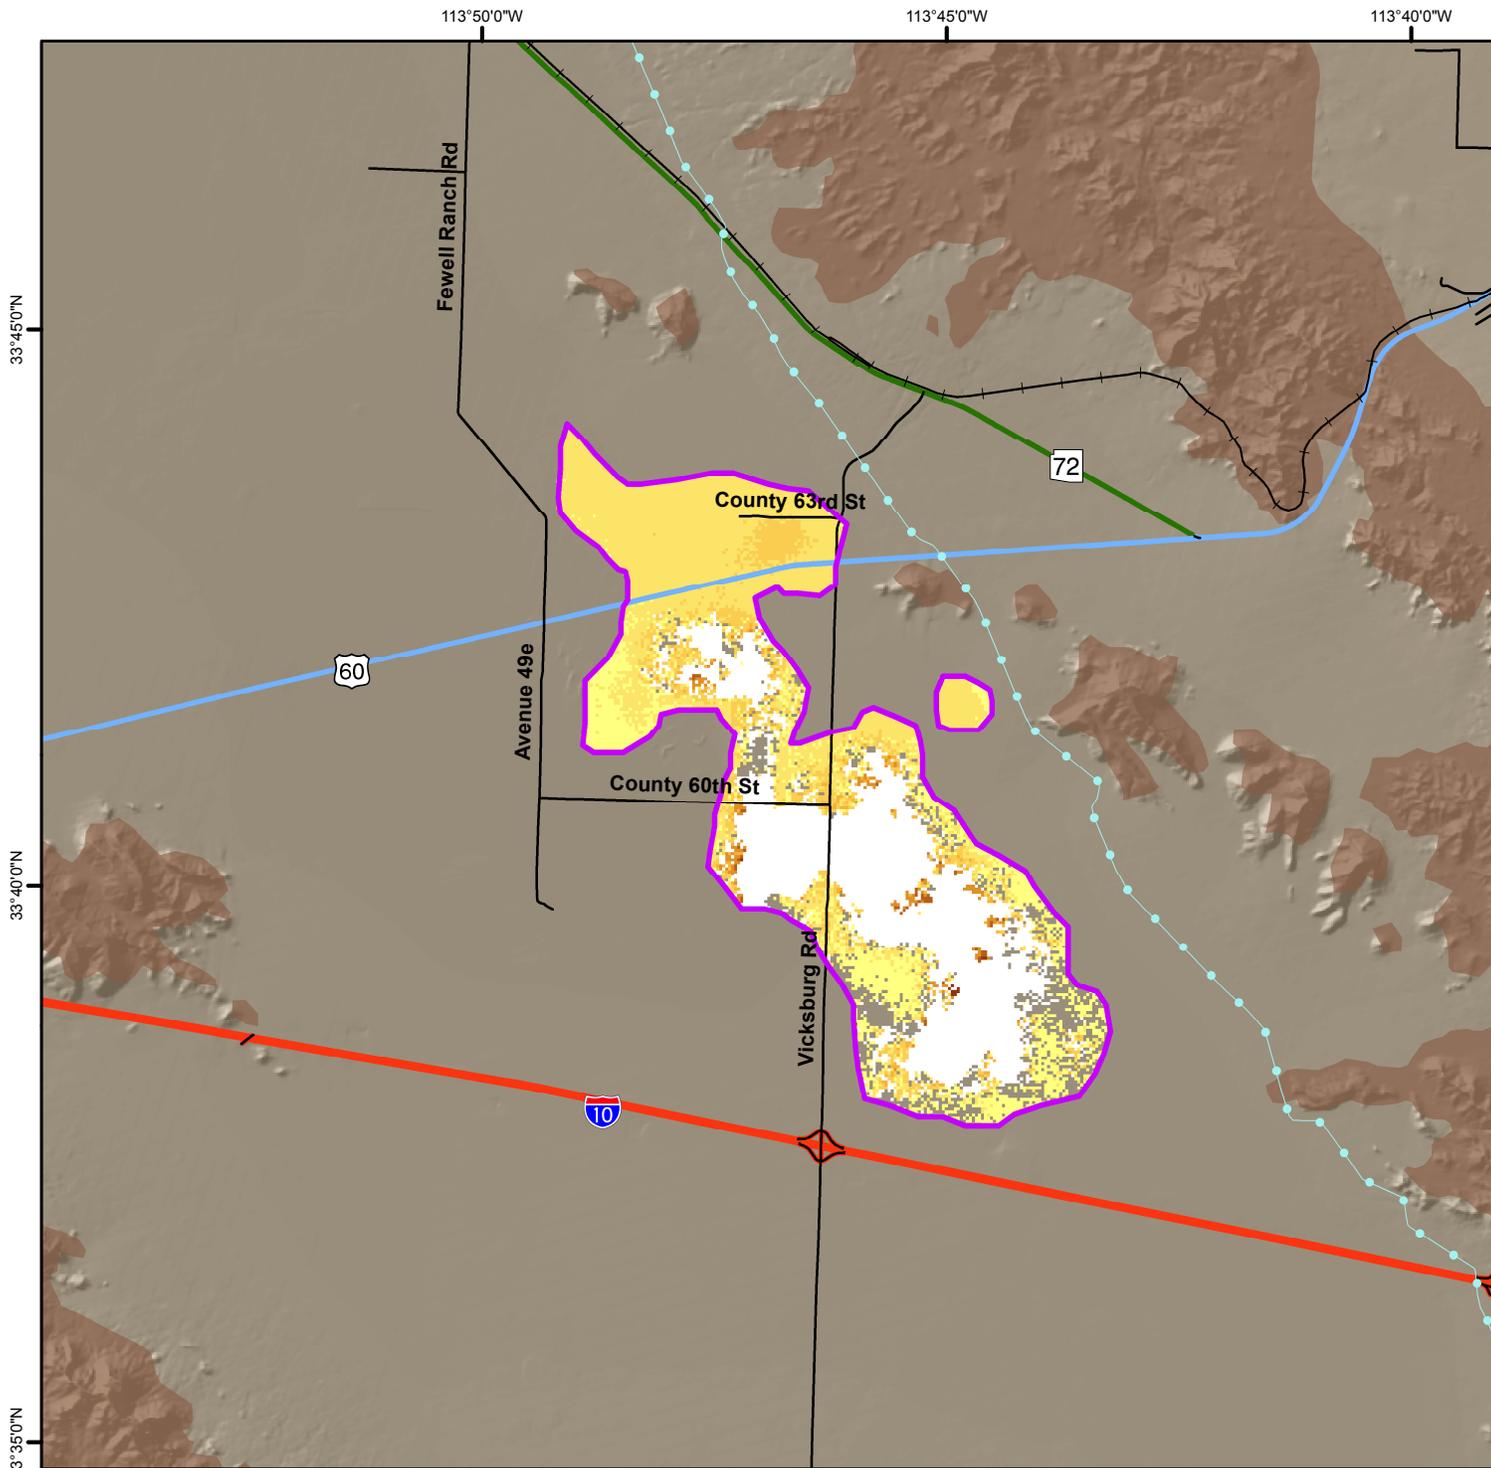
Decorrelation (white areas) are areas where the phase of the received satellite signal changed between satellite passes, causing the data to be unusable. This occurs in areas where the land surface has been disturbed (i.e. bodies of water, snow, agriculture areas, areas of development, etc).
