**Land Subsidence Rate in the Ranegras Valley, La Paz County**  
 Based on Radarsat-2 Satellite Interferometric Synthetic Aperture Radar (InSAR) Data  
**Time Period of Analysis: 1.0 Years 03/17/2014 To 04/05/2015**

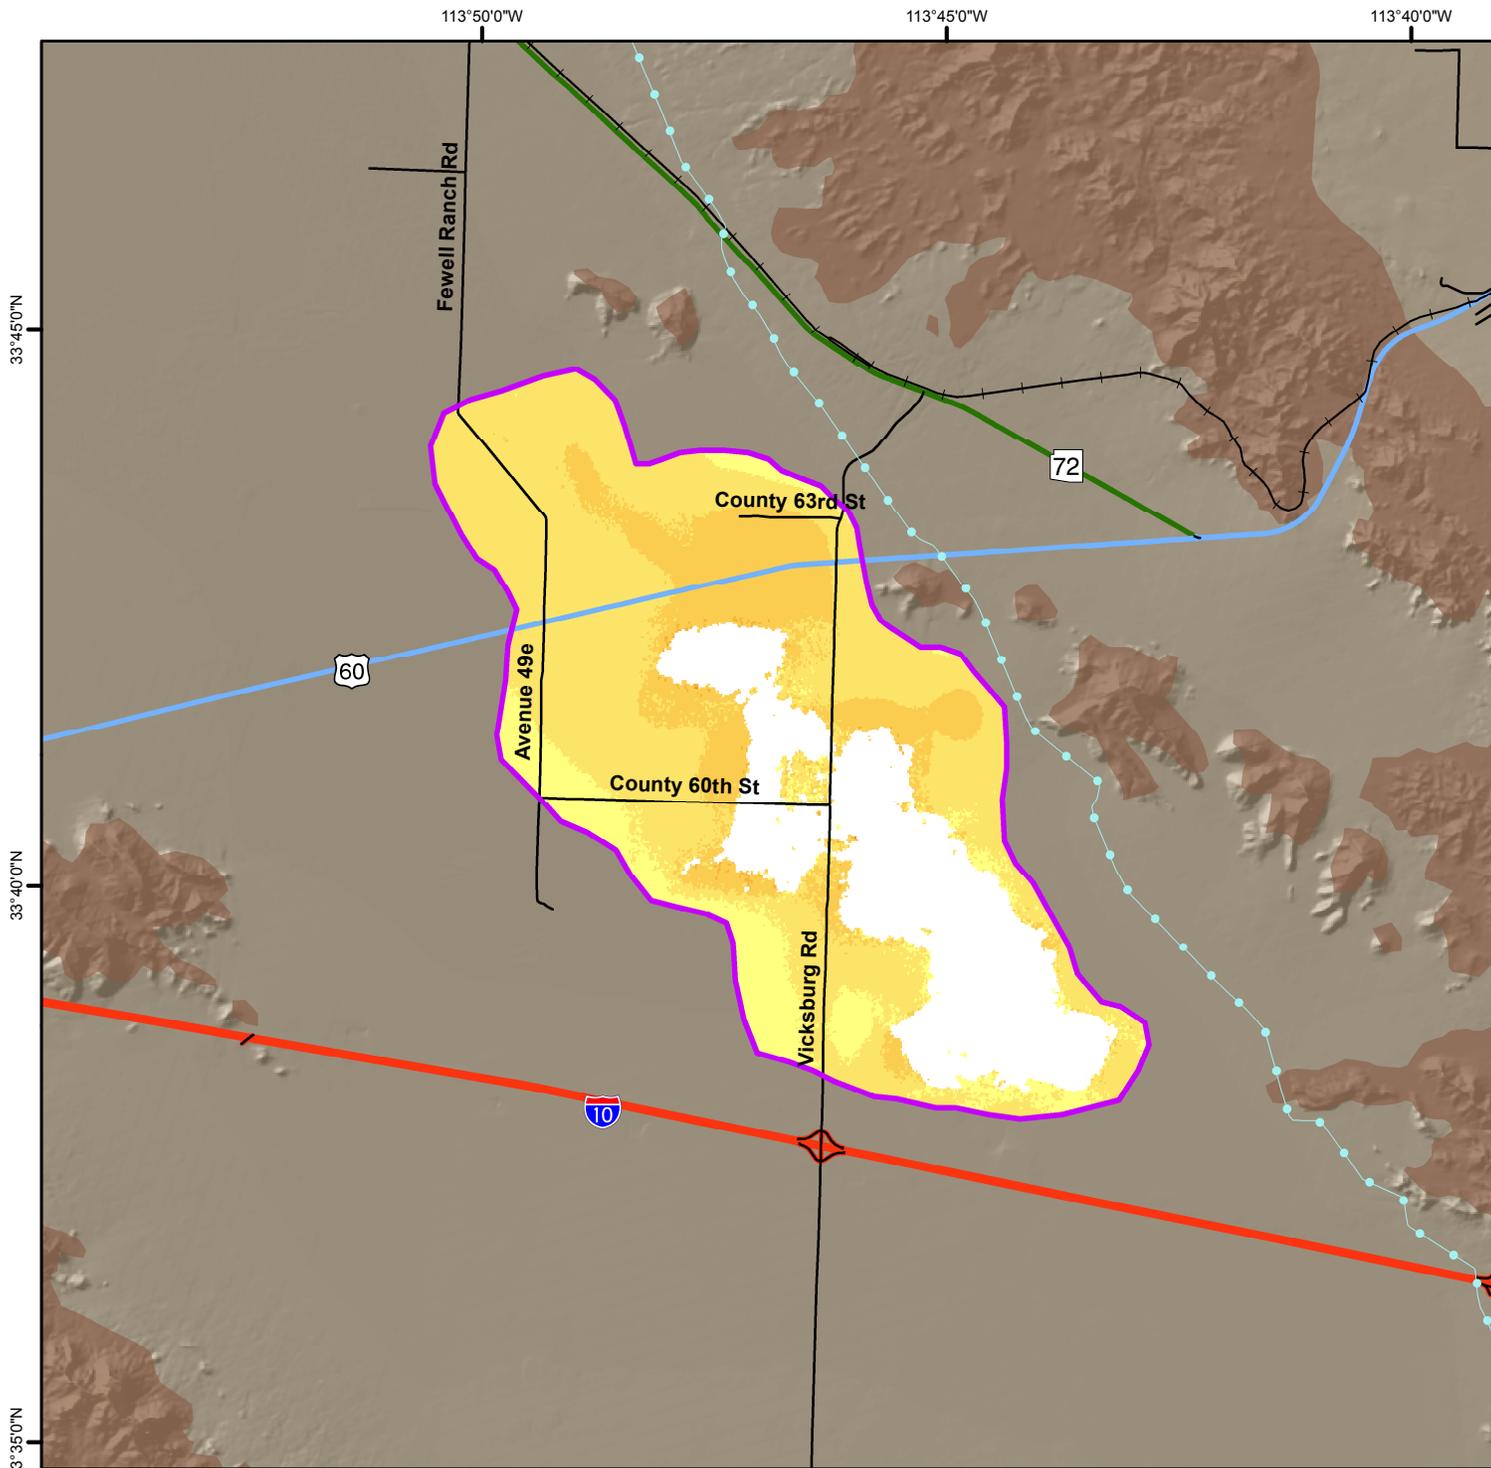
Explanation	
<b>03/17/2014 To 04/05/2015</b>	
Land Subsidence Rate	
	Decorrelation/No Data
	Greater 7 cm/yr (2.8 in/yr)
	5 - 7 cm/yr (2.0 - 2.8 in/yr)
	3 - 5 cm/yr (1.2 - 2.0 in/yr)
	2 - 3 cm/yr (0.8 - 1.2 in/yr)
	1 - 2 cm/yr (0.4 - 0.8 in/yr)
	0.5 - 1 cm/yr (0.2 - 0.4 in/yr)
	0 - 0.5 cm/yr (0 - 0.2 in/yr)
	Subsidence Feature
	Hardrock
	CAP Canal
Highways and Interstates	
	Interstate
	US
	State
	Roads
	Railway

Decorrelation (white areas) are areas where the phase of the received satellite signal changed between satellite passes, causing the data to be unusable. This occurs in areas where the land surface has been disturbed (i.e. bodies of water, snow, agriculture areas, areas of development, etc).
