Land Subsidence Rate in the Ranegras Valley, La Paz County
 Based on ERS-1 and 2 Satellite Interferometric Synthetic Aperture Radar (InSAR) Data
Time Period of Analysis: 4.7 Years 06/08/1992 To 03/13/1997

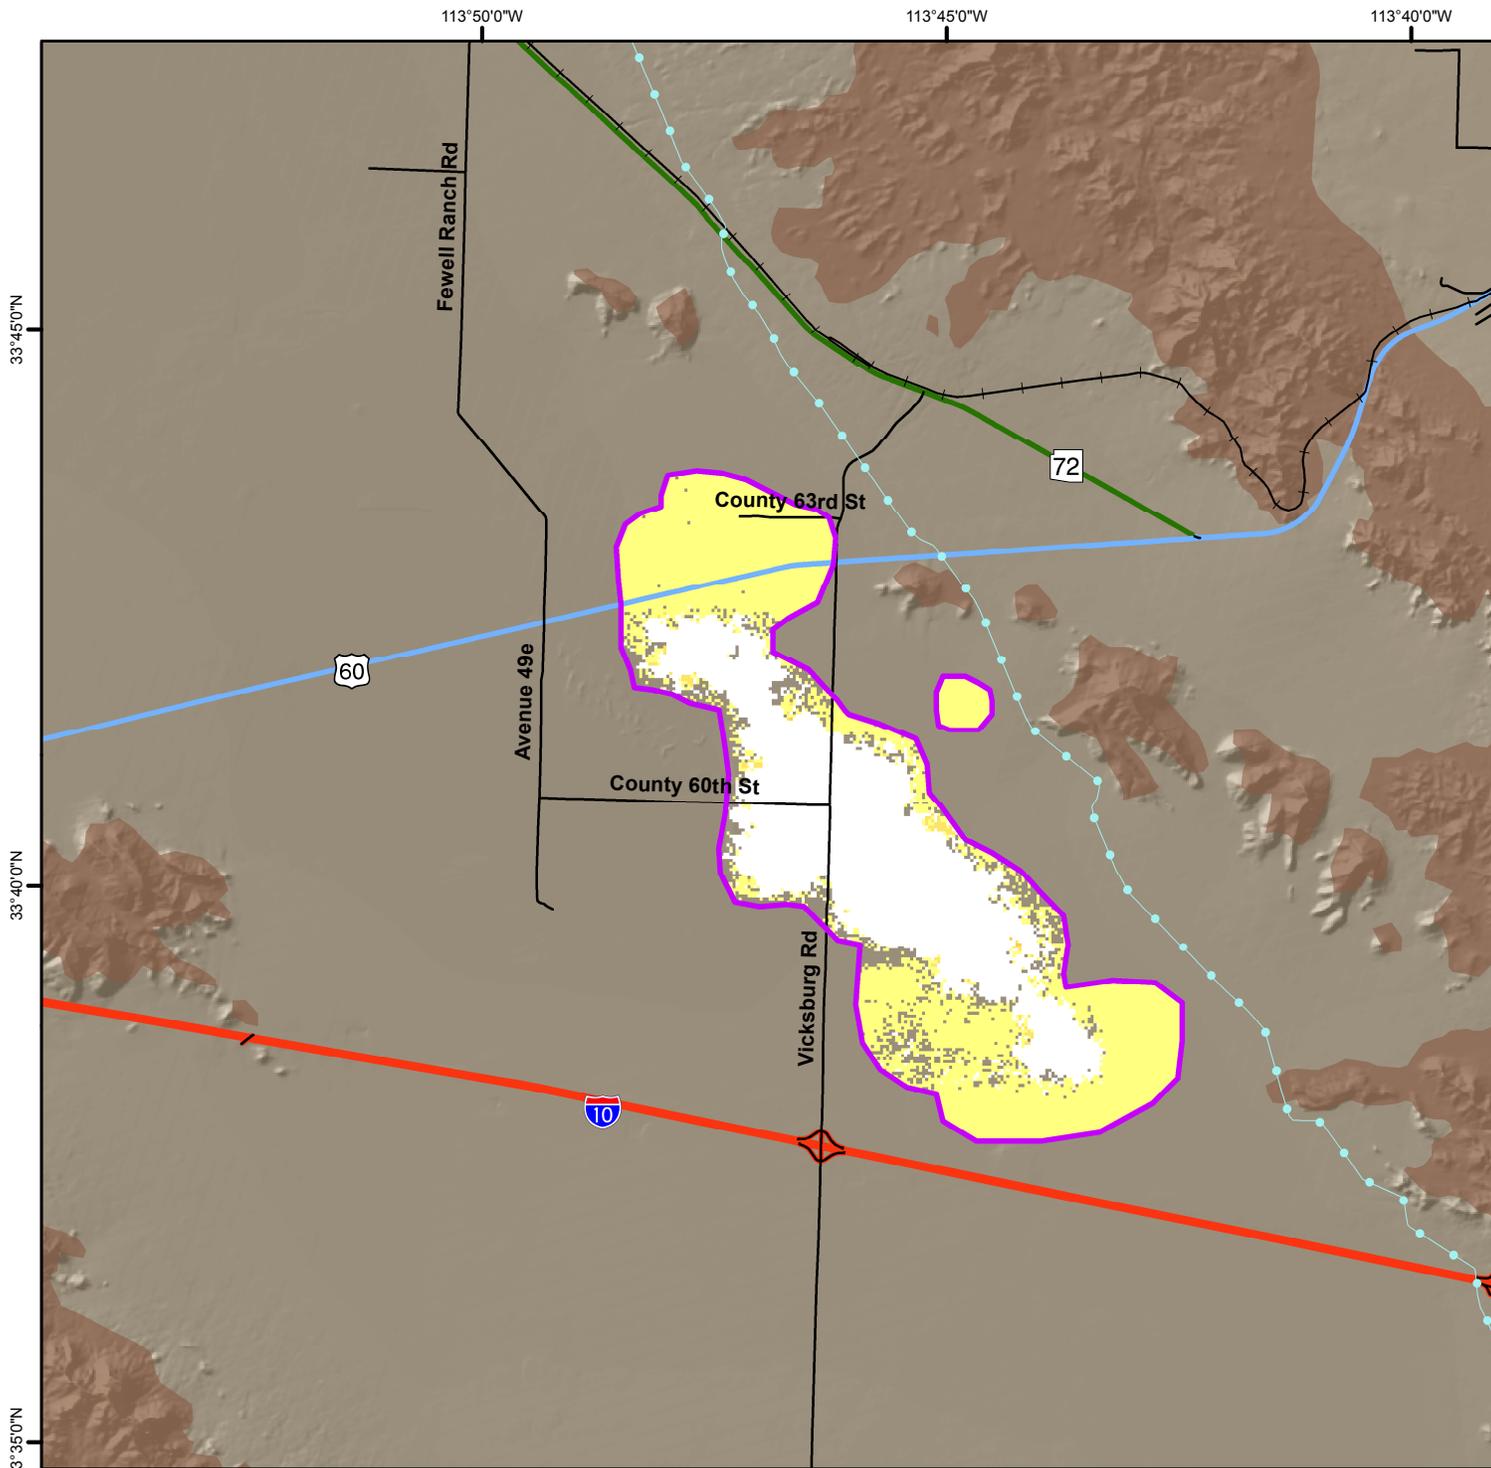
Decorrelation (white areas) are areas where the phase of the received satellite signal changed between satellite passes, causing the data to be unusable. This occurs in areas where the land surface has been disturbed (i.e. bodies of water, snow, agriculture areas, areas of development, etc).
