Land Subsidence Rate in the Northeast Phoenix and Scottsdale Areas, Maricopa County
 Based on Envisat Satellite Interferometric Synthetic Aperture Radar (InSAR) Data
 Time Period of Analysis: 2.0 Years 02/11/2008 To 02/15/2010

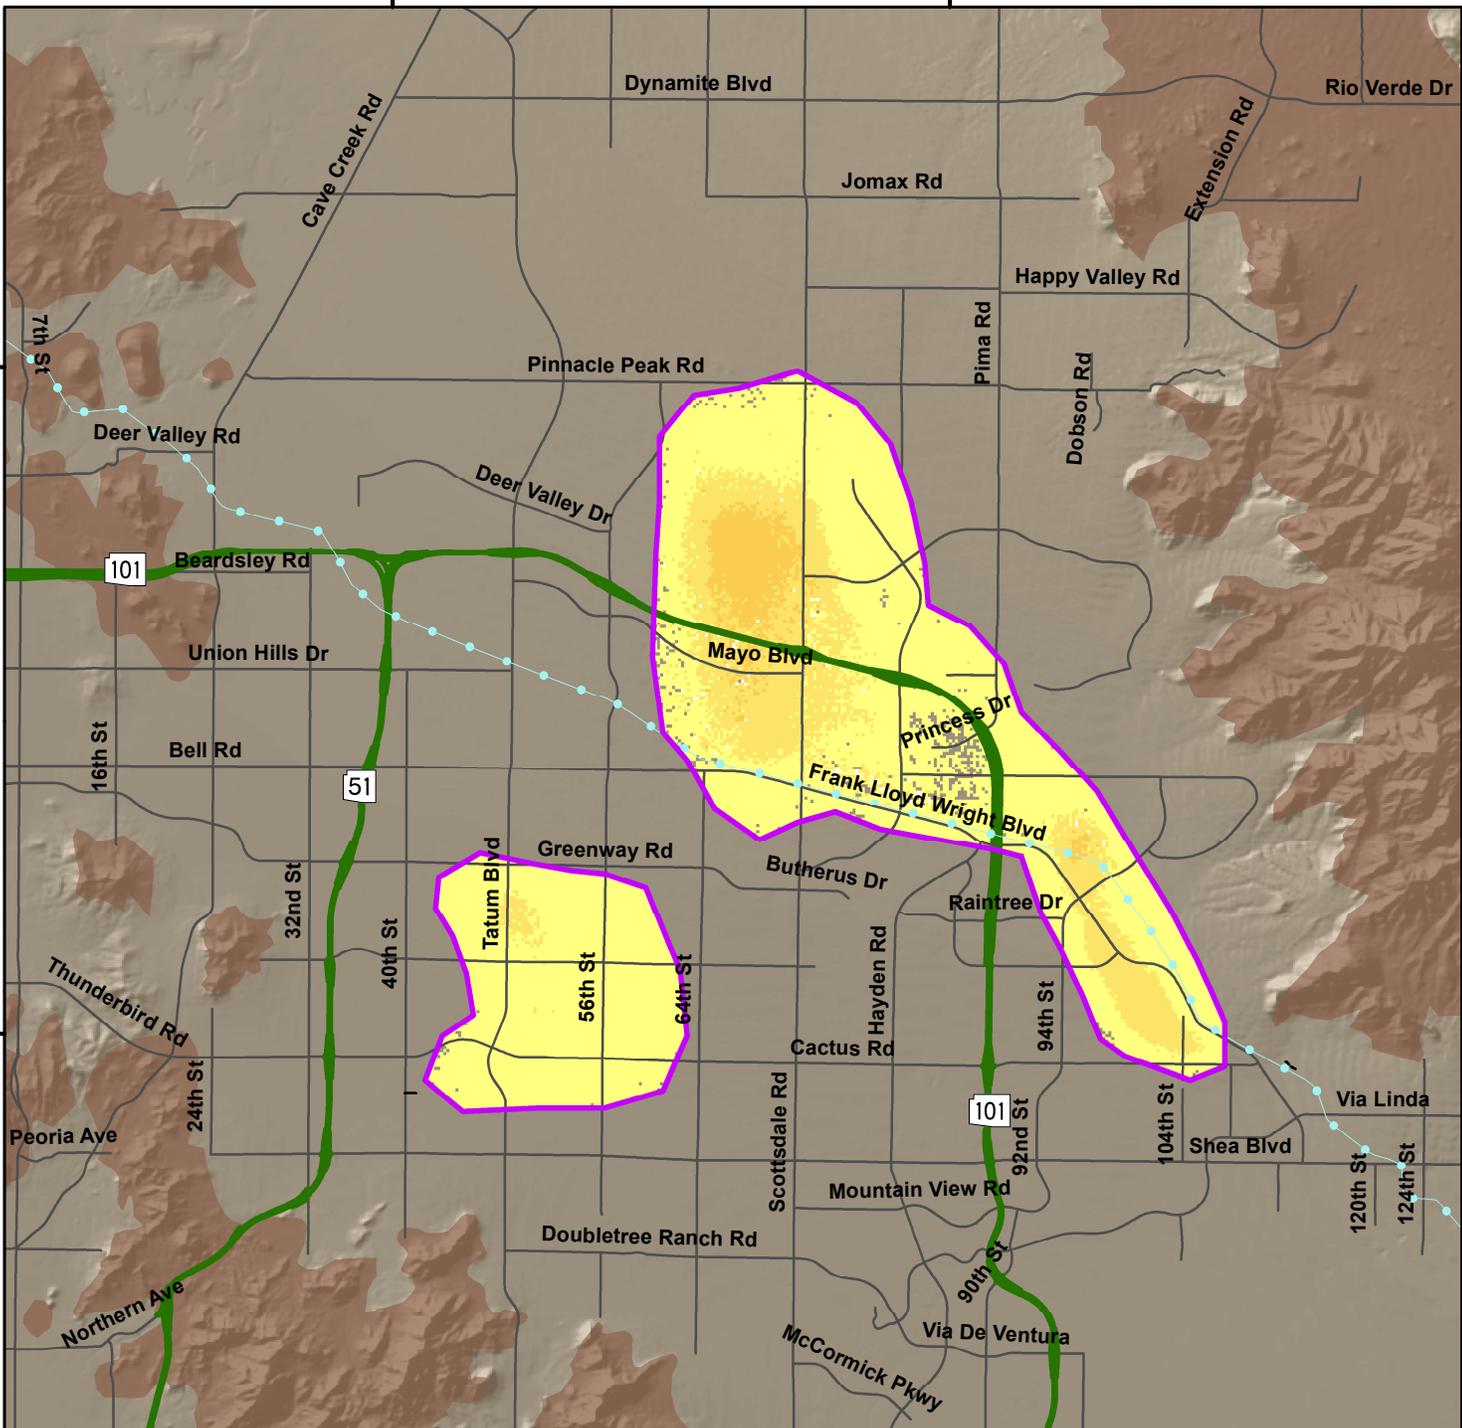
Decorrelation (white areas) are areas where the phase of the received satellite signal changed between satellite passes, causing the data to be unusable. This occurs in areas where the land surface has been disturbed (i.e. bodies of water, snow, agriculture areas, areas of development, etc).
