Fact Sheet

Land Subsidence and Earth Fissures in Arizona

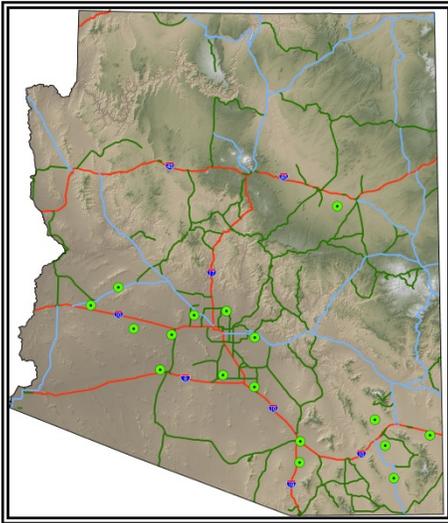
Active Land Subsidence Areas in Arizona Based on ADWR InSAR

Land subsidence maps were developed by ADWR using archived and current InSAR data with the goal of providing hydrologists, geologists, water managers, and the public the most accurate land subsidence data.

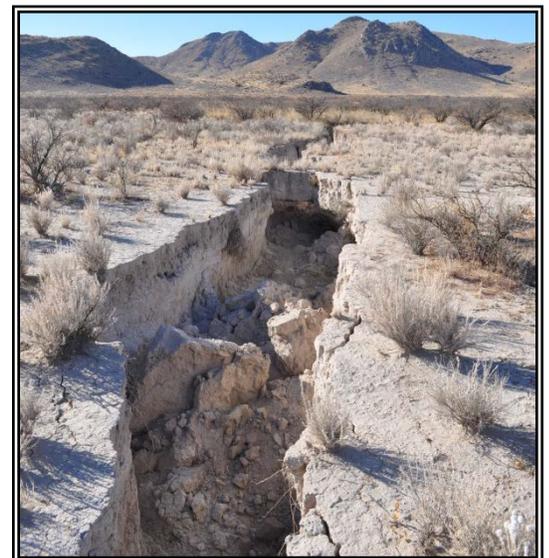
Earth Fissure near the Sulphur Hills in Cochise County that opened up after a Monsoon Storm in July 2010

Earth fissures are cracks at or near the earth's surface that are the result of differential subsidence. Earth fissures start out as small cracks and may not be visible on the surface. They grow and widen from surface water flowing into the crack, eroding material from the sides.

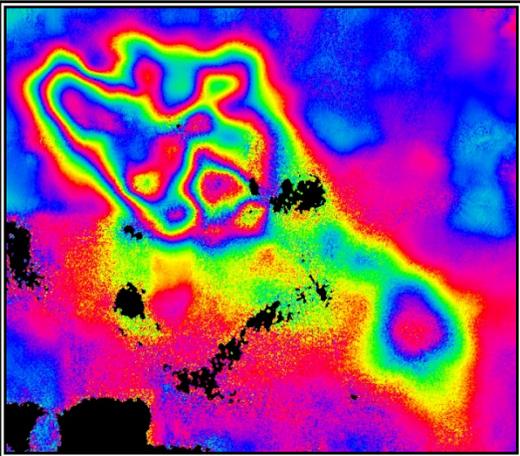
Hawk Rock Area 2010 - 2014 Interferogram

Land subsidence has been detected over the years using surveying techniques such as differential leveling and high accuracy Global Positioning System (GPS) surveying. In the early 1990's scientists began to use Synthetic Aperture Radar (SAR) and interferometric processing (InSAR) to detect land surface elevation changes. InSAR has been developed into a highly reliable land subsidence monitoring technique that has been utilized by ADWR since 2002. ADWR has identified numerous subsidence features around the State and continues to monitor the extent and rates of these features on an annual basis.

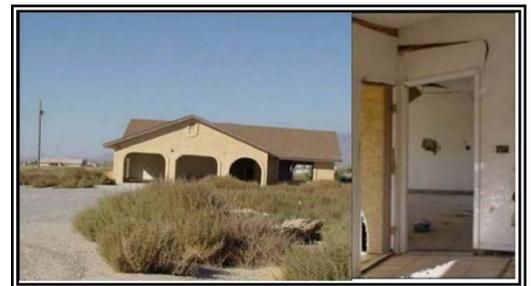
A House in Nevada Damaged by Land Subsidence and an Earth Fissure

There are many consequences of land subsidence and earth fissures: Elevation and slope change affecting the natural flood plain drainage, flow within canals and drains, damaging intermodal infrastructure (roads, bridges, railways, etc), damaging water retention and retarding structures (dams, levees, floodways, etc), and damaging private property (homes, driveways, fences, etc).
