Total Land Subsidence in the Maricopa-Stanfield Sub-Basin, Pinal County  
Based on Envisat Satellite Interferometric Synthetic Aperture Radar (InSAR) Data  
Time Period of Analysis: 1.9 Years 04/18/2007 To 02/27/2008

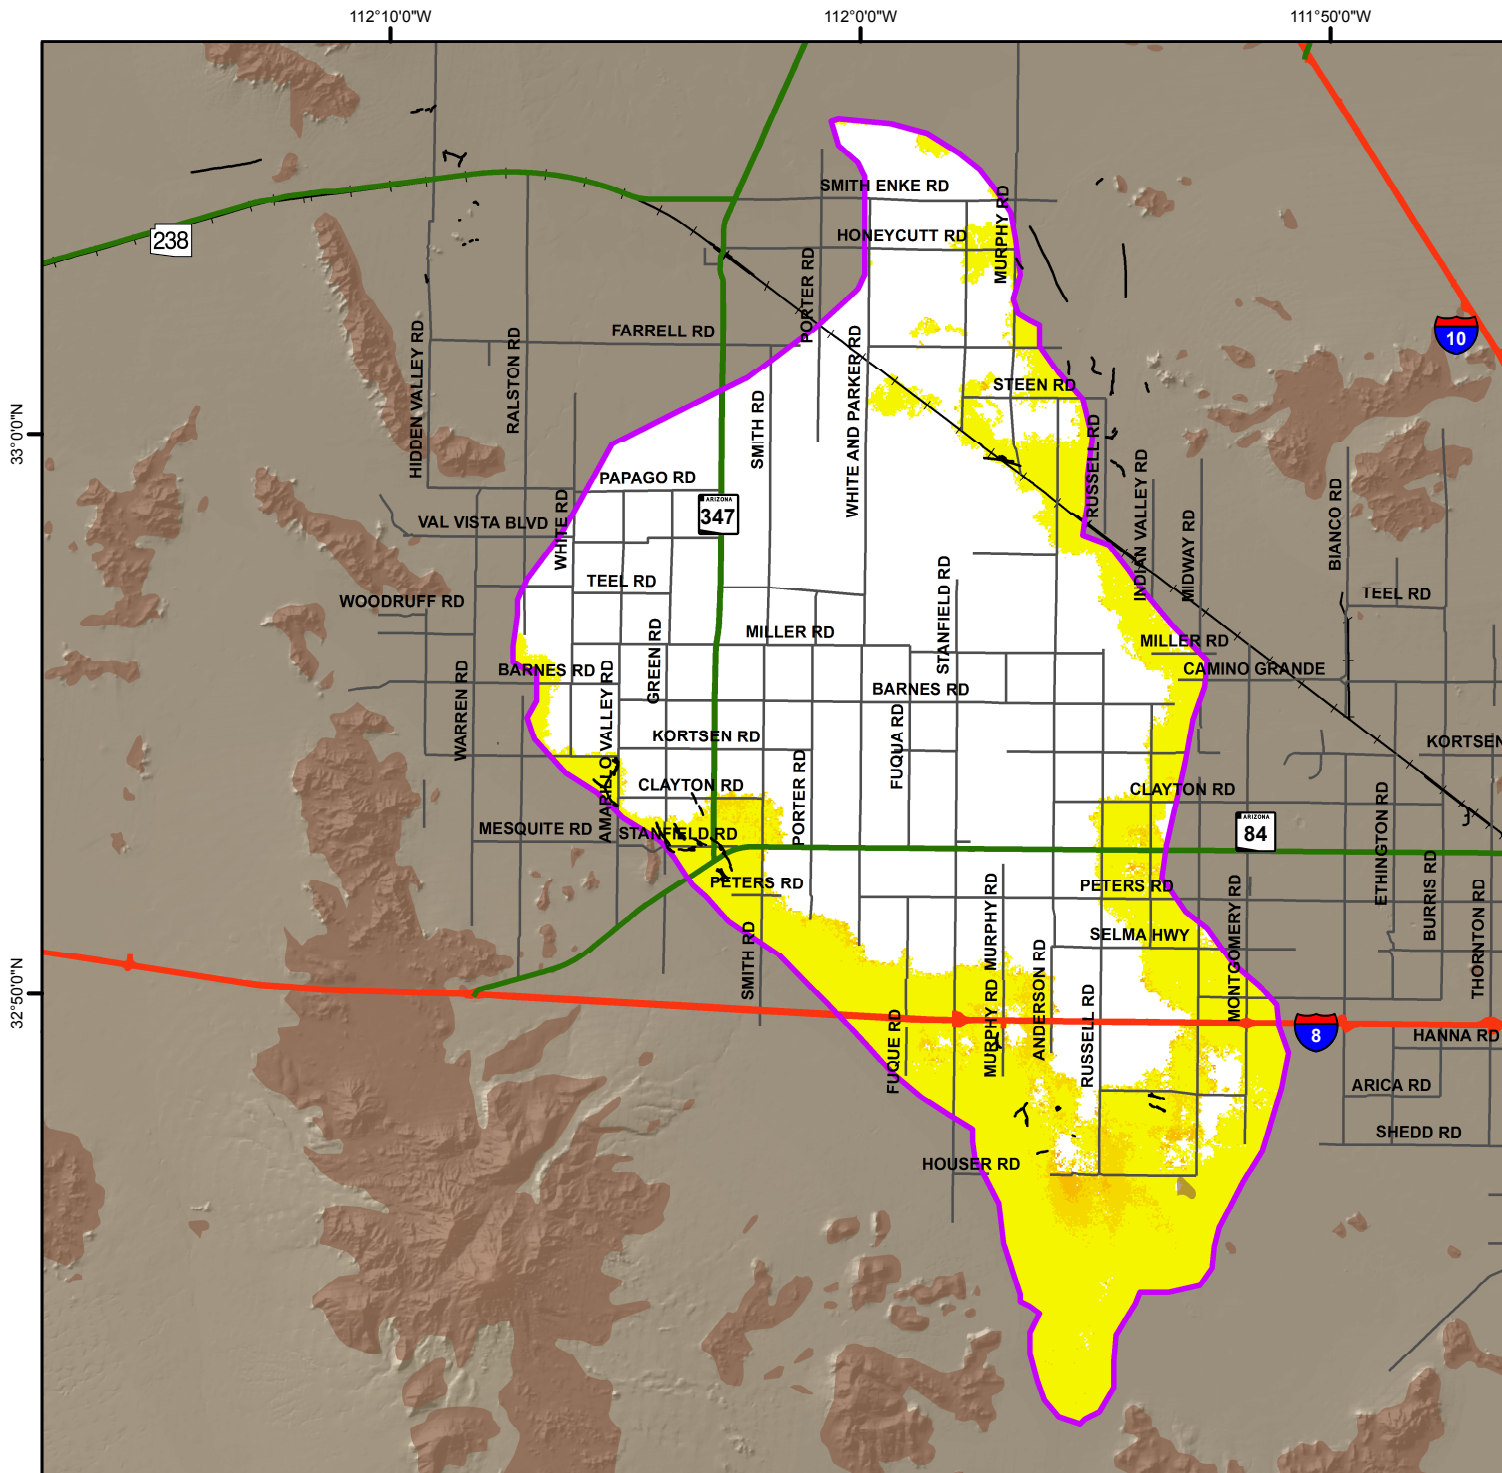
Decorrelation (white areas) are areas where the phase of the received satellite signal changed between satellite passes, causing the data to be unusable. This occurs in areas where the land surface has been disturbed (i.e. bodies of water, snow, agriculture areas, areas of development, etc).
