Land Subsidence Rate in the Bowie and San Simon Areas, Cochise County
 Based on Sentinel-1 Satellite Interferometric Synthetic Aperture Radar (InSAR) Data
 Time Period of Analysis: 2.0 Years 05/13/2025 To 05/08/2026

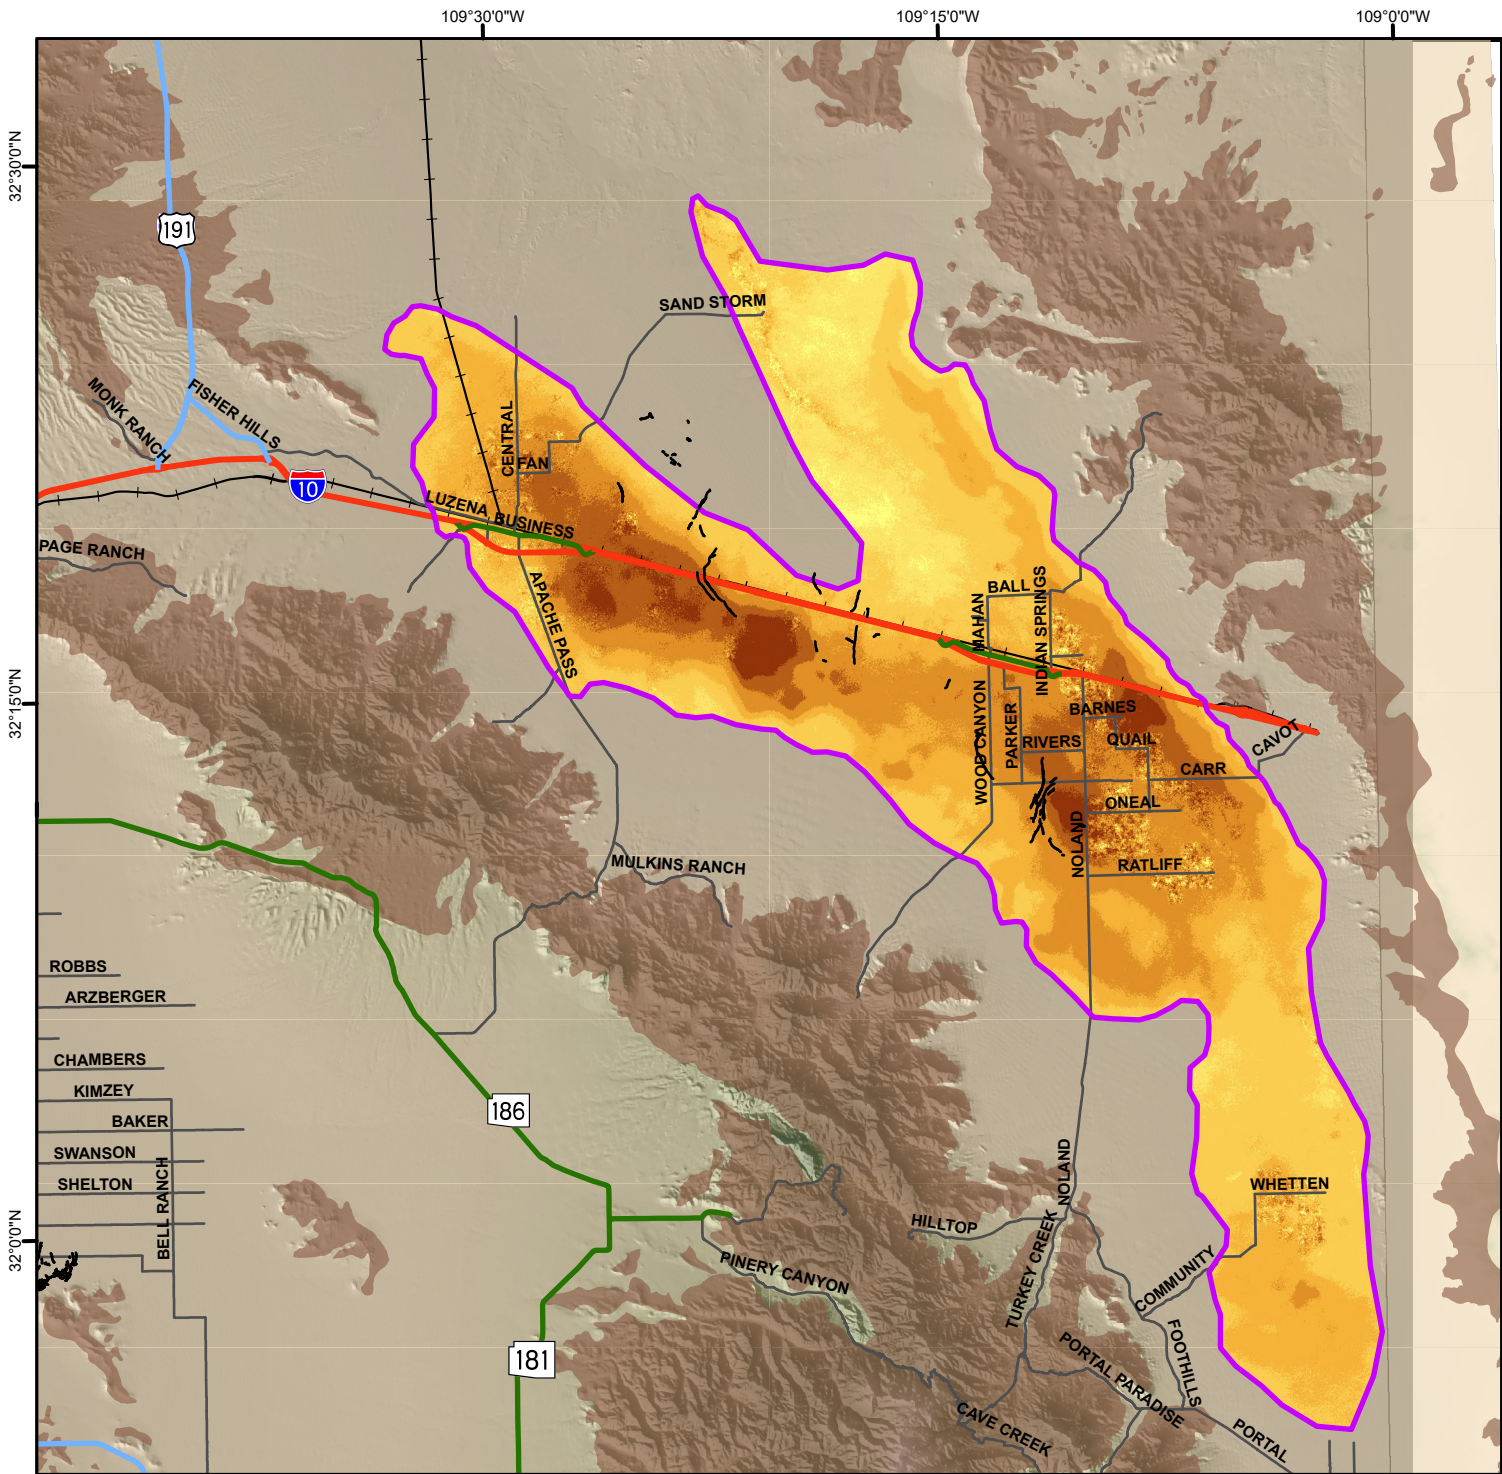
Decorrelation (white areas) are areas where the phase of the received satellite signal changed between satellite passes, causing the data to be unusable. This occurs in areas where the land surface has been disturbed (i.e. bodies of water, snow, agriculture areas, areas of development, etc).

Earth fissures were mapped by the Arizona Geological Survey. For information on earth fissures visit: www.azgs.gov/EFC
