Land Subsidence Rate in the Butler Valley Area, La Paz County
 Based on Radarsat-2 Satellite Interferometric Synthetic Aperture Radar (InSAR) Data
 Time Period of Analysis: 1.0 Years 03/31/2025 To 03/26/2026

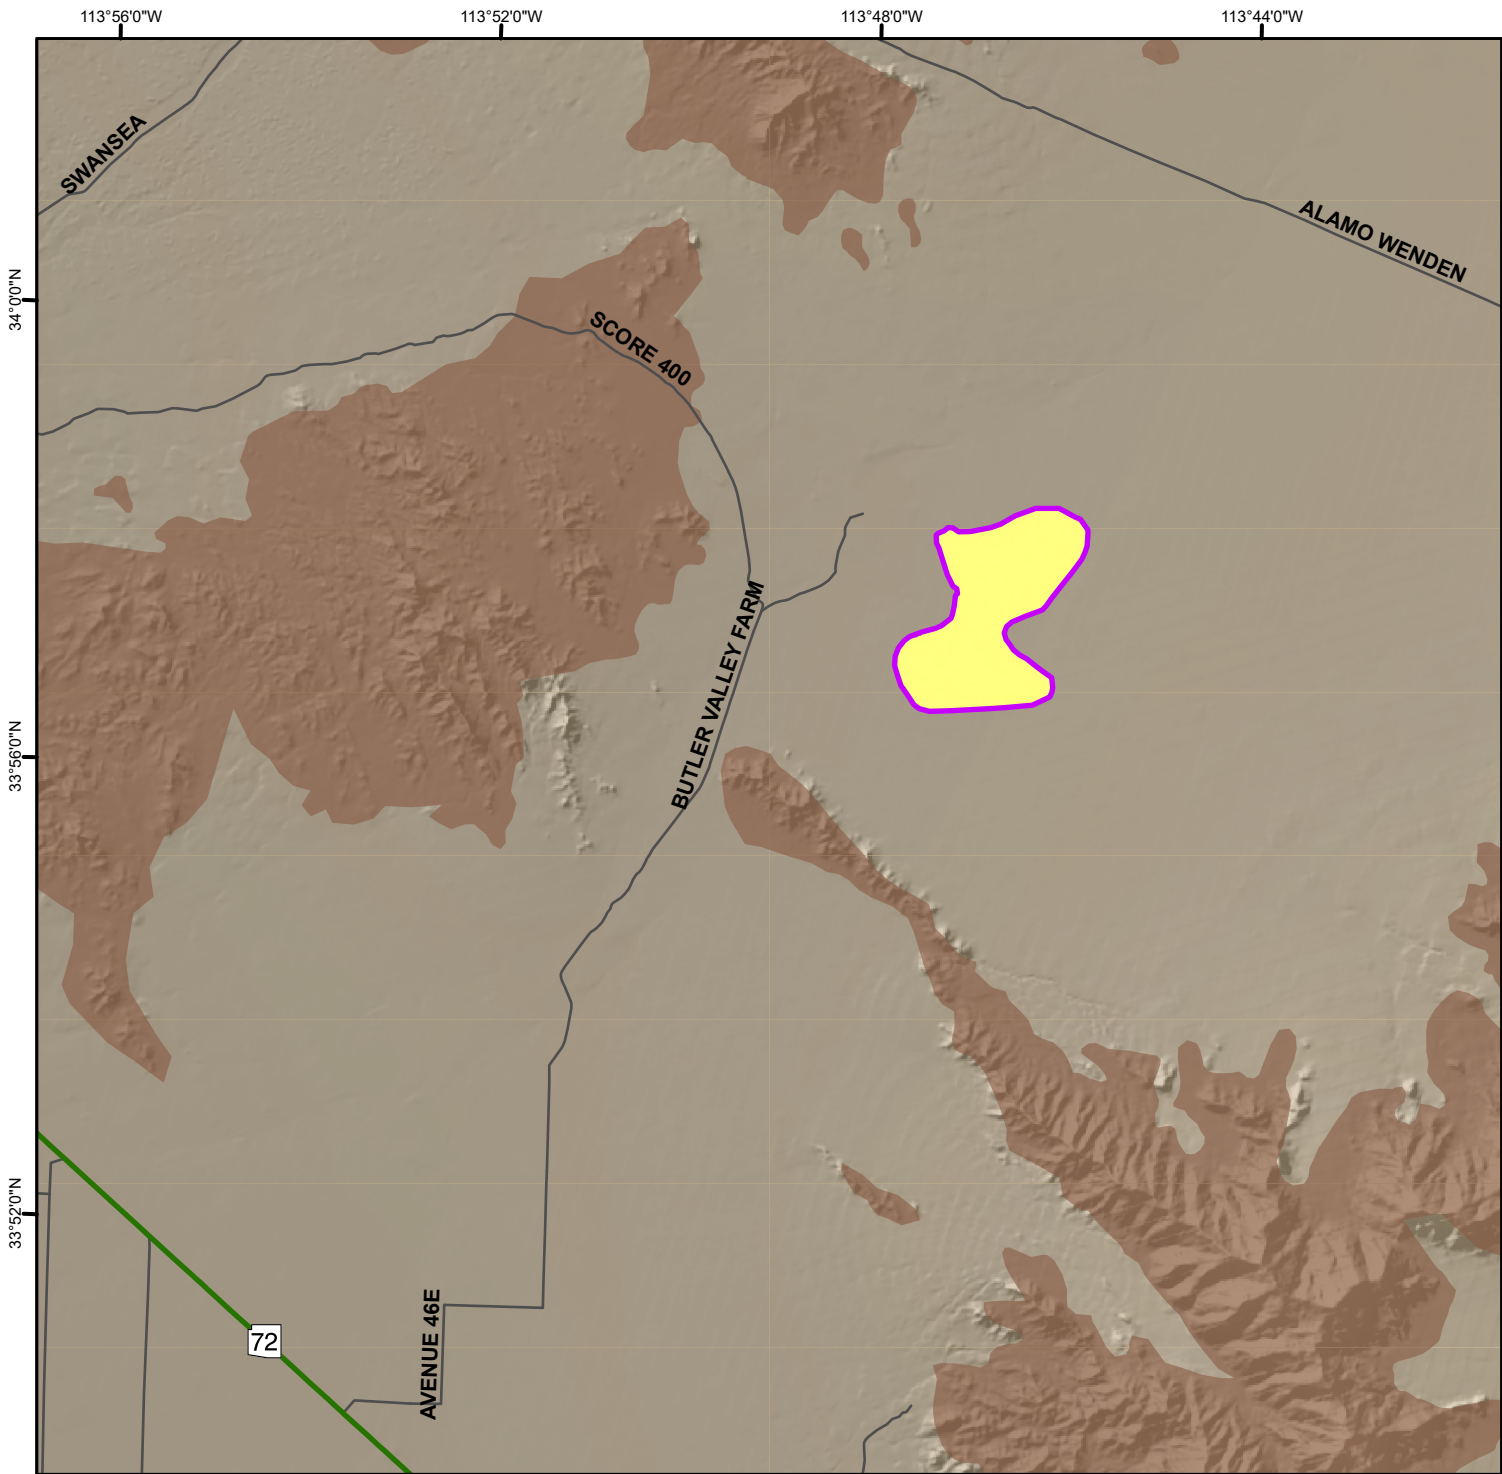
Decorrelation (white areas) are areas where the phase of the received satellite signal changed between satellite passes, causing the data to be unusable. This occurs in areas where the land surface has been disturbed (i.e. bodies of water, snow, agriculture areas, areas of development, etc).
