Total Land Subsidence in the Elfrida Area, Cochise County
 Based on Radarsat-2 Satellite Interferometric Synthetic Aperture Radar (InSAR) Data
Time Period of Analysis: 16.0 Years 05/05/2010 To 03/30/2026

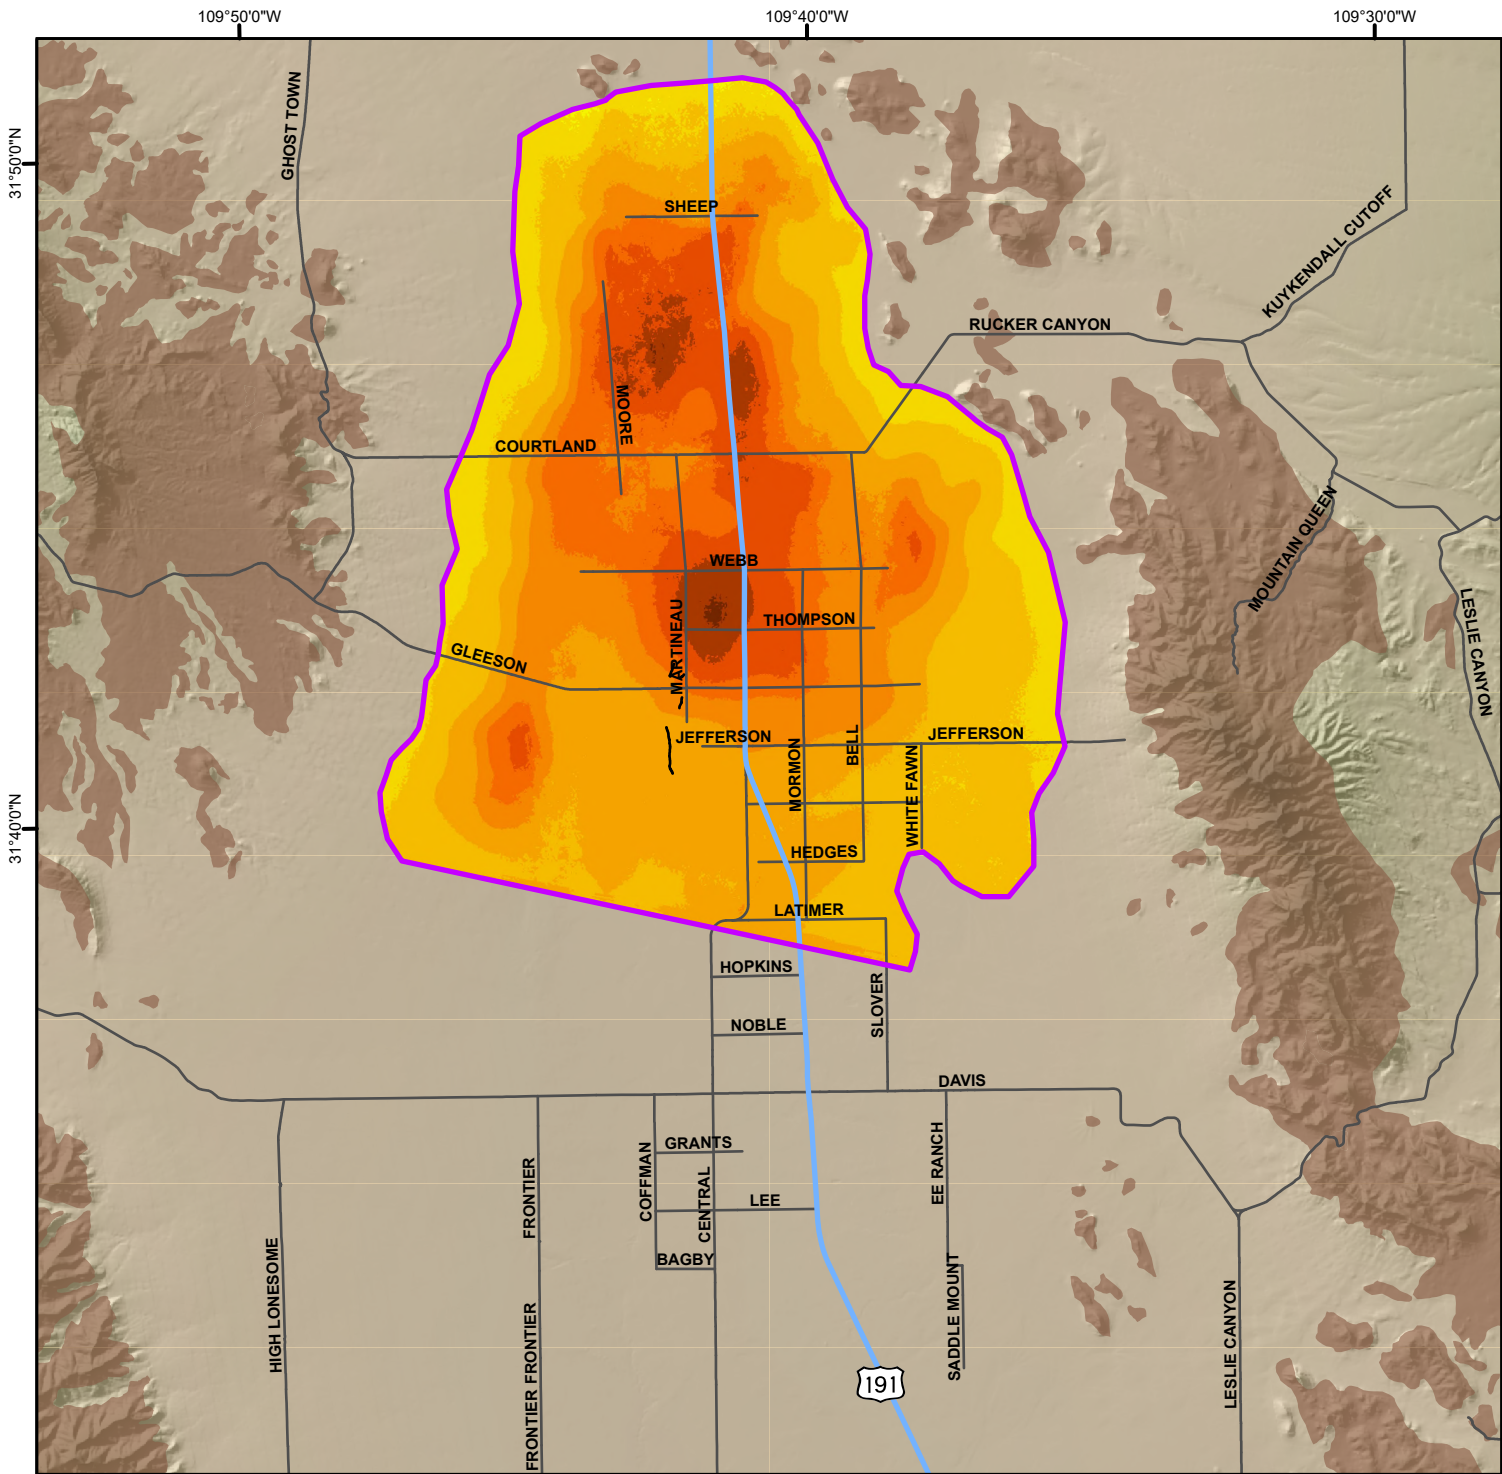
Decorrelation (white areas) are areas where the phase of the received satellite signal changed between satellite passes, causing the data to be unusable. This occurs in areas where the land surface has been disturbed (i.e. bodies of water, snow, agriculture areas, areas of development, etc).
