**Total Land Subsidence in the Gila Bend Area, Maricopa County**  
 Based on Sentinel-1 Satellite Interferometric Synthetic Aperture Radar (InSAR) Data  
 Time Period of Analysis: 9.1 Years 03/01/2017 To 05/13/2026

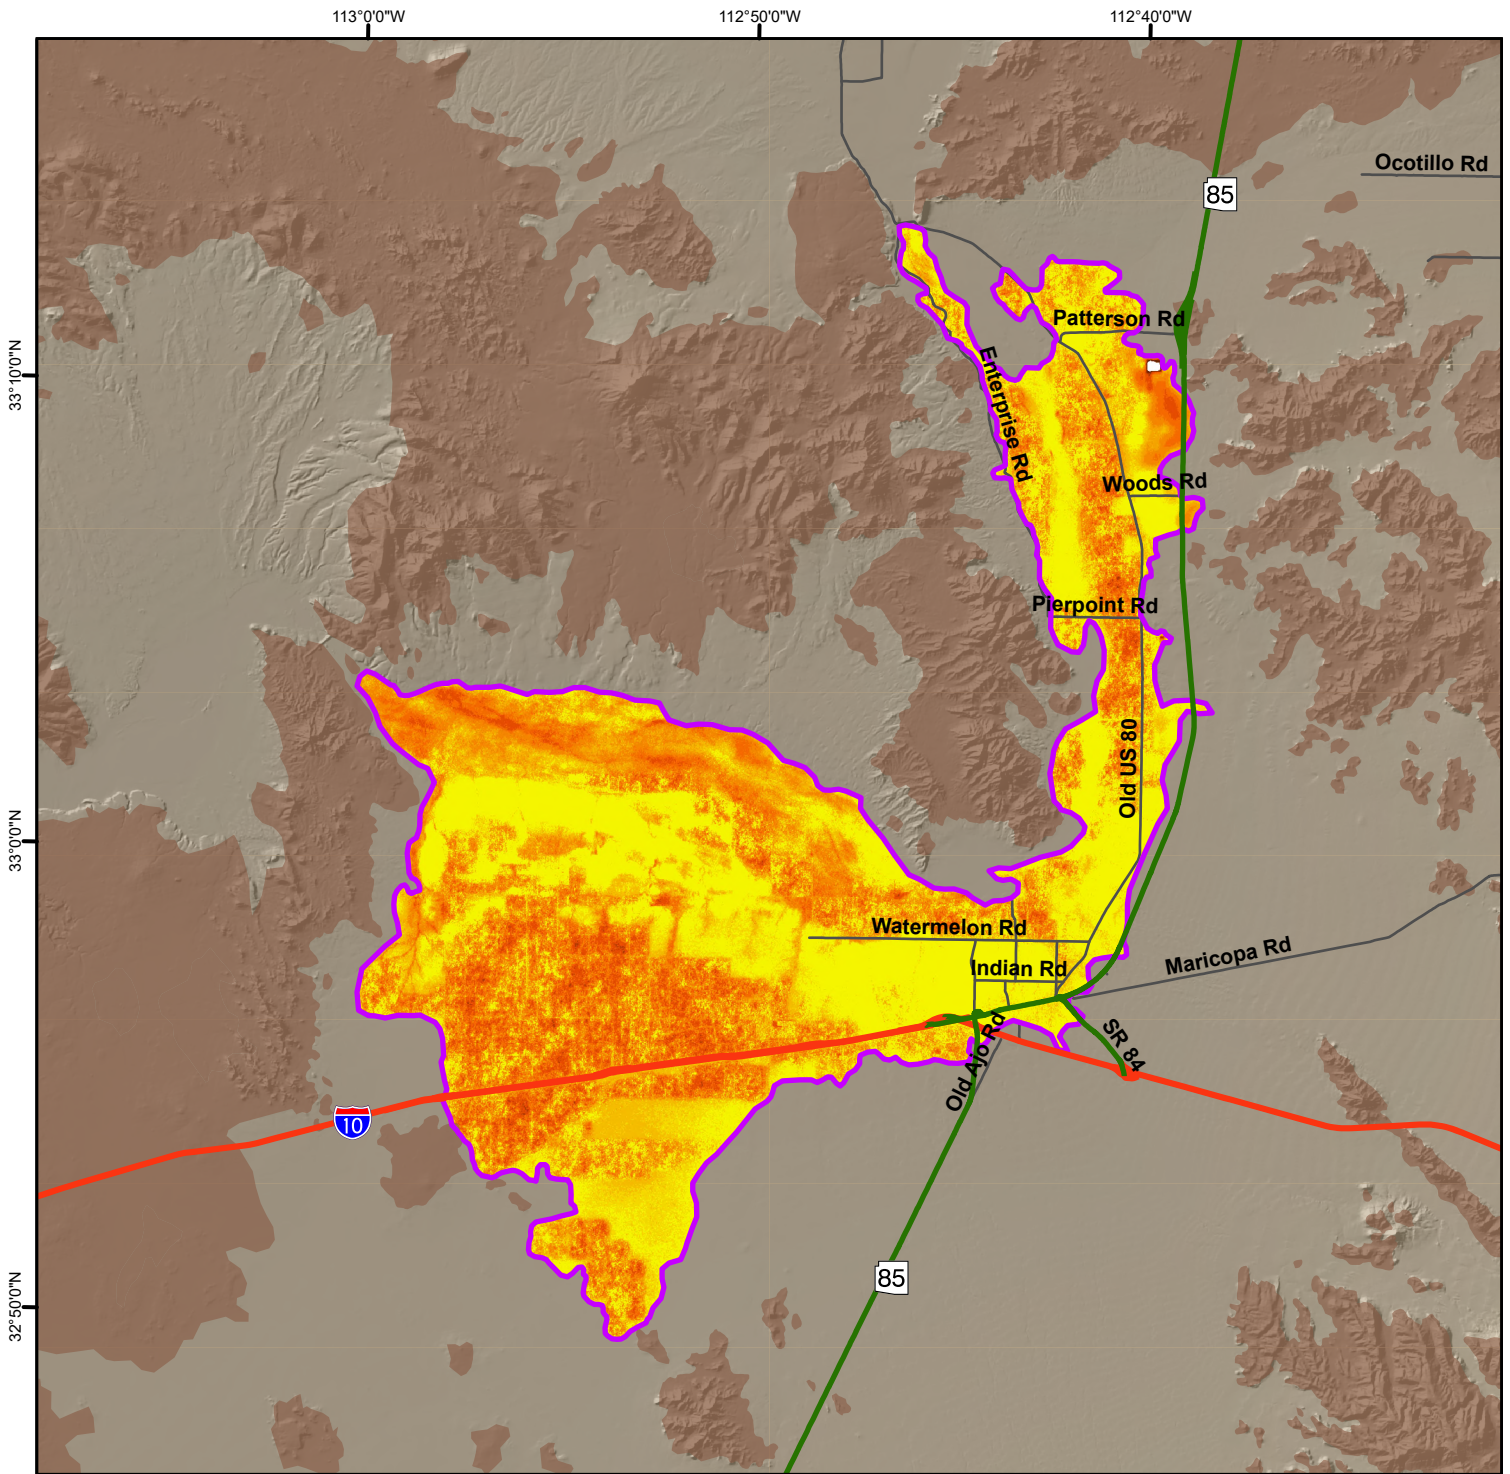
03/01/2017 To 05/13/2026	Subsidence Feature
Total Land Subsidence	Hardrock
Decorrelation/No Data	<b>Highways and Interstates</b>
Greater 40 cm (15.7 in)	Interstate
25 - 40 cm (9.8 - 15.7 in)	US
15 - 25 cm (5.9 - 9.8 in)	State
10 - 15 cm (3.9 - 5.9 in)	Roads
6 - 10 cm (2.4 - 3.9 in)	
4 - 6 cm (1.6 - 2.4 in)	
2 - 4 cm (0.8 - 1.6 in)	
1 - 2 cm (0.4 - 0.8 in)	
0 - 1 cm (0 - 0.4 in)

Decorrelation (white areas) are areas where the phase of the received satellite signal changed between satellite passes, causing the data to be unusable. This occurs in areas where the land surface has been disturbed (i.e. bodies of water, snow, agriculture areas, areas of development, etc).
