Total Land Subsidence in the Gila Bend Area, Maricopa County
Based on Radarsat-2 Satellite Interferometric Synthetic Aperture Radar (InSAR) Data
Time Period of Analysis: 2.0 Years 05/16/2024 To 05/06/2026

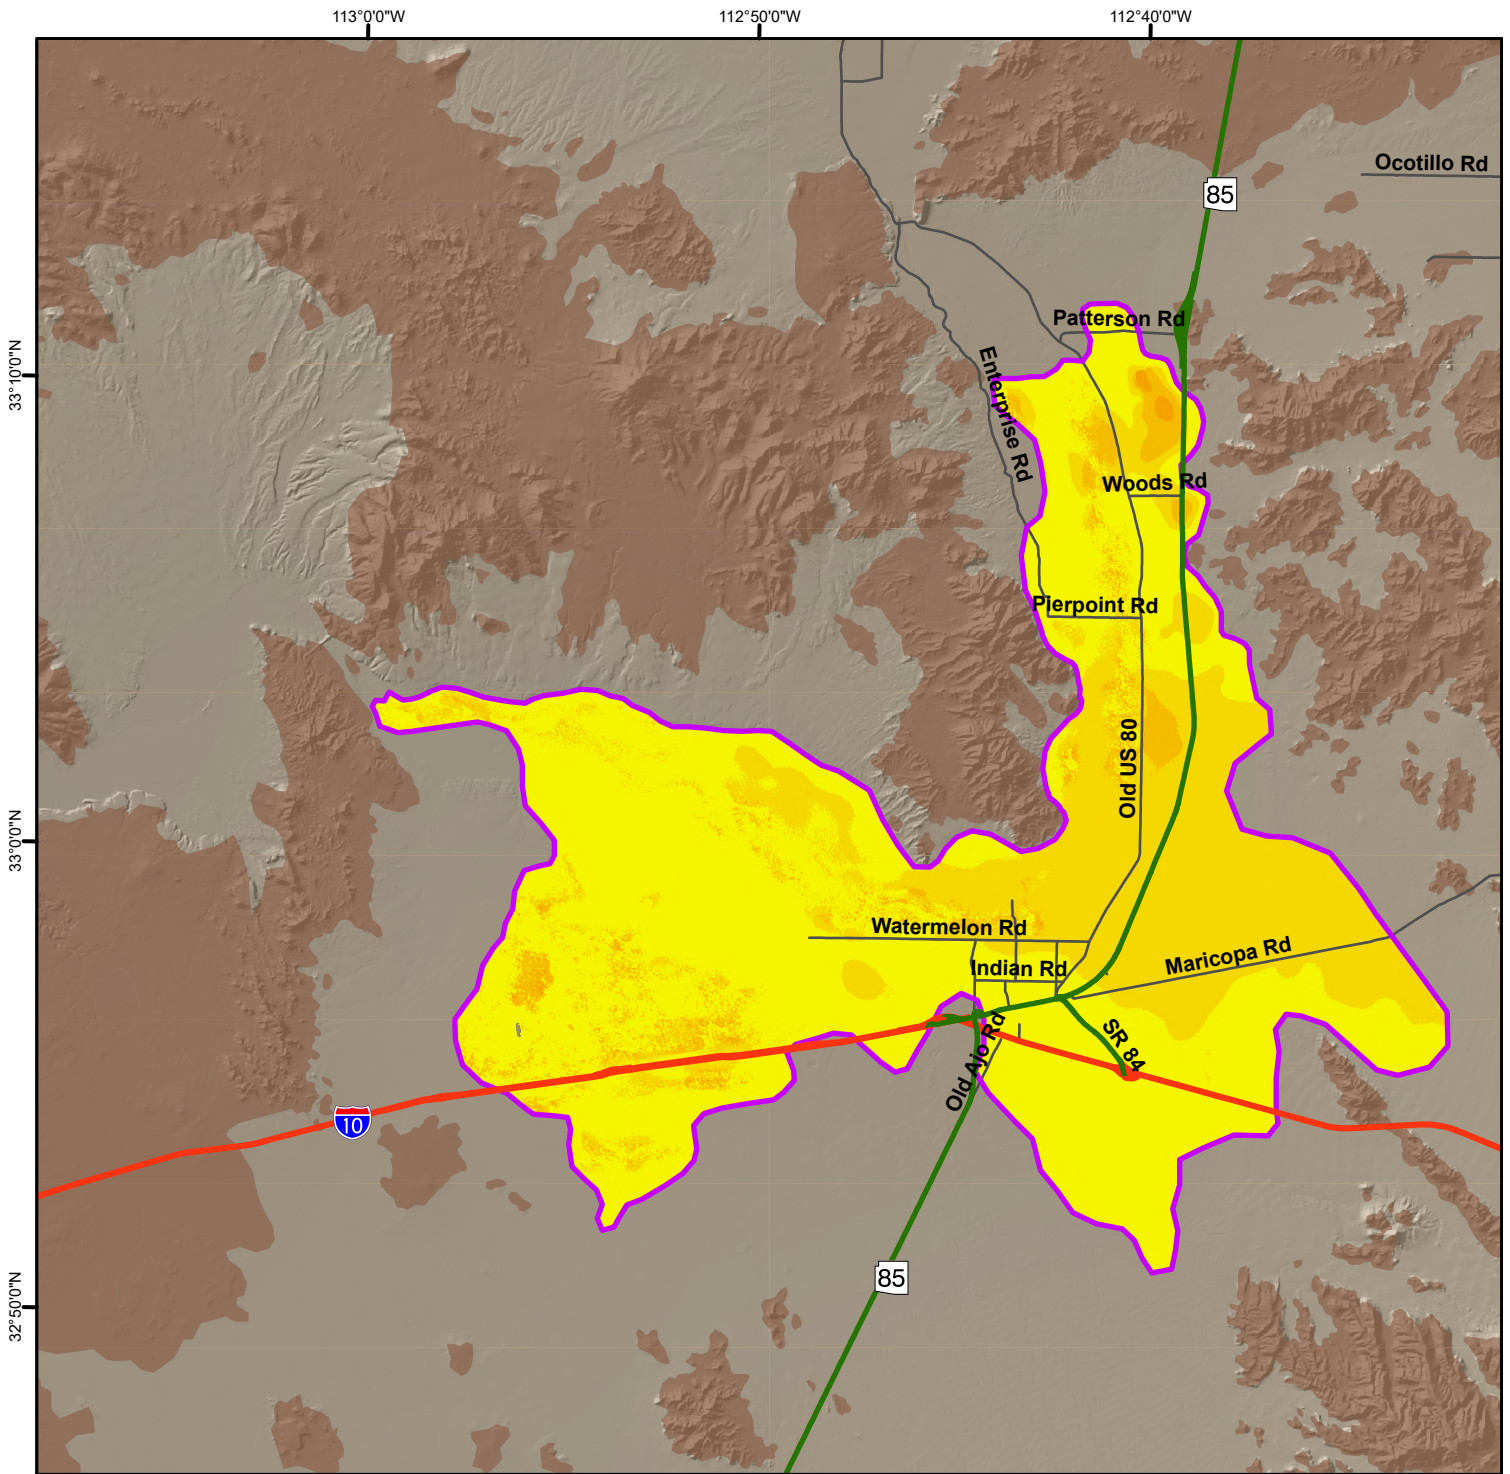
05/16/2024 To 05/06/2026	Subsidence Feature
Total Land Subsidence	Hardrock
Decorrelation/No Data	Highways and Interstates
Greater 40 cm (15.7 in)	Interstate
25 - 40 cm (9.8 - 15.7 in)	US
15 - 25 cm (5.9 - 9.8 in)	State
10 - 15 cm (3.9 - 5.9 in)	Roads
6 - 10 cm (2.4 - 3.9 in)	
4 - 6 cm (1.6 - 2.4 in)	
2 - 4 cm (0.8 - 1.6 in)	
1 - 2 cm (0.4 - 0.8 in)	
0 - 1 cm (0 - 0.4 in)

Decorrelation (white areas) are areas where the phase of the received satellite signal changed between satellite passes, causing the data to be unusable. This occurs in areas where the land surface has been disturbed (i.e. bodies of water, snow, agriculture areas, areas of development, etc).
