**Total Land Subsidence in the Harquahala Valley, Maricopa County**  
 Based on Radarsat-2 Satellite Interferometric Synthetic Aperture Radar (InSAR) Data  
 Time Period of Analysis: 2.0 Years 03/12/2024 To 03/26/2026

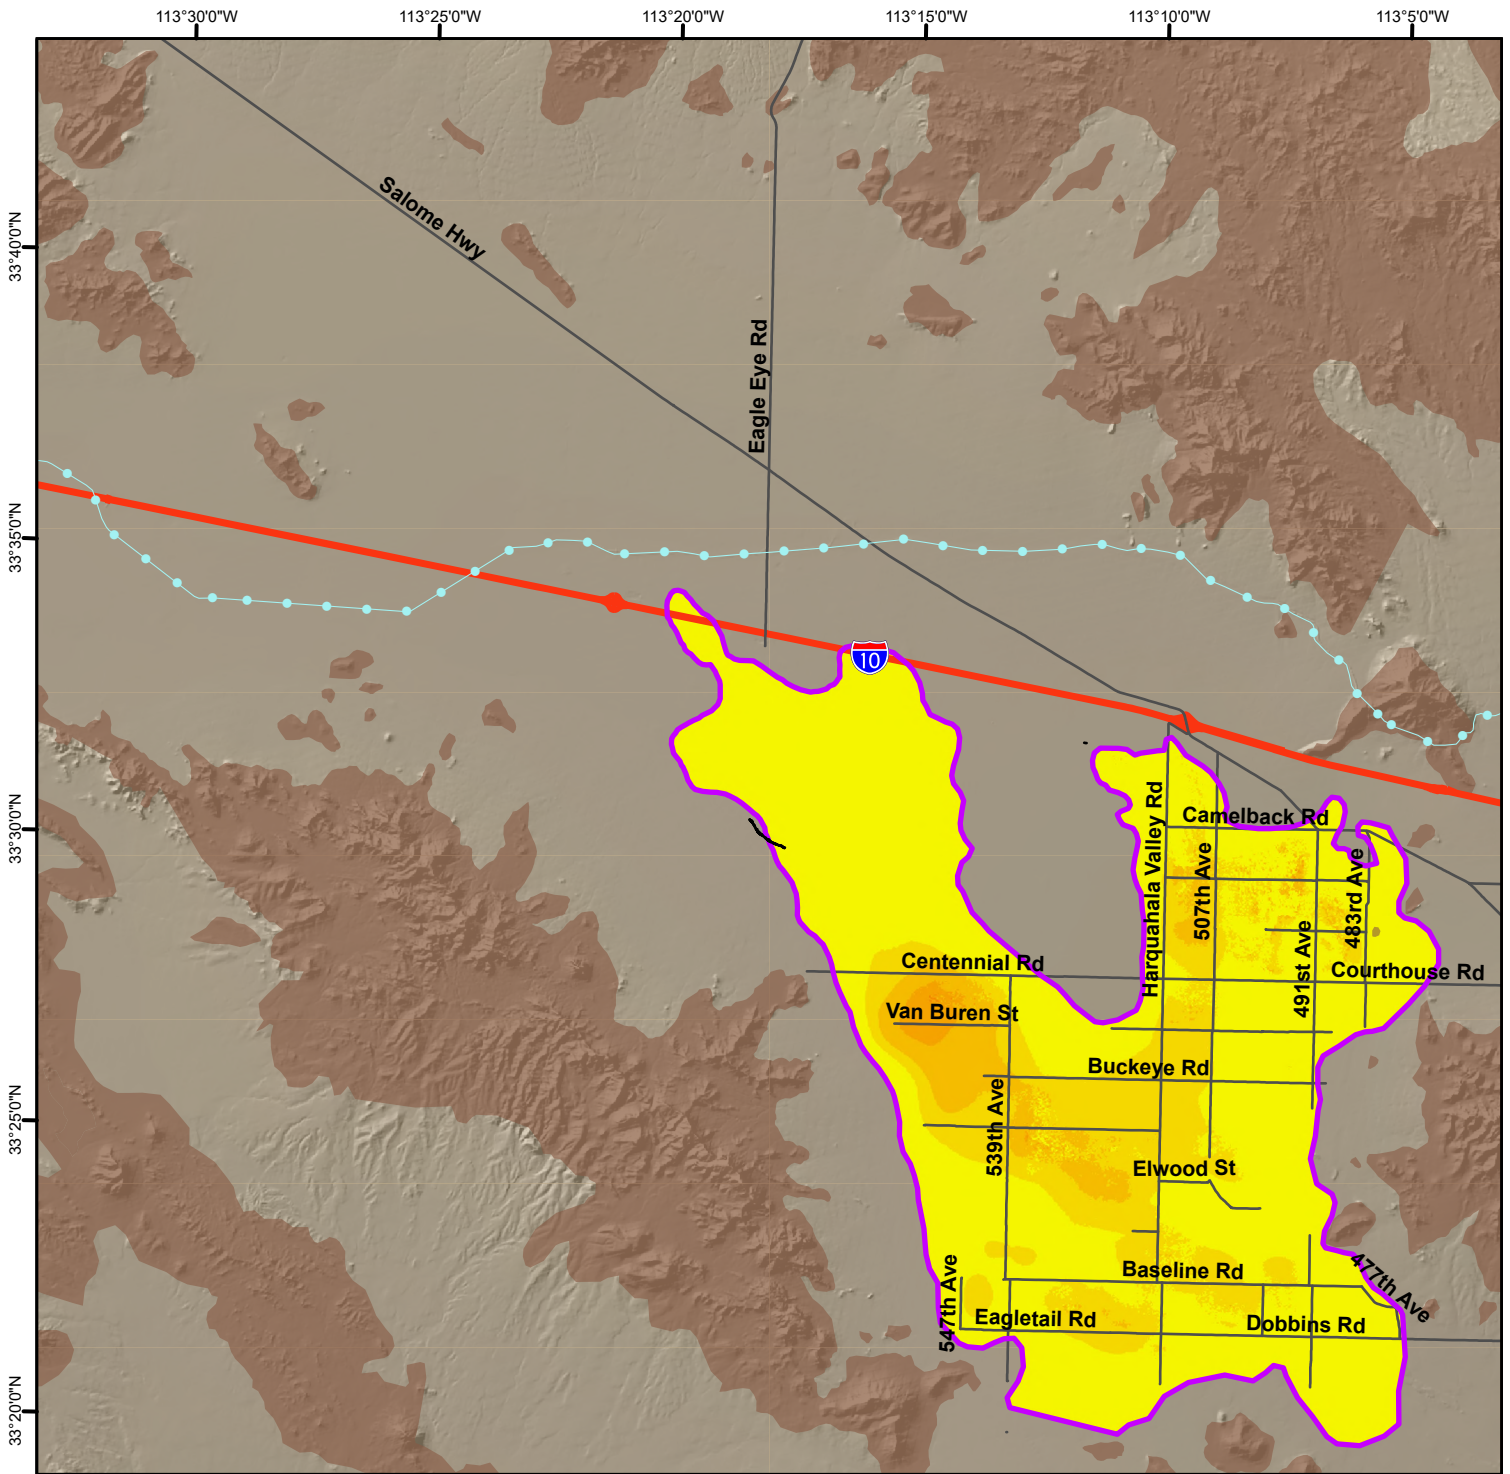
Decorrelation (white areas) are areas where the phase of the received satellite signal changed between satellite passes, causing the data to be unusable. This occurs in areas where the land surface has been disturbed (i.e. bodies of water, snow, agriculture areas, areas of development, etc).

Earth fissures were mapped by the Arizona Geological Survey. For information on earth fissures visit: [www.azgs.gov/EFC](http://www.azgs.gov/EFC)
