**Total Land Subsidence in the Lower Gila Area, Maricopa and Yuma Counties**  
 Based on Sentinel-1 Satellite Interferometric Synthetic Aperture Radar (InSAR) Data  
 Time Period of Analysis: 9.0 Years 04/23/2017 To 04/24/2026

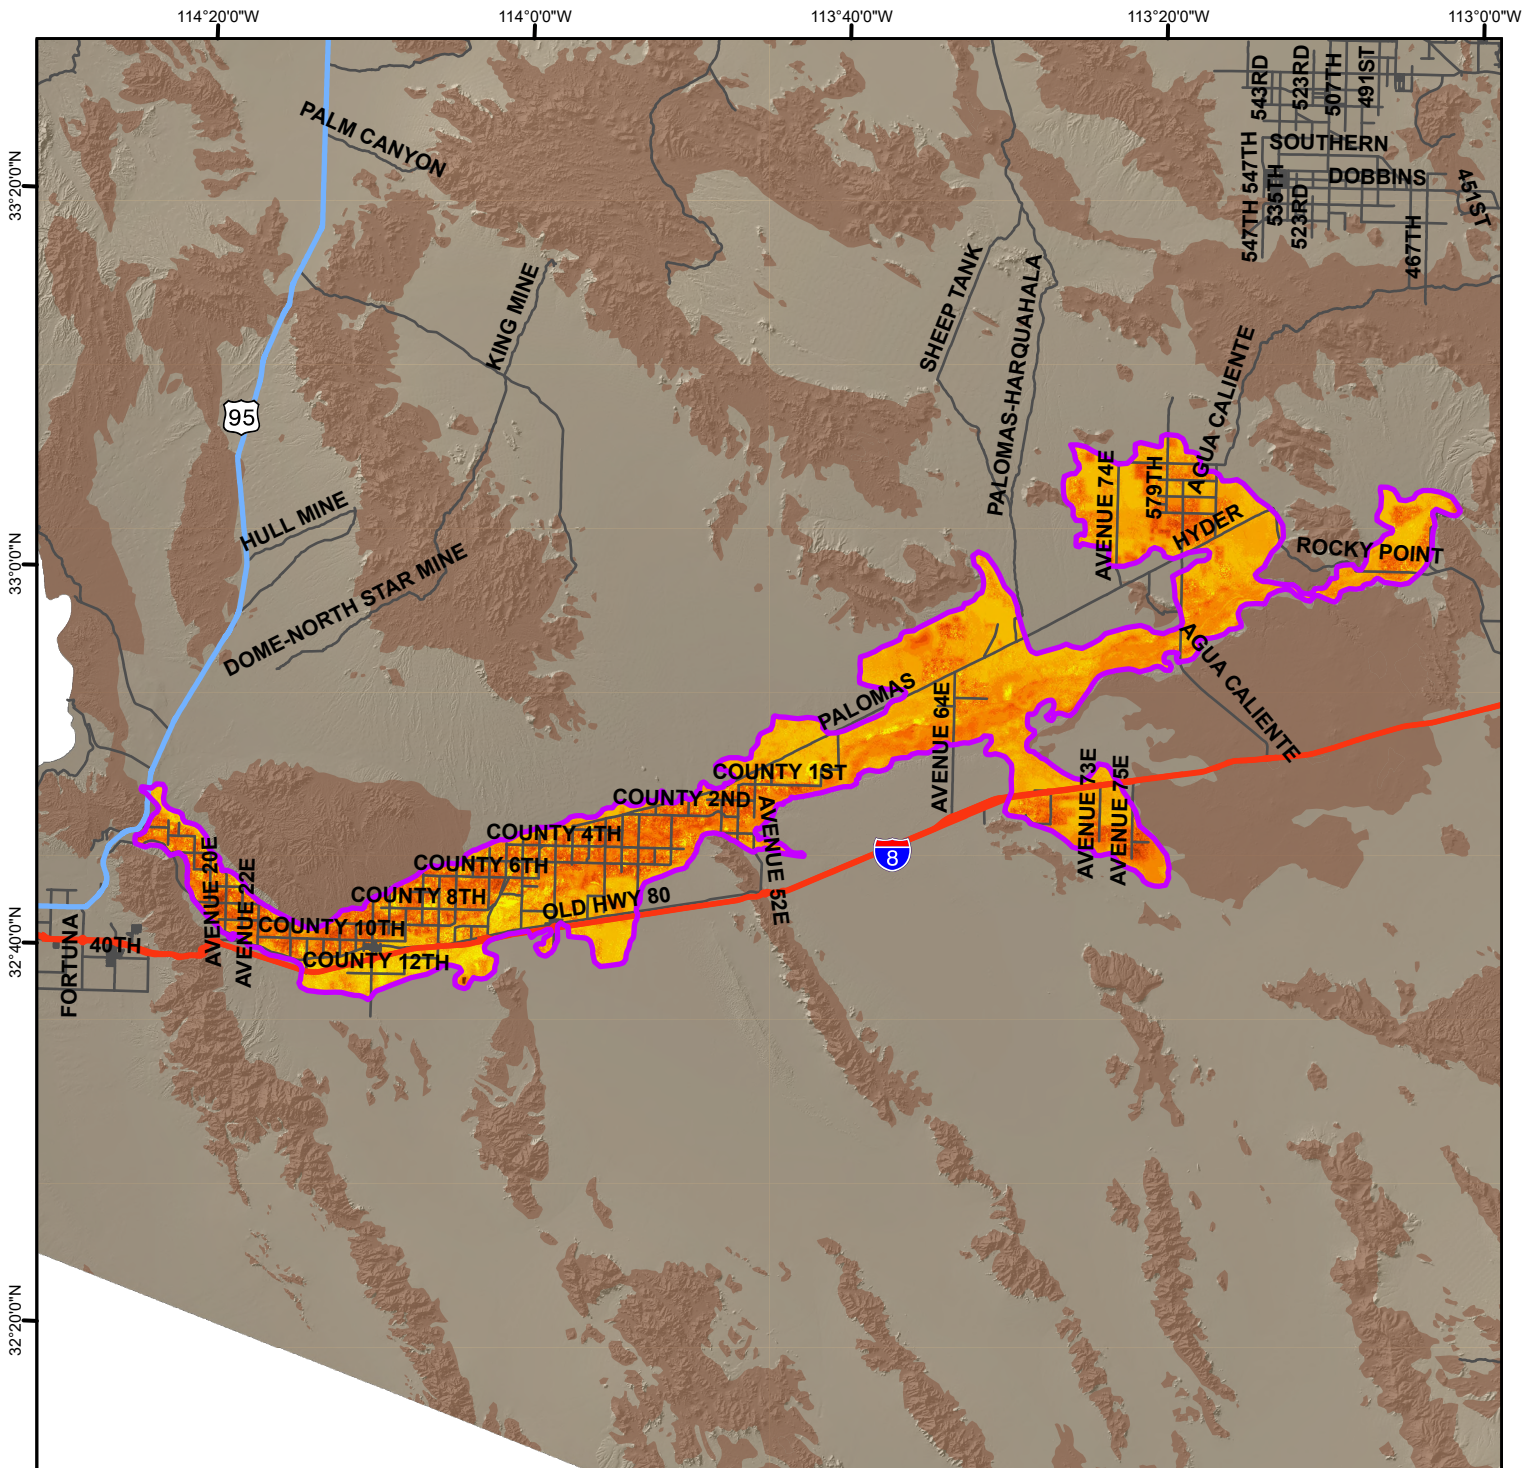
Decorrelation (white areas) are areas where the phase of the received satellite signal changed between satellite passes, causing the data to be unusable. This occurs in areas where the land surface has been disturbed (i.e. bodies of water, snow, agriculture areas, areas of development, etc).
